HALLIBURTON

iCem[®] Service

Northwest A S20-25-10N Production

1.0 Cementing Job Summary

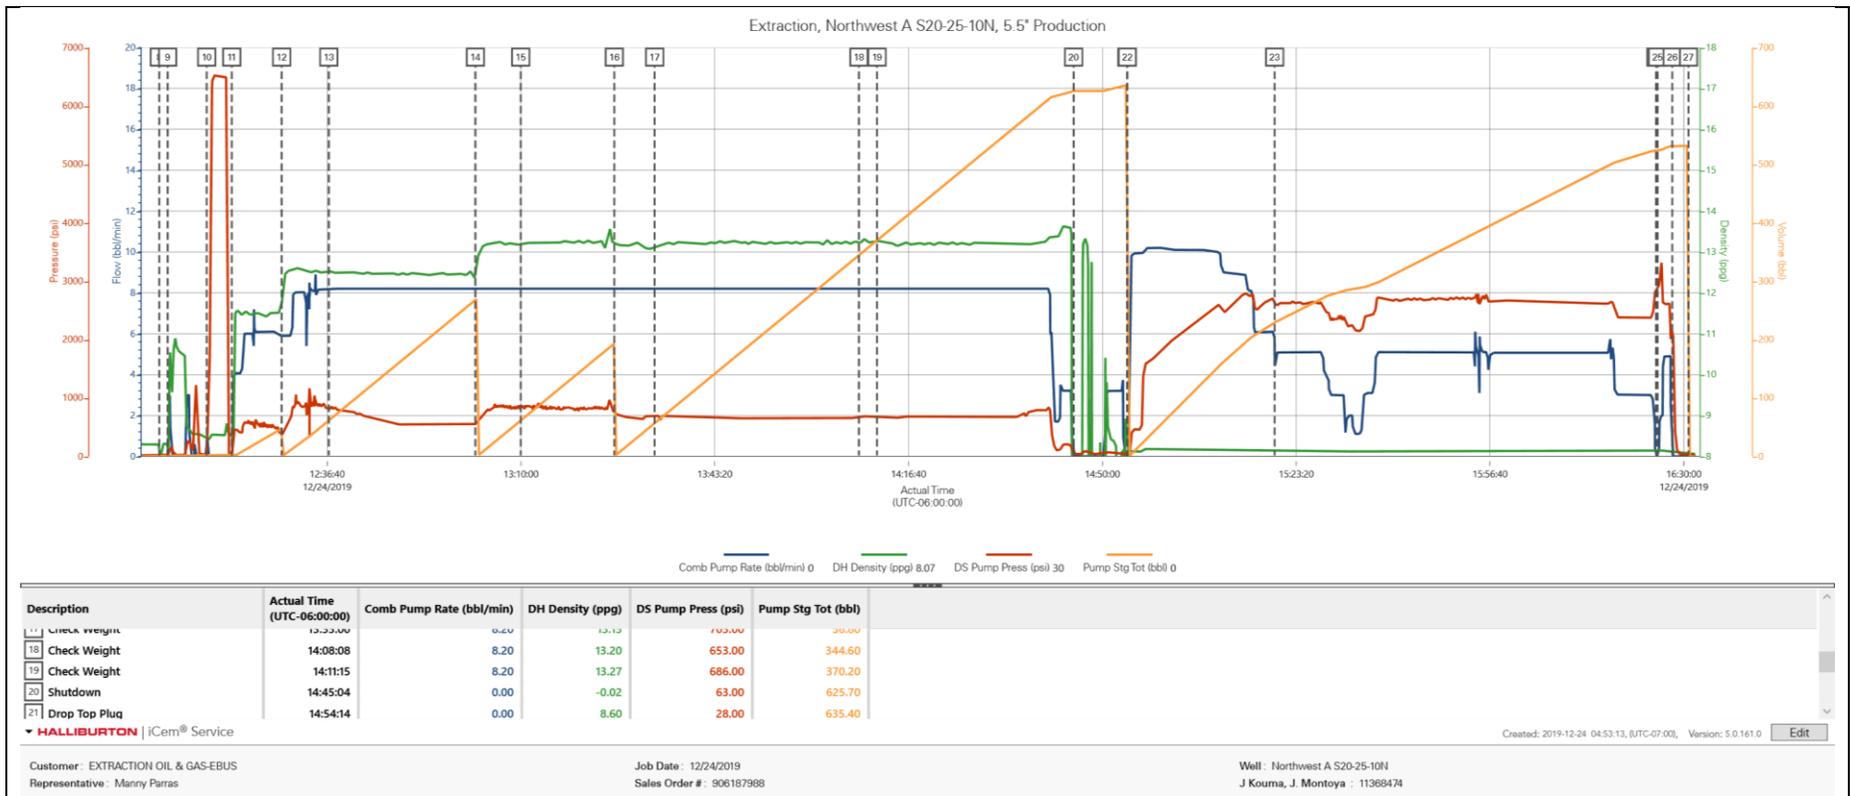
3.1 Northwest A S20-25-10N Production – Job Chart

Comment Got 0bbls cap cement to surface. Lost returns around 260bbls away. Did not regain after slowing rate. Est 720bbls cement in OH once returns stopped. Based on 720bbls Est TOT-4076', TOL-5210'
