| Location: | Whitehead 12-7 |
| Line: | Well to Treater |
| Date | 10/4/2019 |

Pass/Fail

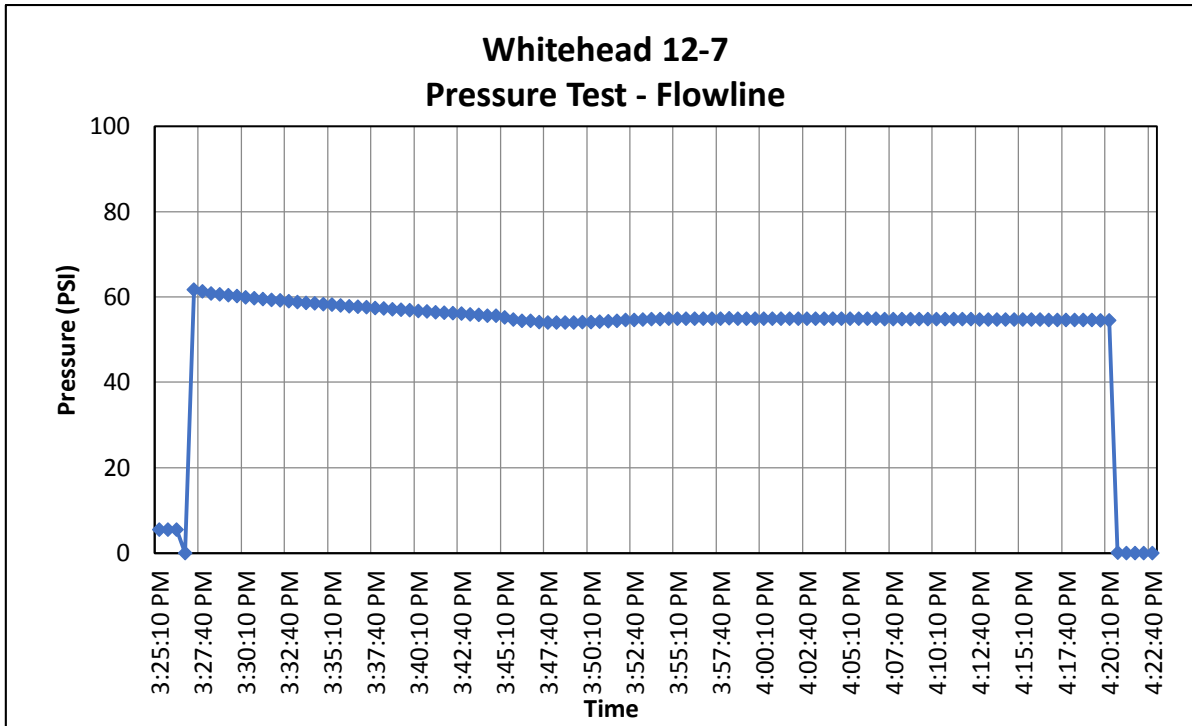
| % loss over 30 minutes | 2.17% | Less than 10% | Yes | | |
| % loss in last 5 minutes | 0.37% | Less than 1% | Yes | | Pass |

Found and repaired leaking valve in middle of test
