APACHE CANYON 06-14 API# 05-071-08321 – TIMBER CREEK OPERATING
OGCC OPERATOR NUMBER 10672 - DATE: MARCH 26, 2020
CORRECTIVE ACTIONS COMPLETED REGARDING COGCC FIR DOCUMENT # 689901859

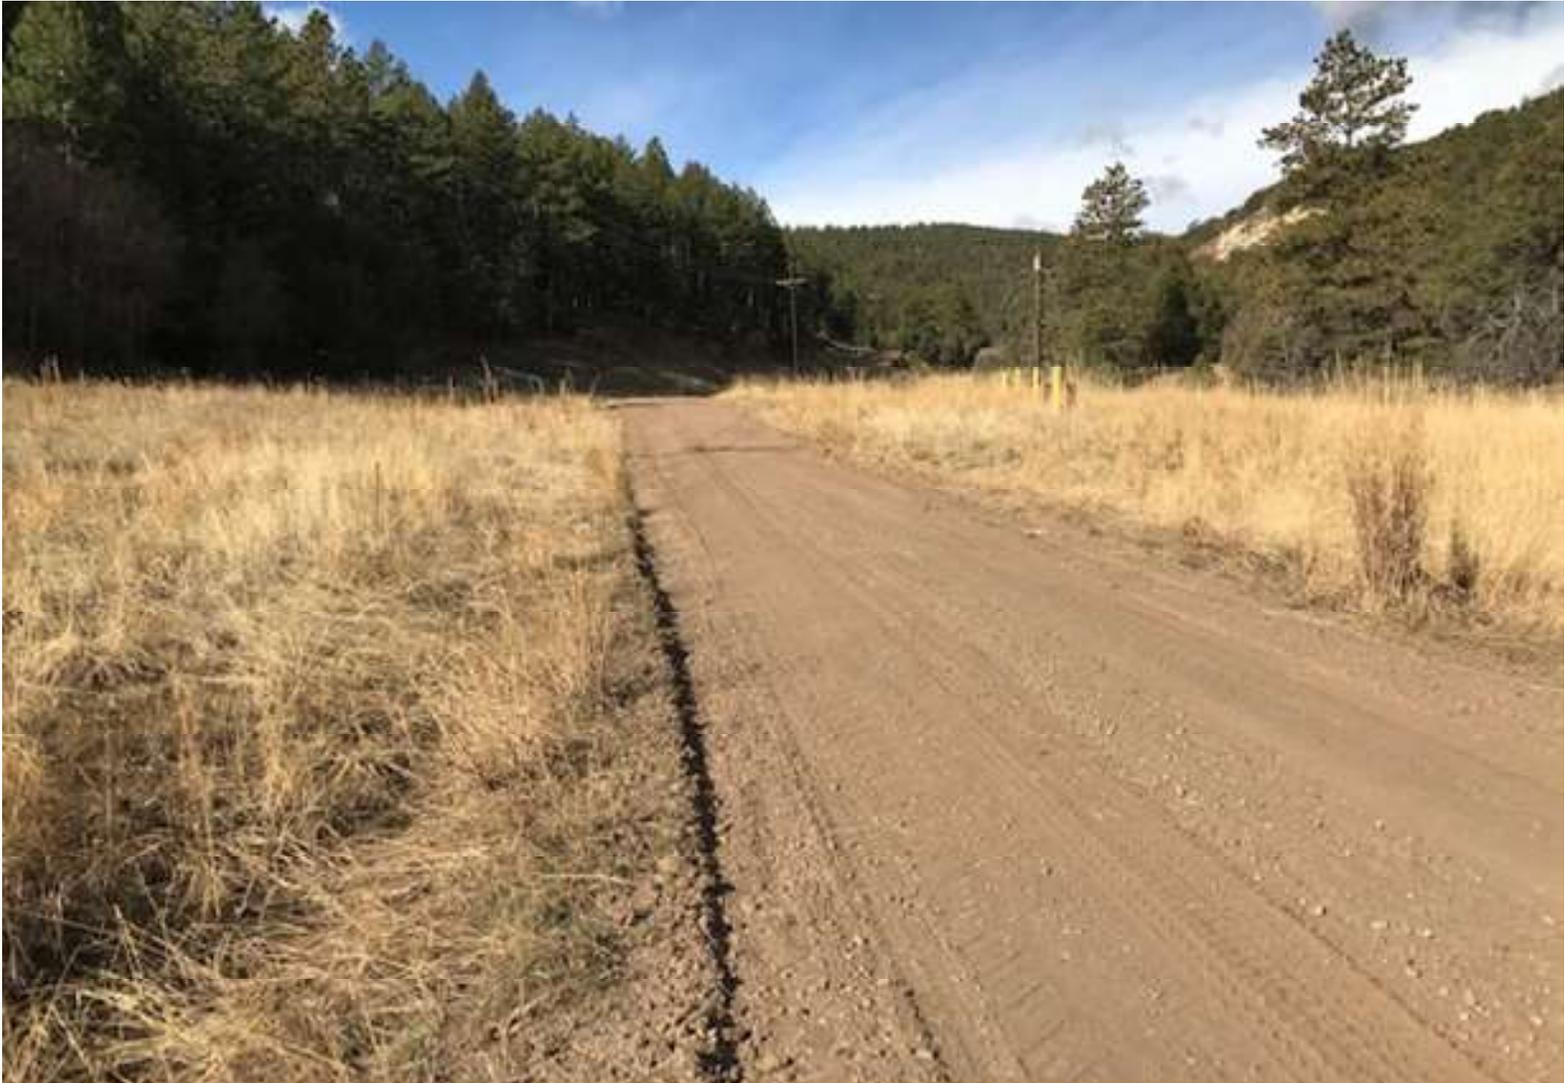
PHOTO 1: FACING WEST ALONG THE MAIN LEASE ROAD IN ALAMOSITO CANYON. THE MAIN LEASE ROAD SURFACE WAS CROWNED TO REMOVE THE TIRE RUTS AND ESTABLISH SHEET FLOW.

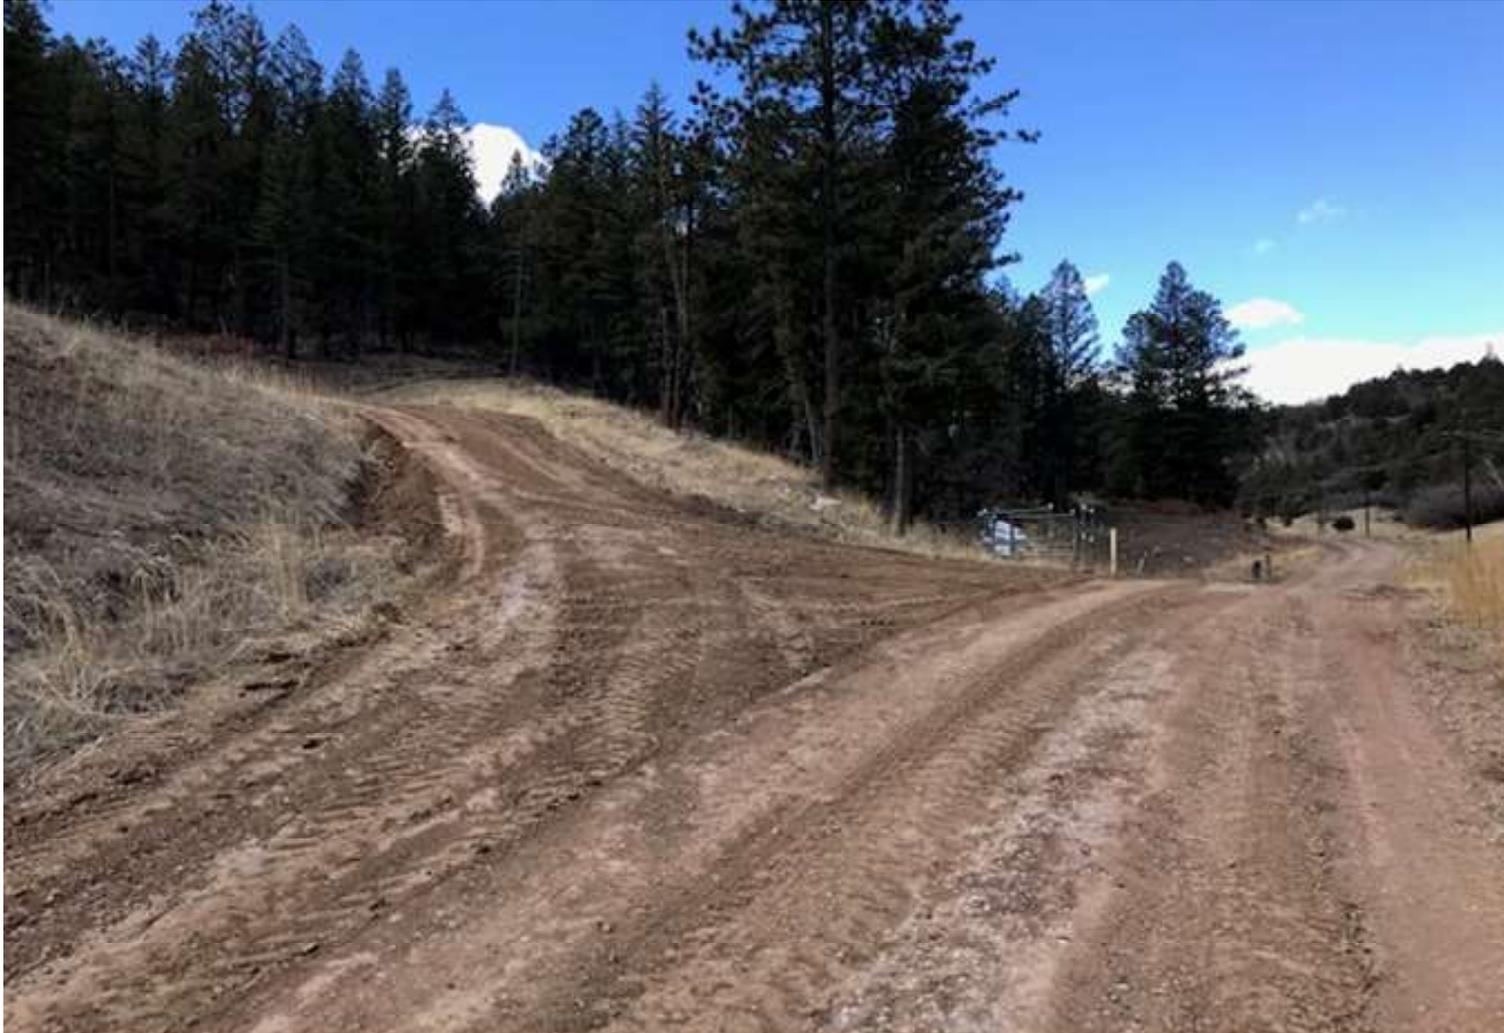
PHOTO 2: FACING SOUTHWEST TOWARD THE ACCESS ROAD TO AC 06-14 WELL PAD. ONCE THE SNOW MELTED AND THE SOIL DRIED OUT, THE ACCESS ROAD SURFACE WAS CROWNED TO REMOVE THE TIRE RUTS AND ESTABLISH SHEET FLOW.

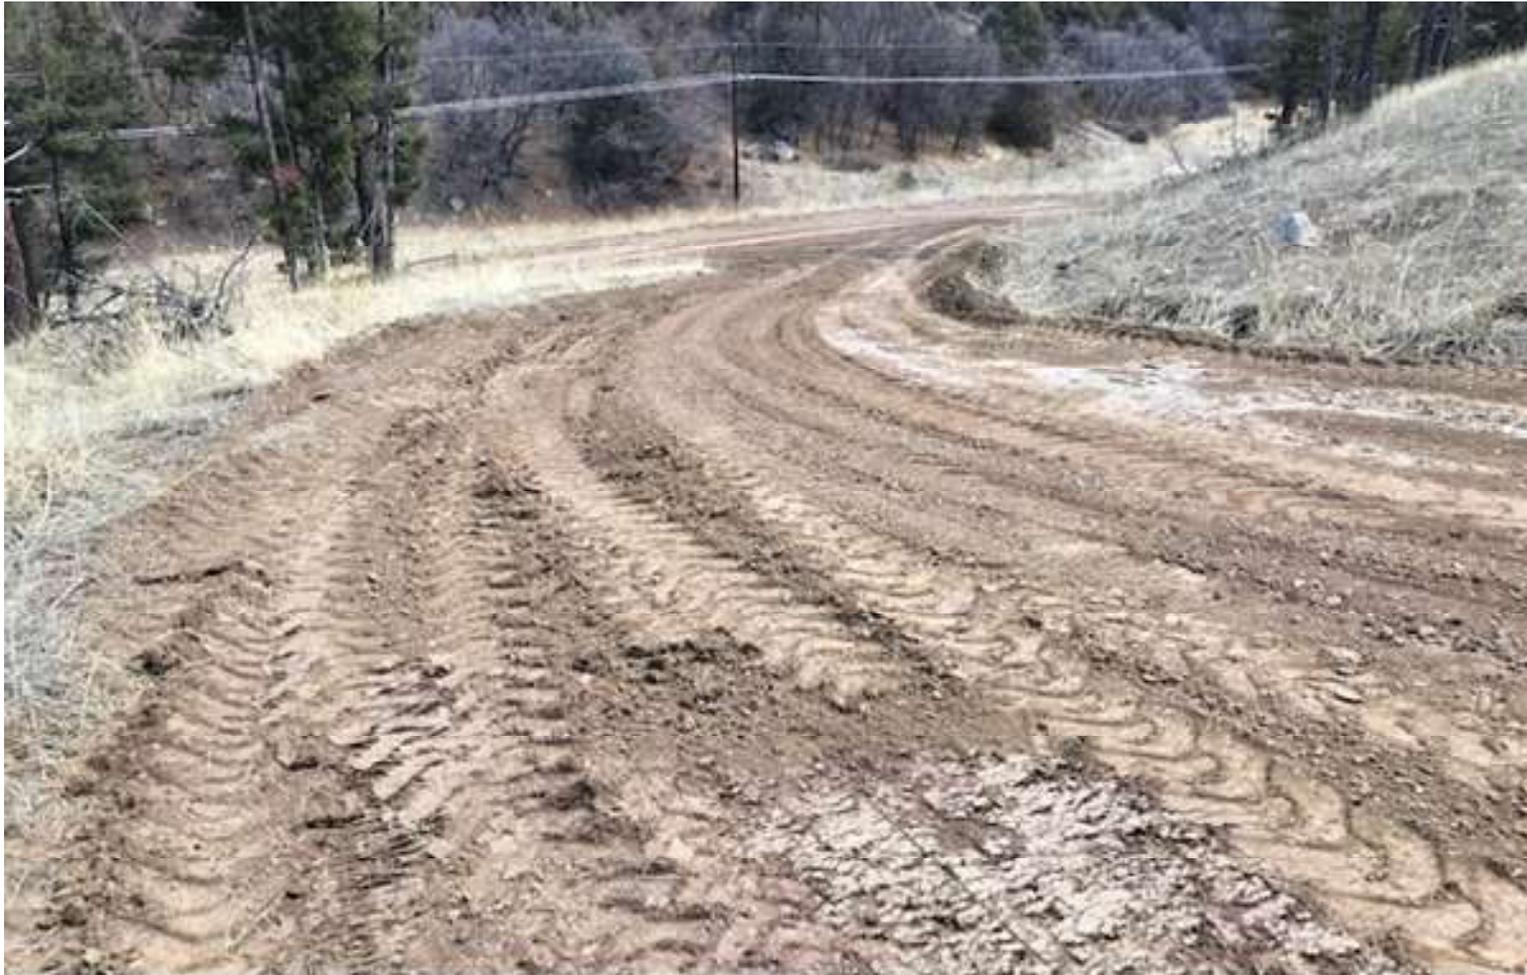
PHOTO 3: FACING BACK TOWARD THE MAIN LEASE ROAD. ONCE THE SNOW MELTED AND THE SOIL DRIED OUT, THE ACCESS ROAD SURFACE WAS CROWNED TO REMOVE THE TIRE RUTS AND ESTABLISH SHEET FLOW.
