spill 468756

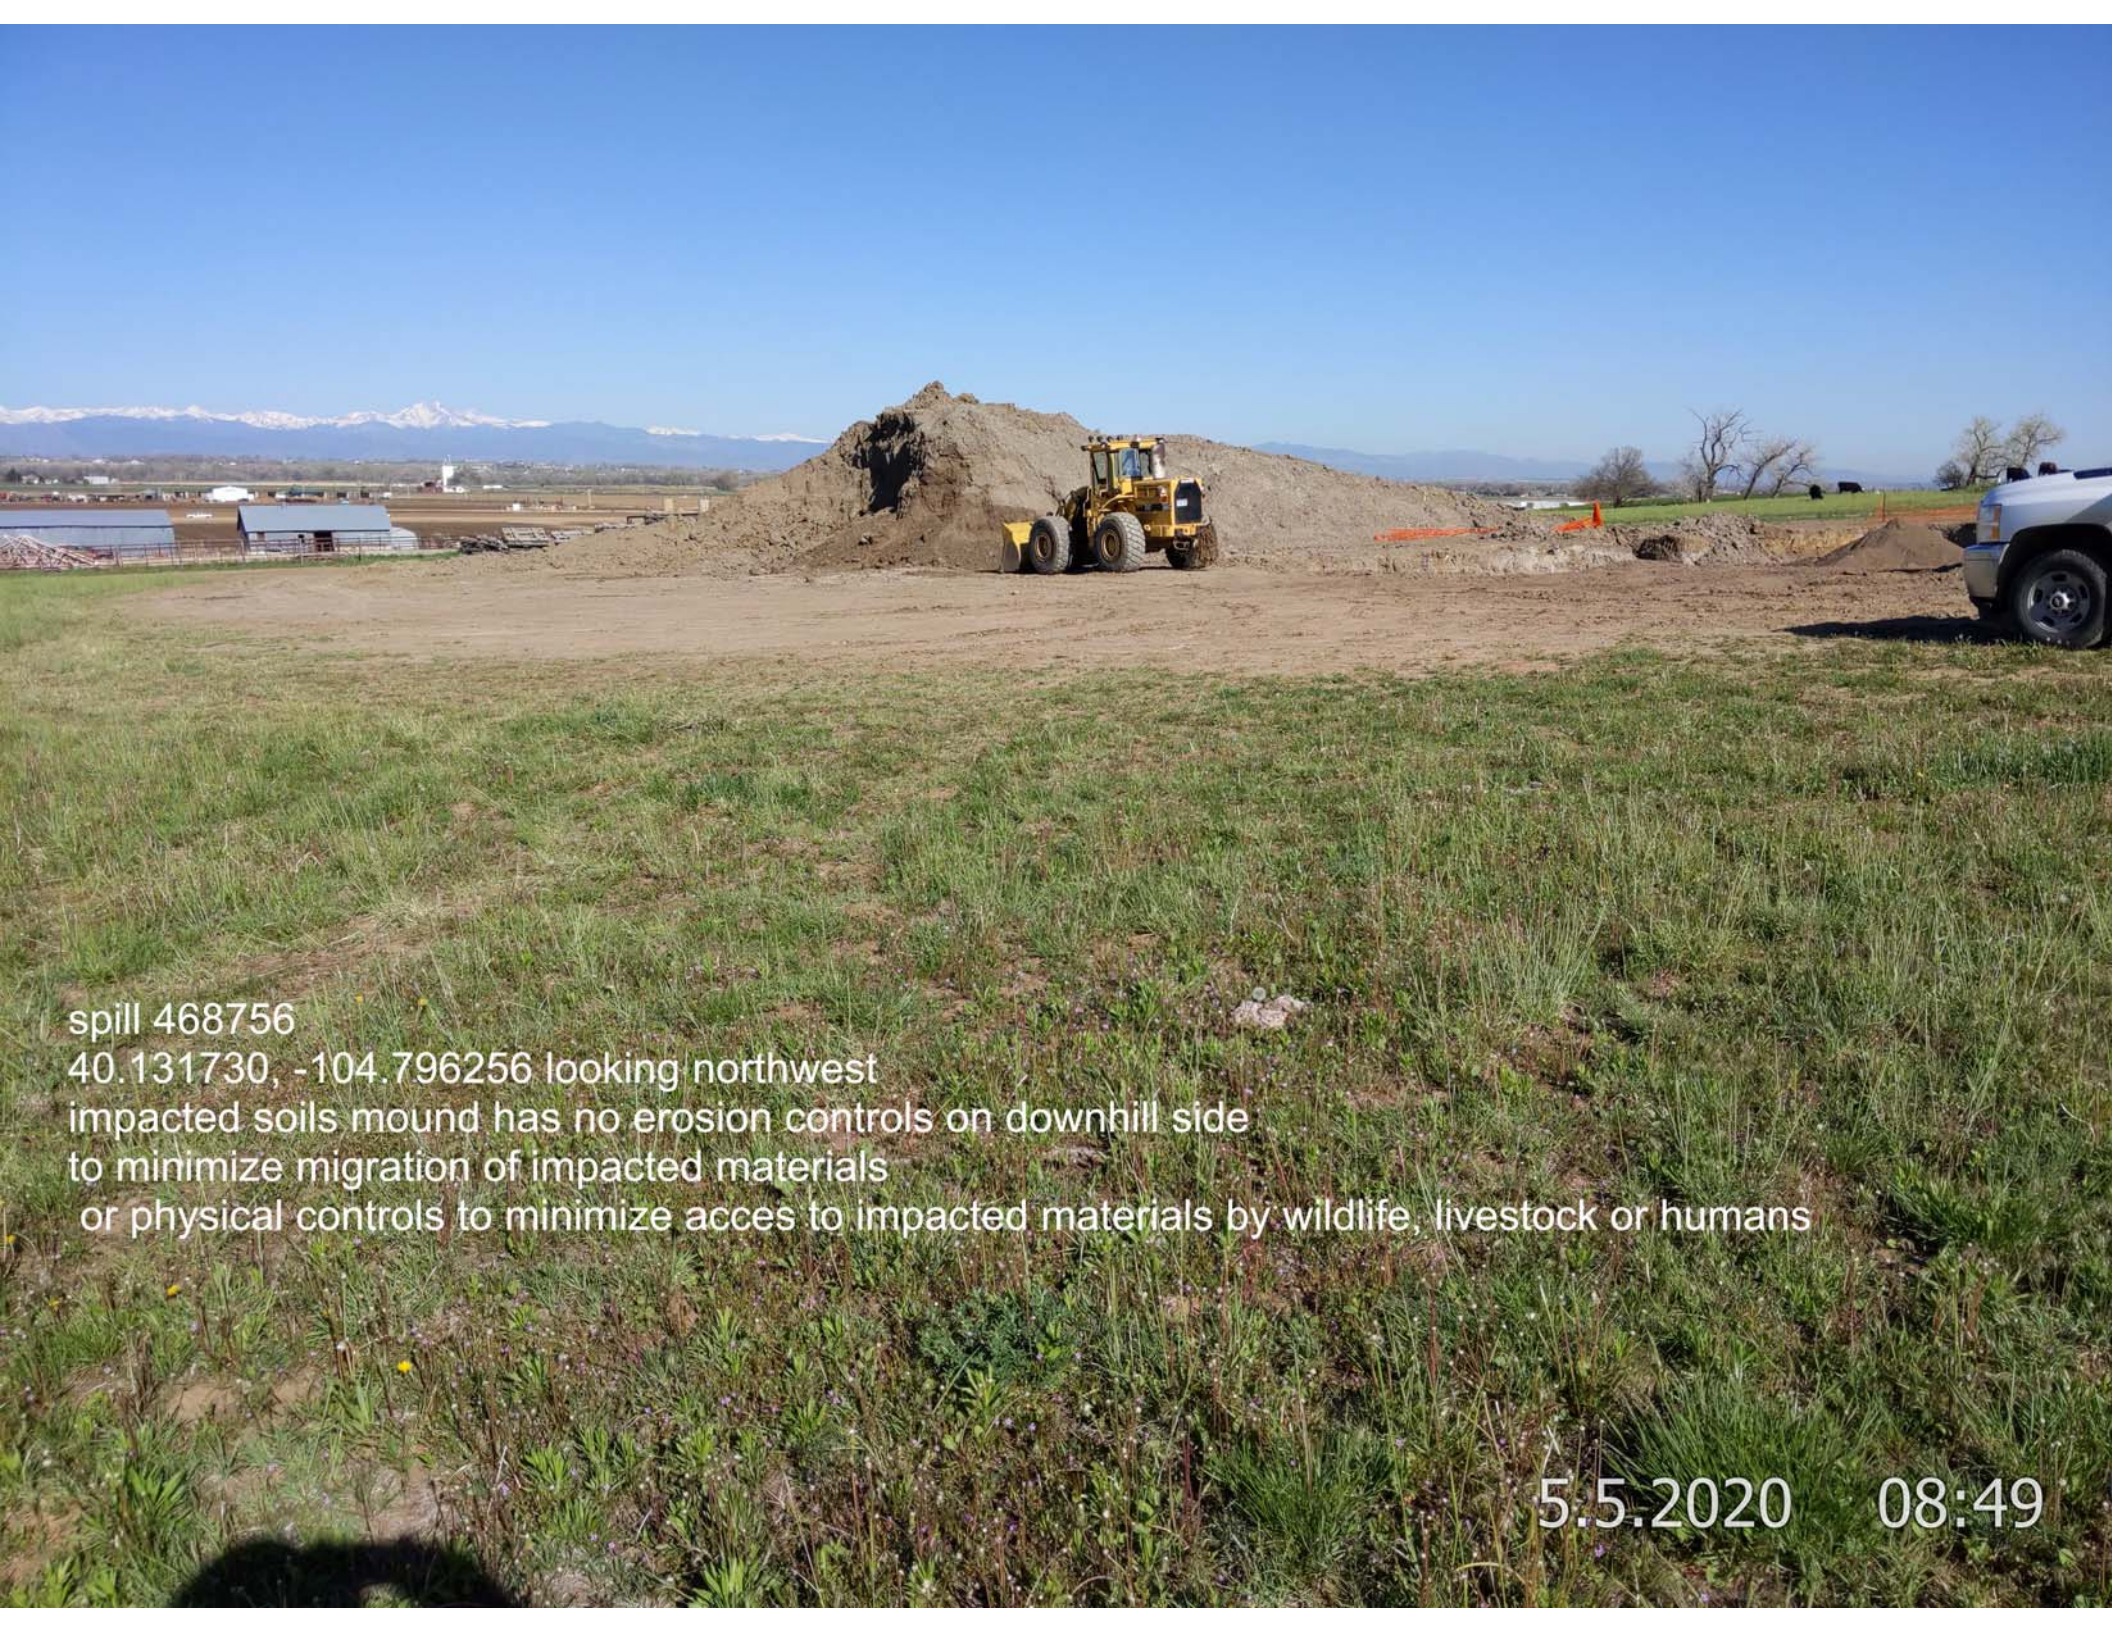
40.131730, -104.796256 looking northwest

impacted soils mound has no erosion controls on downhill side

to minimize migration of impacted materials

or physical controls to minimize access to impacted materials by wildlife, livestock or humans
