Inspection Photos  
Location Name: MORRISON 44-17  
API#: 05-071-08653  
INSP. #: 695102849

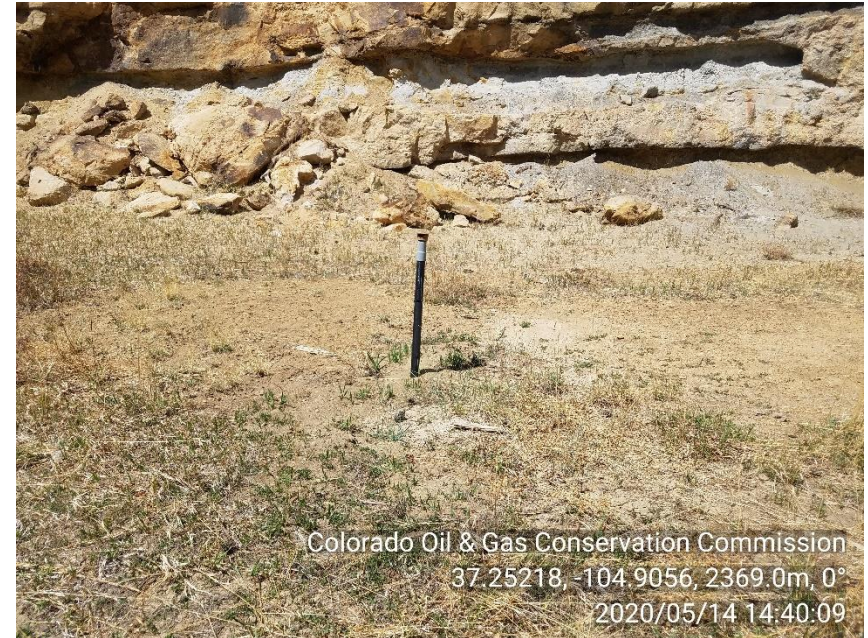
**PHOTO 4: UNUSED EQUIPMENT (2" RISER). REMOVE  
 UNUSED EQUIPMENT COMPLY WITH NTO AND RULE 603.f.  
 CA DATE 8-14-20.**
