# Inspection Photos

Operator: LARAMIE ENERGY LLC - 10433

Location ID: 312620

Mesa County, CO

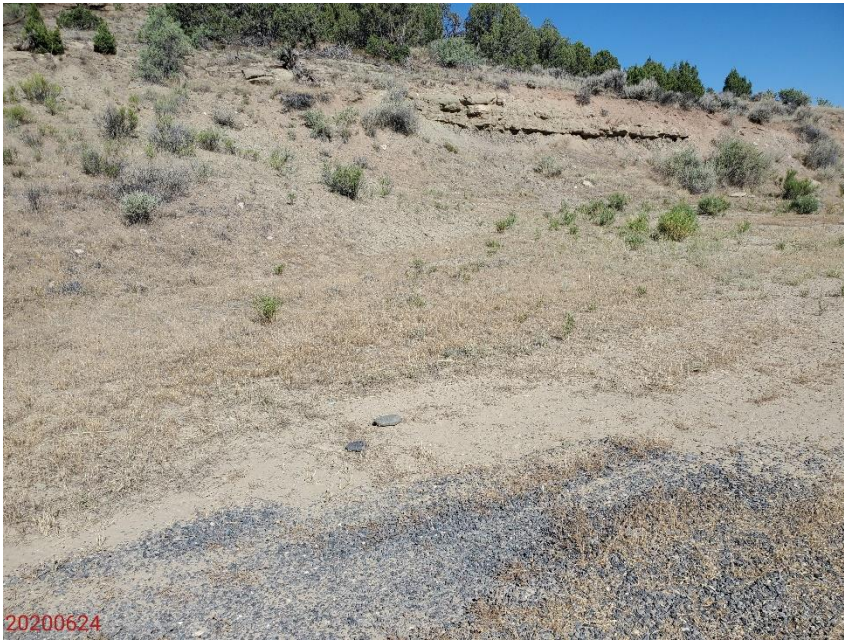
**Photo 1:** Photo taken from the south end of the Location, facing northwest. Photos 1-3 provide an overview of the Location from northwest, north to northeast. Photos show that production equipment has been removed from the Location, however reclamation activities including, but not limited to removal of gravel, compaction alleviation, recontouring, regrading and revegetation activities have not been conducted on the Location and access road in accordance with Rule 1004.a. Final reclamation required to be completed by 11/3/2018.

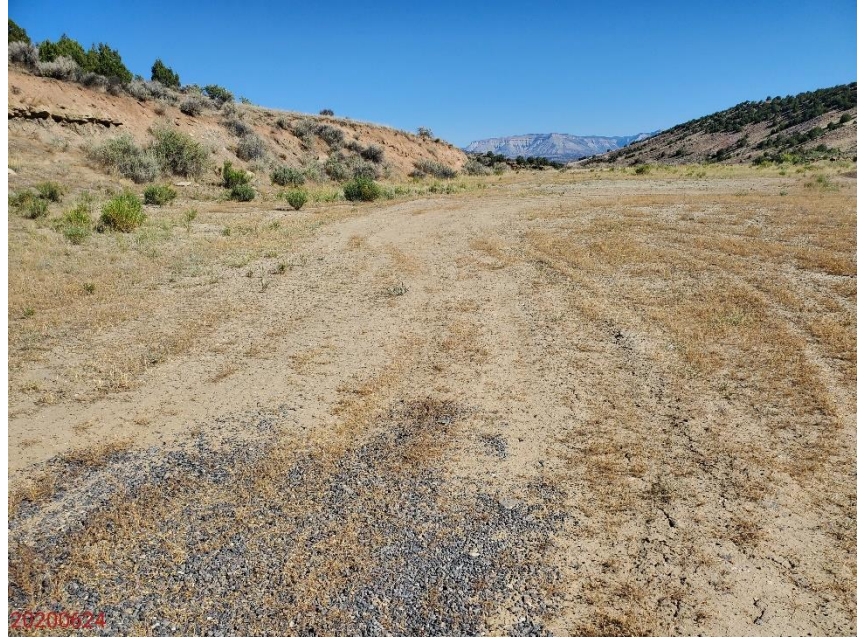
**Photo 2:** See comments under photo 1.

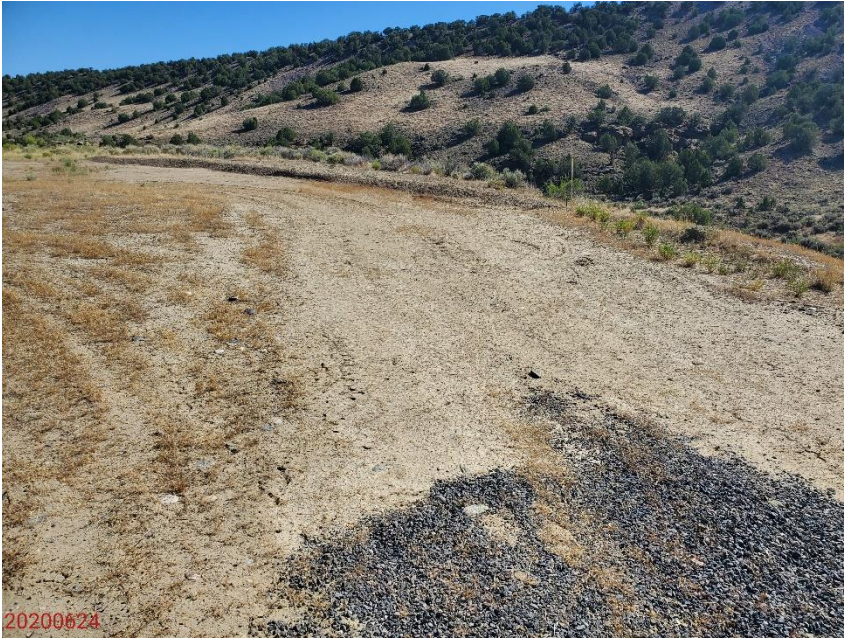
**Photo 3:** See comments under photo 1.

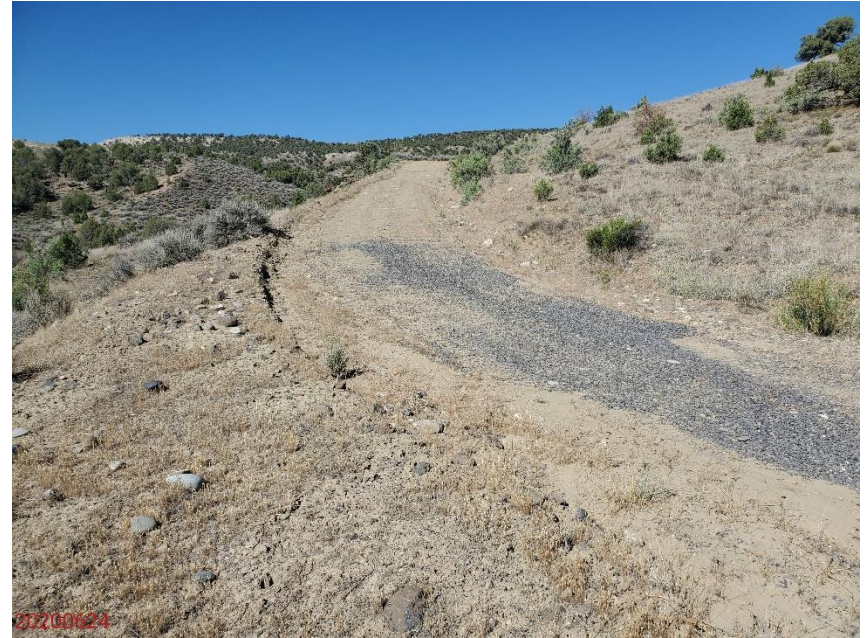
**Photo 4:** Photo taken from the south end of the Location facing west. Photo shows access road has not been reclaimed. See comments under photo 1.
