Inspection Photos
Location Name: EY #3-4
API#: 05-067-08149
INSP. #: 695103022

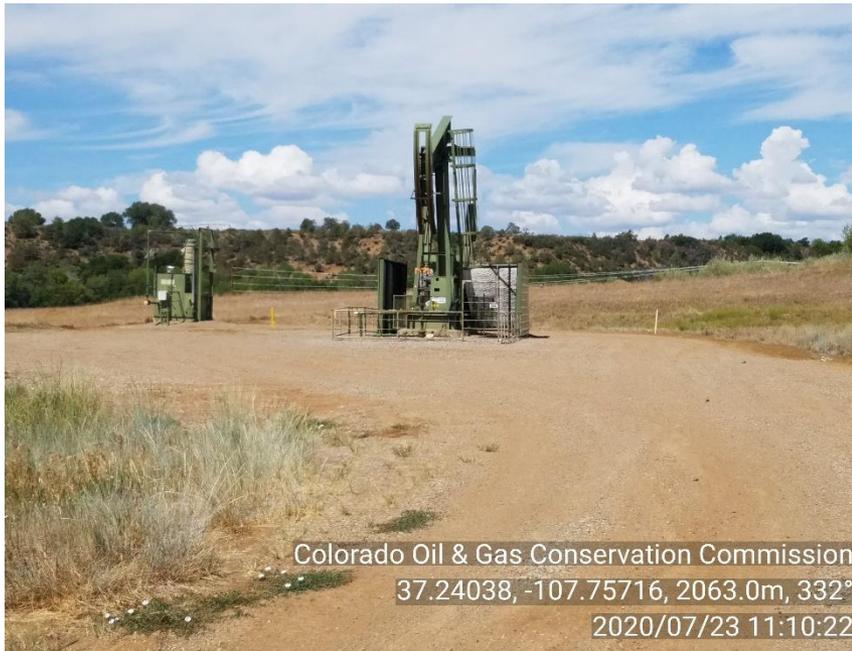
Colorado Oil & Gas Conservation Commission
37.24038, -107.75716, 2063.0m, 332°
2020/07/23 11:10:22

PHOTO 1: LOCATION

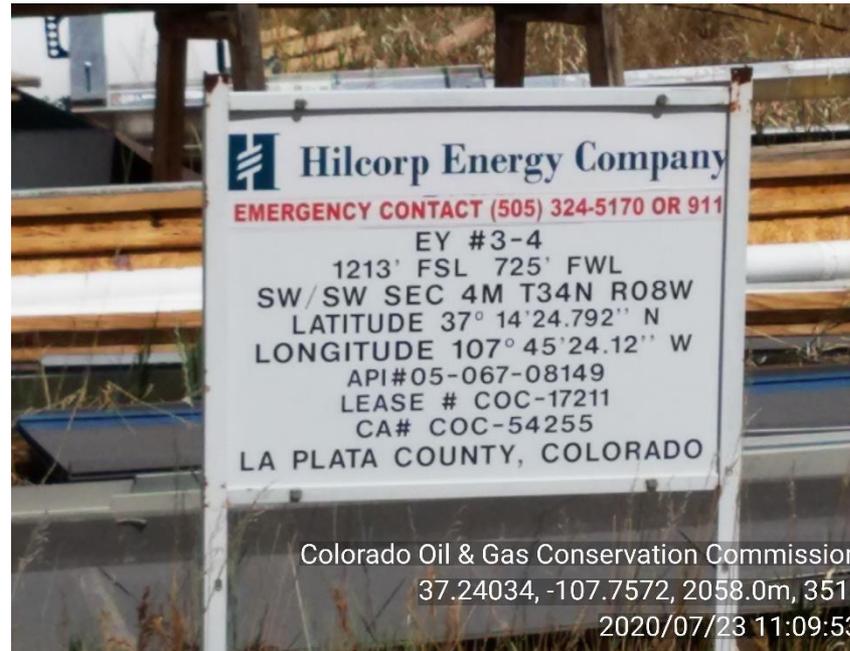
Colorado Oil & Gas Conservation Commission
37.24034, -107.7572, 2058.0m, 351°
2020/07/23 11:09:53

PHOTO 2: WELL SIGN

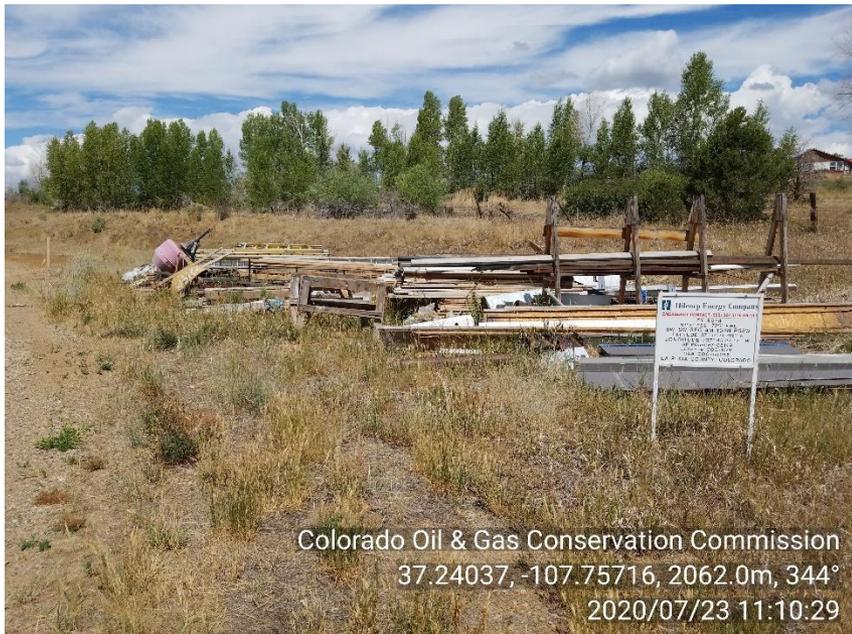
Colorado Oil & Gas Conservation Commission
37.24037, -107.75716, 2062.0m, 344°
2020/07/23 11:10:29

PHOTO 3: UNUSED EQUIPMENT STORED ON LOCATION NEAR ENTRANCE (APPEARS TO BE BUILDING TOOLS AND SUPPLIES). REMOVE ALL UNUSED EQUIPMENT FROM LOCATION, COMPLY WITH RULE 603.f. CA DATE 10-23-20

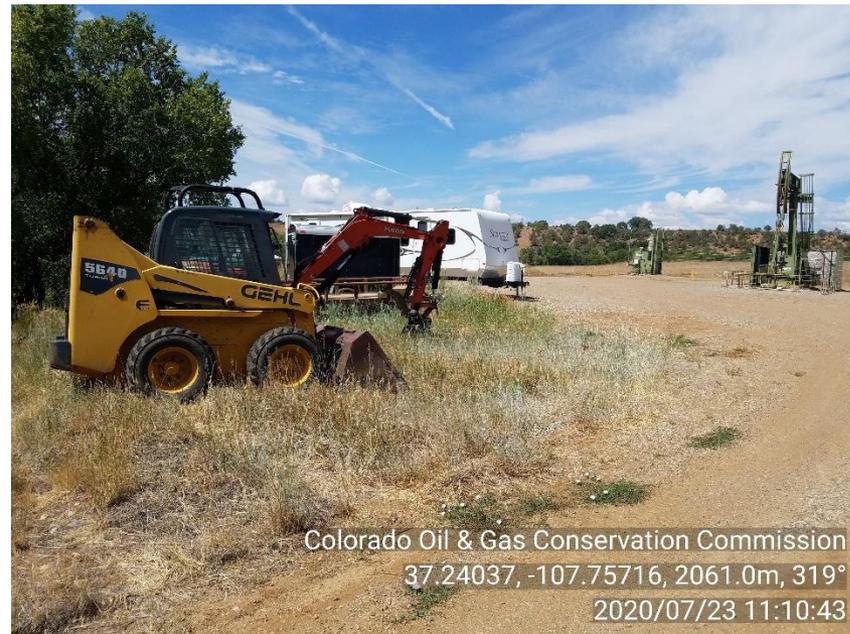
Colorado Oil & Gas Conservation Commission
37.24037, -107.75716, 2061.0m, 319°
2020/07/23 11:10:43

PHOTO 4: UNUSED EQUIPMENT STORED ON LOCATION NEAR ENTRANCE (2 PIECES CONSTRUCTION EQUIPMENT AND 3 TRAILERS). REMOVE ALL UNUSED EQUIPMENT FROM LOCATION, COMPLY WITH RULE 603.f. CA DATE 10-23-20
