APACHE CANYON 24-02V API# 05-071-07186 – TIMBER CREEK OPERATING
OGCC OPERATOR NUMBER 10672 - DATE: AUGUST 26, 2020
CORRECTIVE ACTIONS COMPLETED REGARDING COGCC FIR DOCUMENT # 690200496

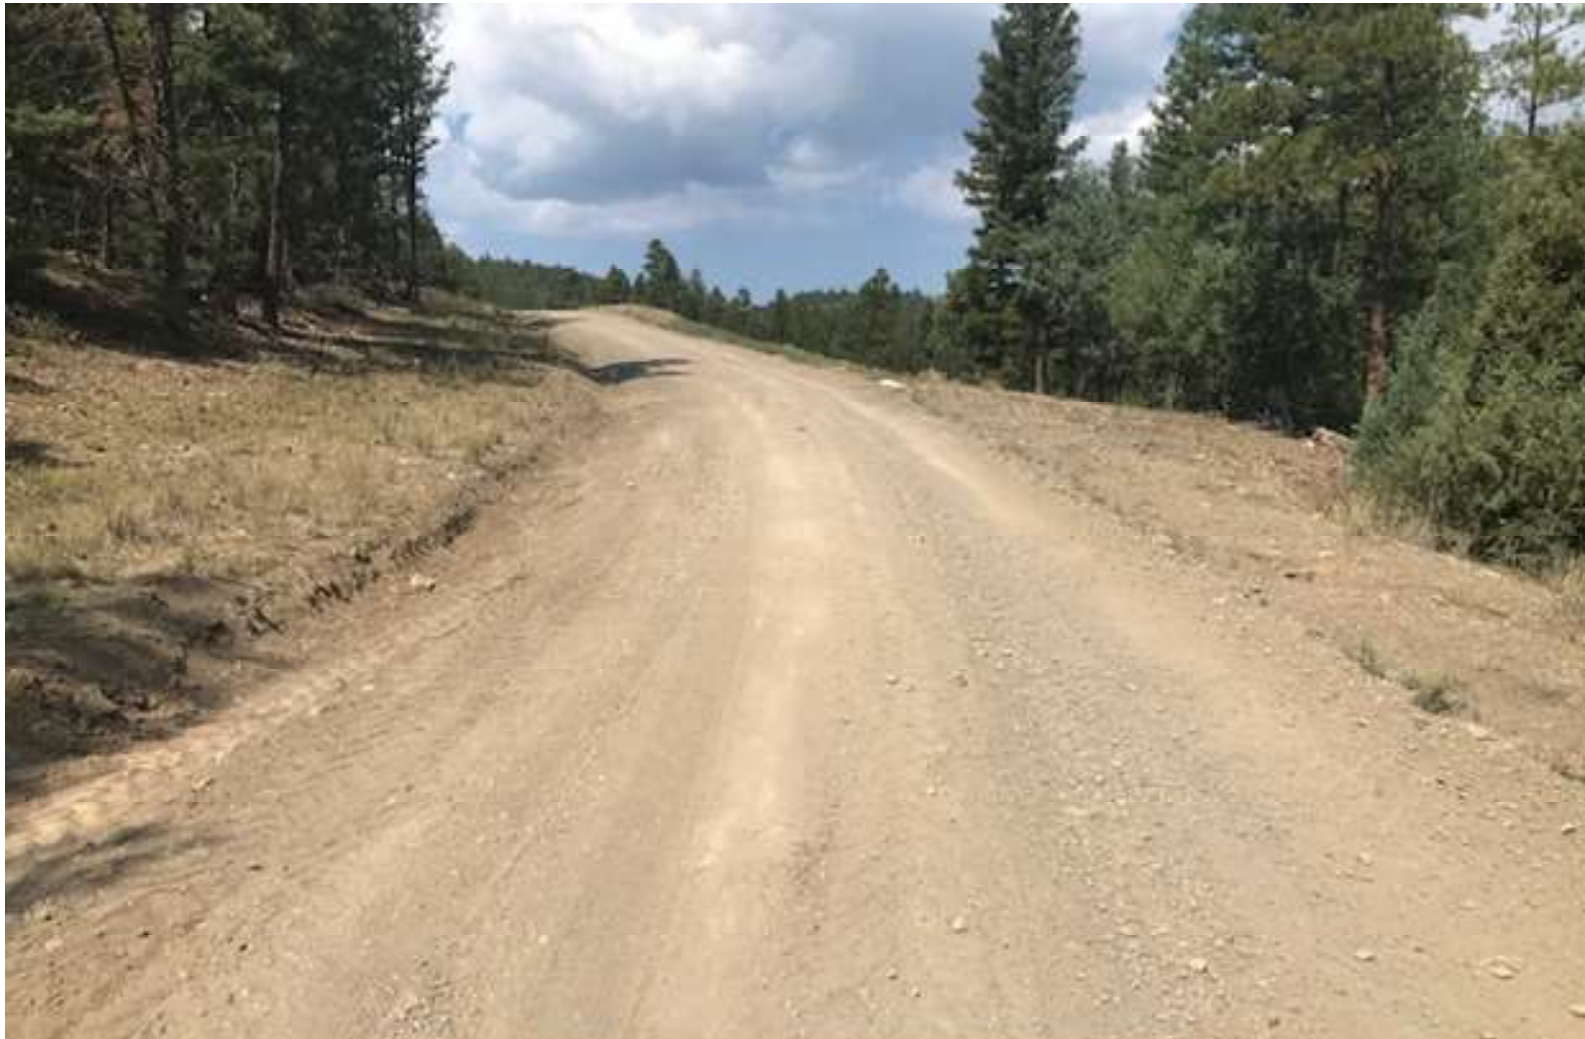
PHOTO 1: THE MAIN LEASE ROAD WAS SURFACE CROWNED TO ESTABLISH SHEET FLOW AND ELIMINATE THE TIRE RUTS AND SURFACE EROSION.

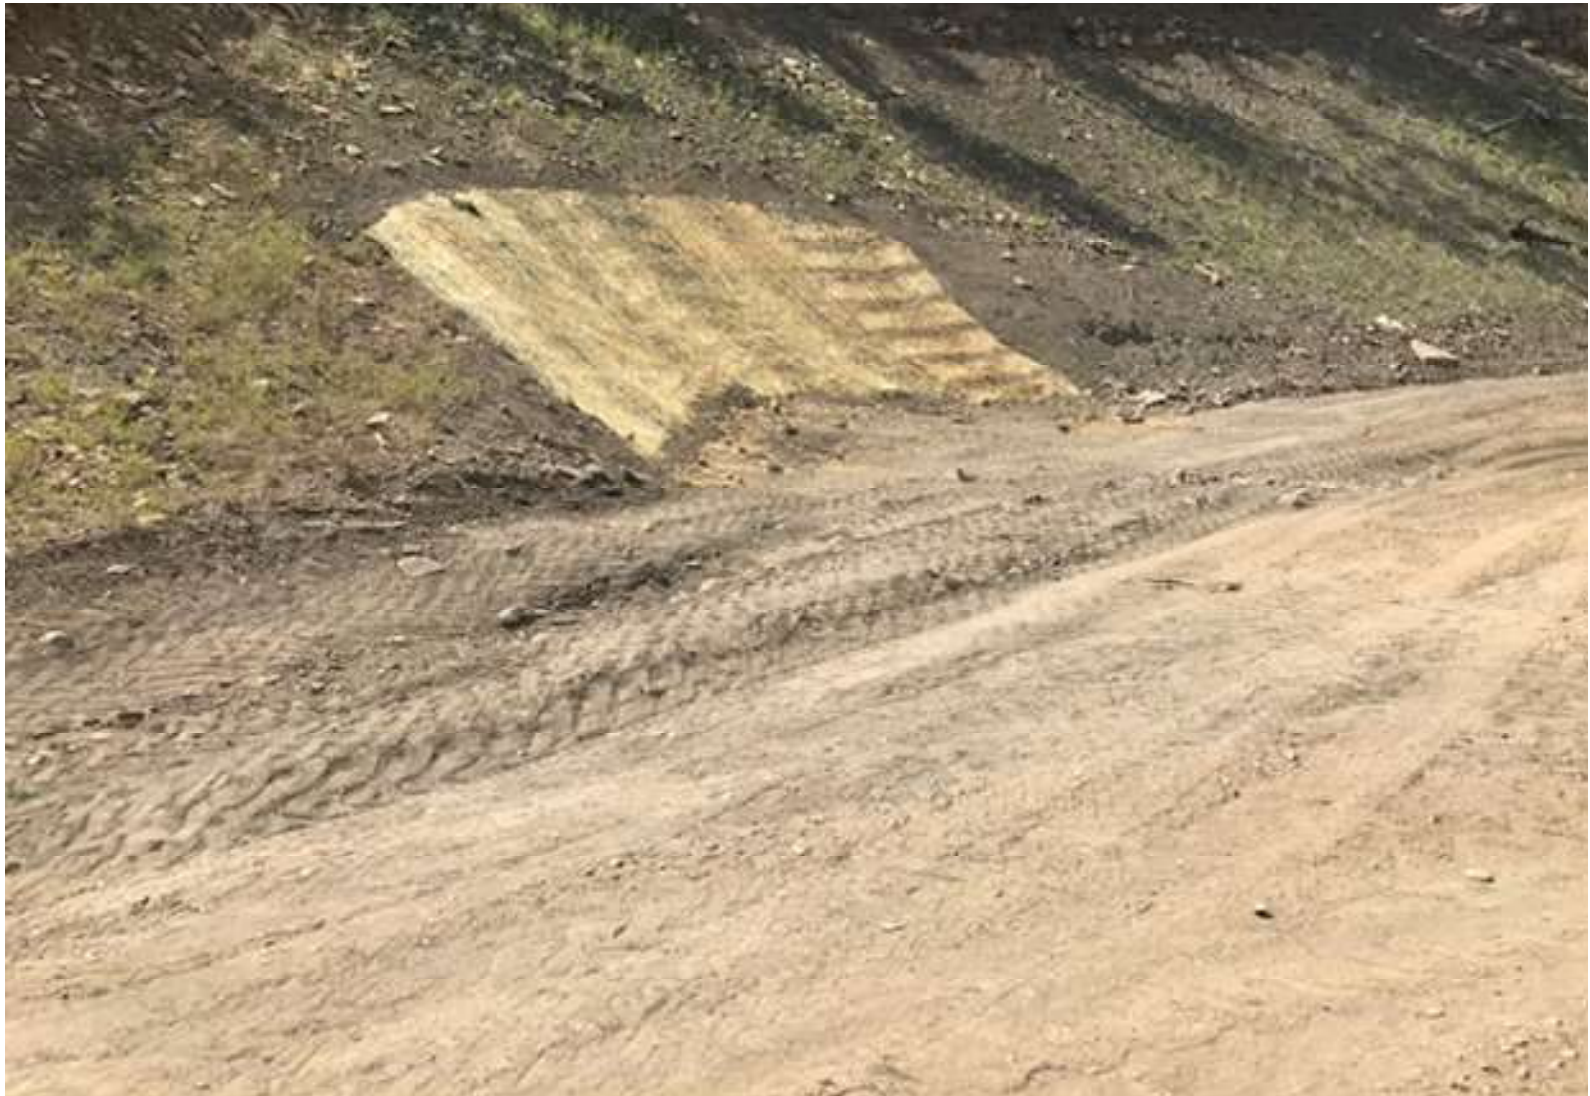
PHOTO 2: THE CUT SLOPE HAD A SOIL STOCKPILE THAT WAS RECENTLY REMOVED DURING REMEDIATION WORK ON THE FILL SLOPE. THE DISTURBANCE WAS SEEDED WITH AN APPROVED CPW SEED MIX. EROSION CONTROL BLANKETS WERE INSTALLED OVER DISTURBED AREA TO PROVIDE TEMPORARY SOIL STABILIZATION AND TO PROMOTE THE ESTABLISHMENT OF VEGETATION.

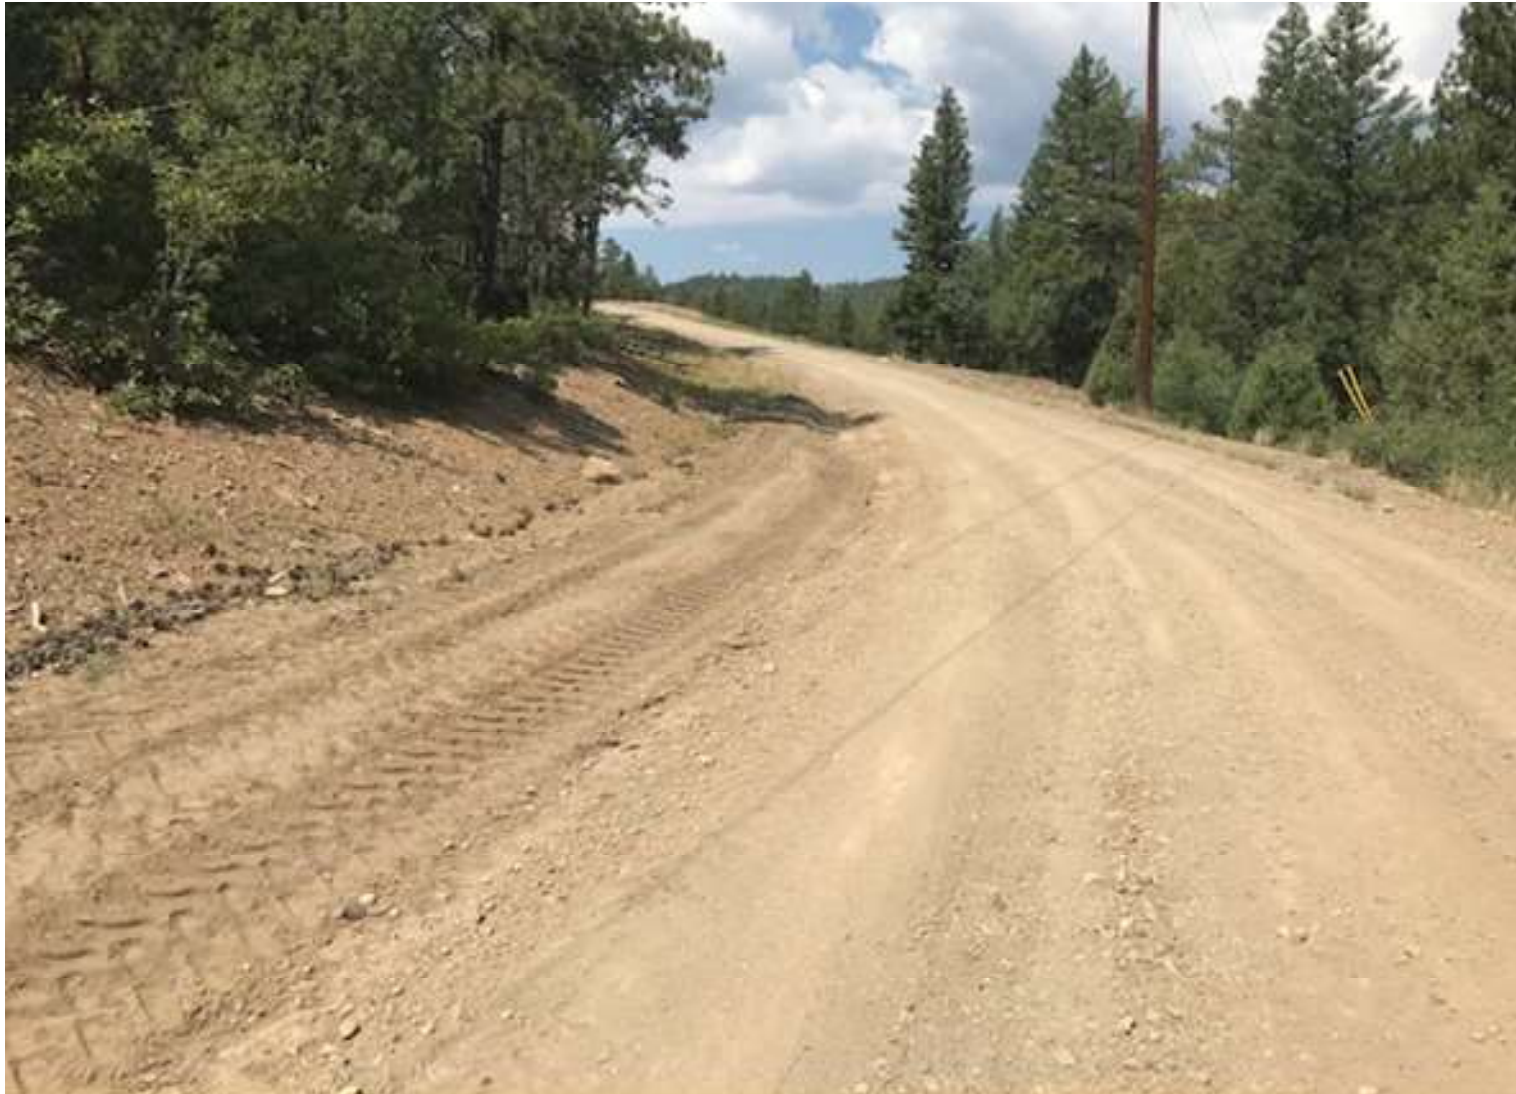
PHOTO 3: RUN OFF FROM THE LOCATION IS DIRECTED TO THIS BAR DITCH. THE BAR DITCH WAS RE-CONFIGURED INTO A WIDE PARABOLIC SHAPE TO REDUCE THE POTENTIAL FOR SCOURING.

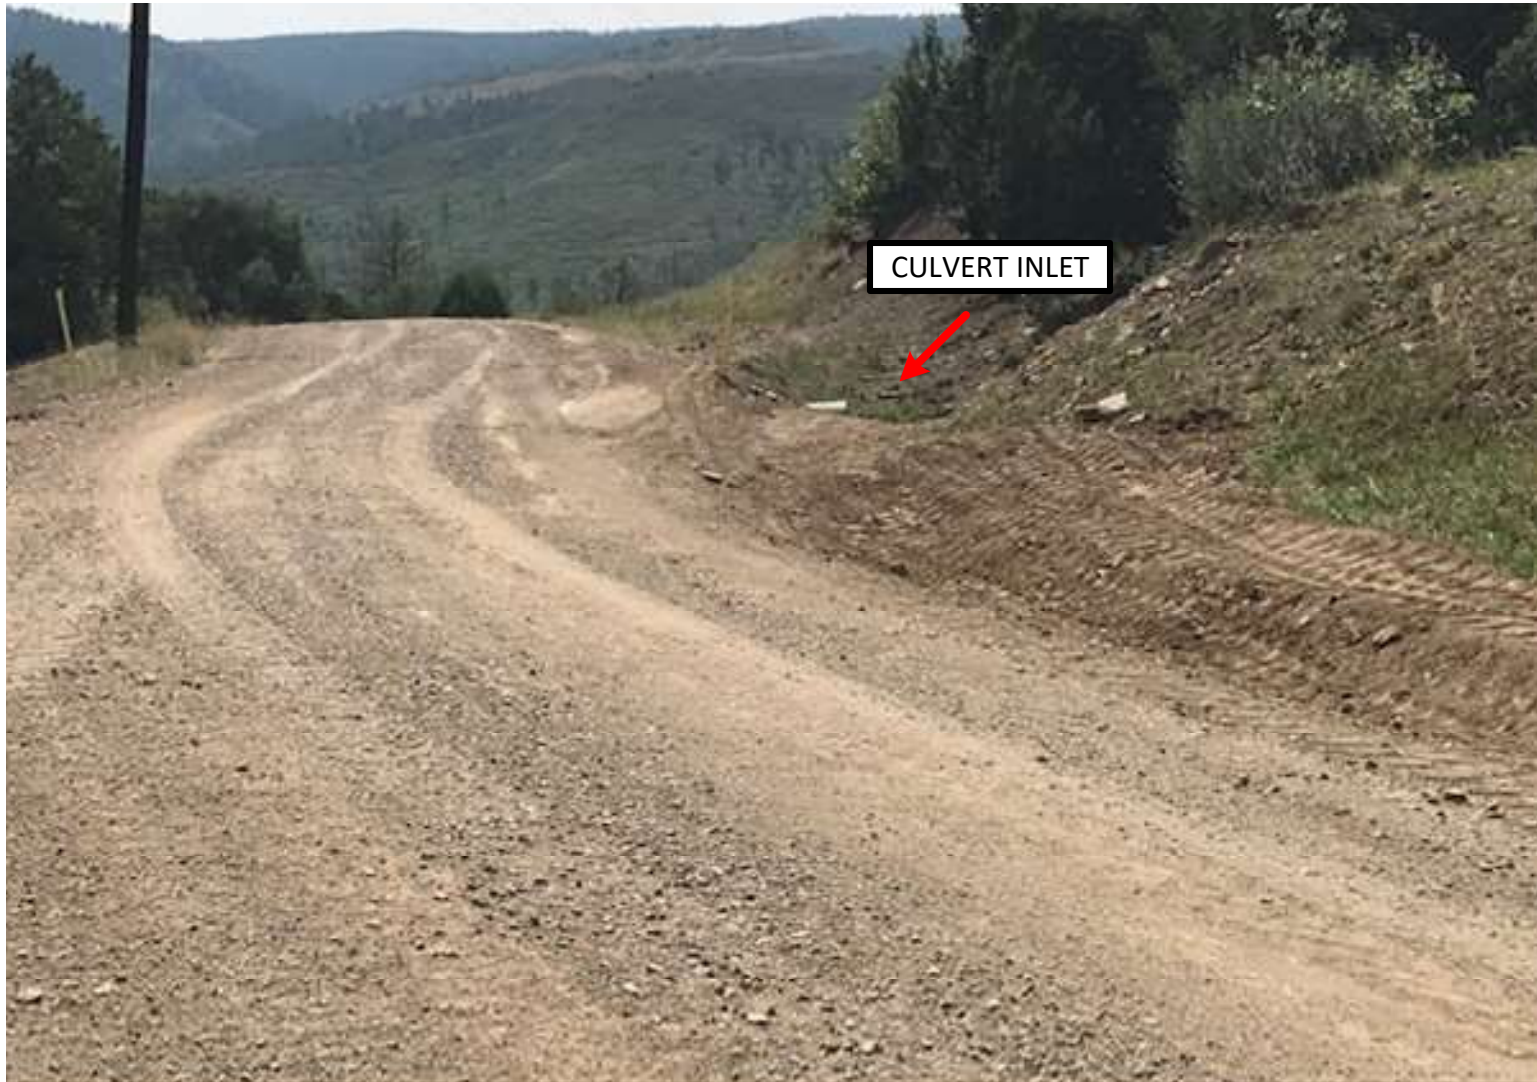
PHOTO 4: STORMWATER FROM THE BAR DITCH IS DIRECTED TO THE CULVERT INLET DOWN GRADIENT OF THE LOCATION.

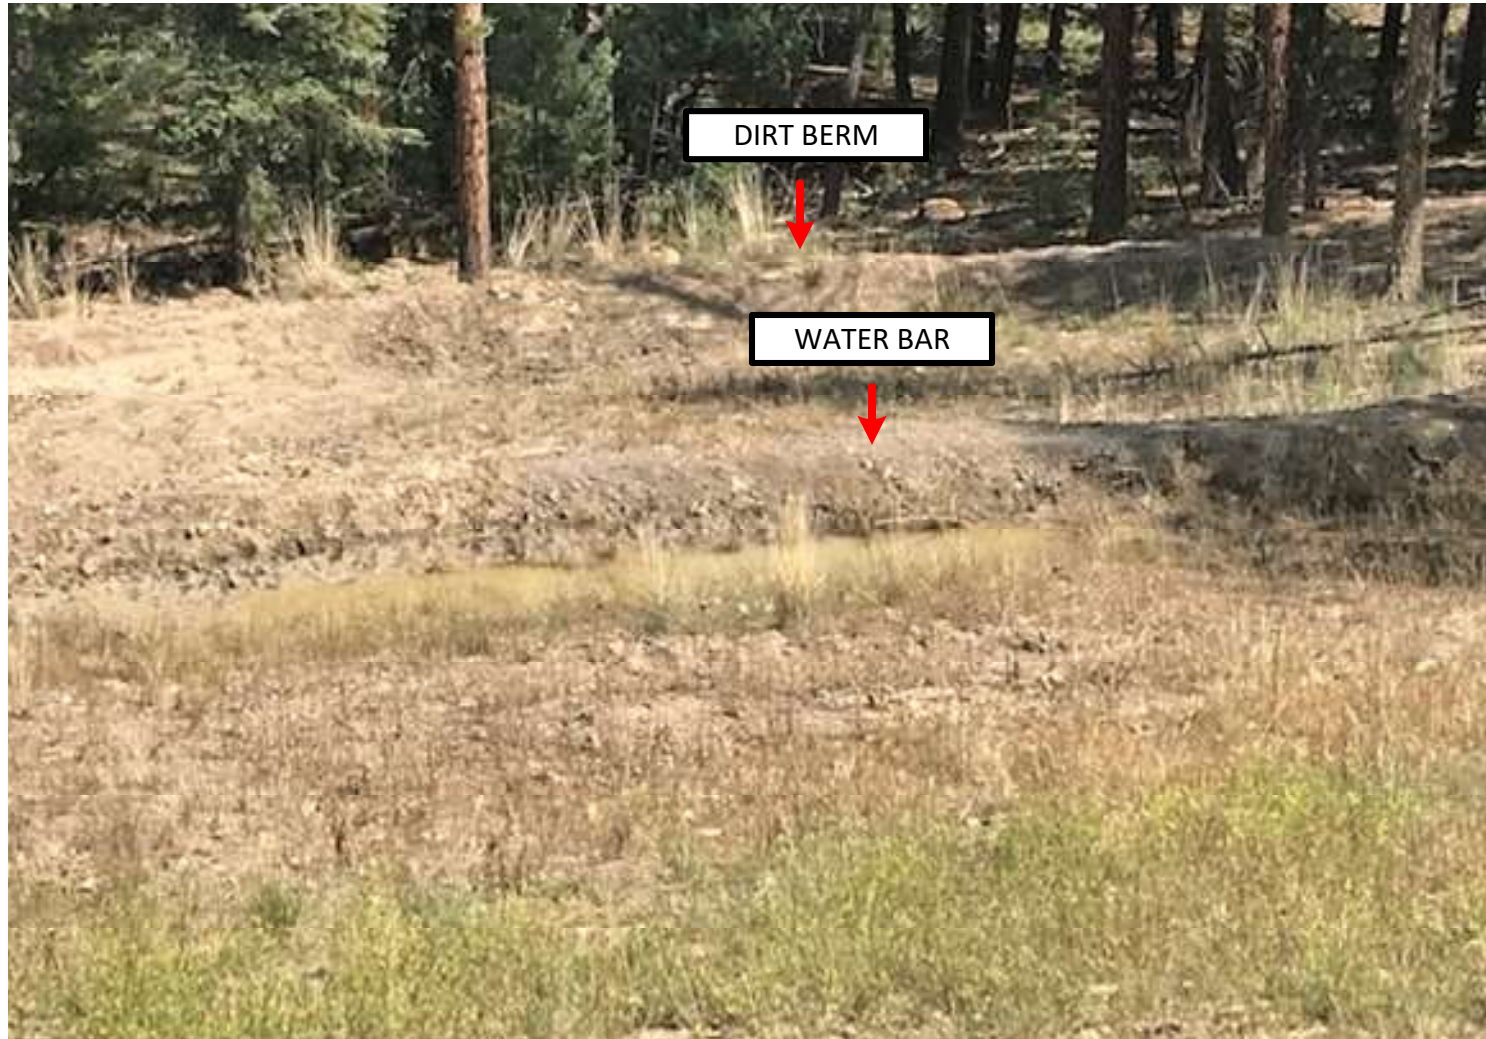
PHOTO 5: THE BREACH IN THE DIRT BERM AND THE WATER BAR AT THE TOE OF THE FILL SLOPE HAVE BEEN REPAIRED.

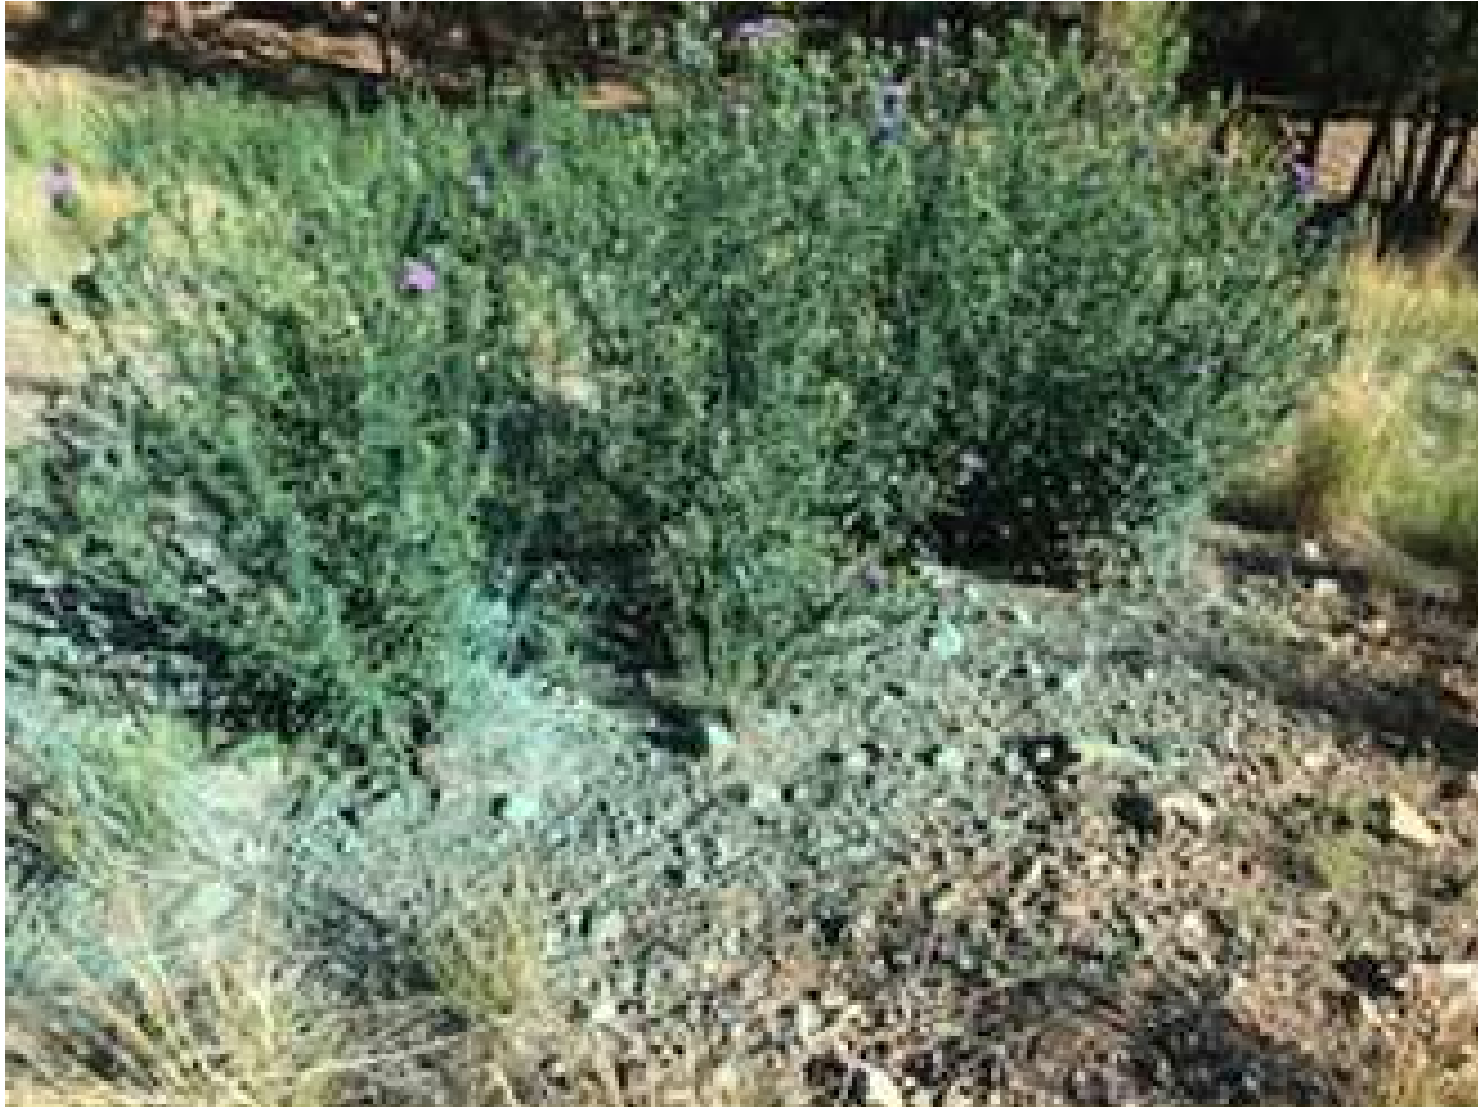
PHOTO 6: NOXIOUS WEEDS ALONG THE LEASE ROAD WERE TREATED ON 08/05/20.

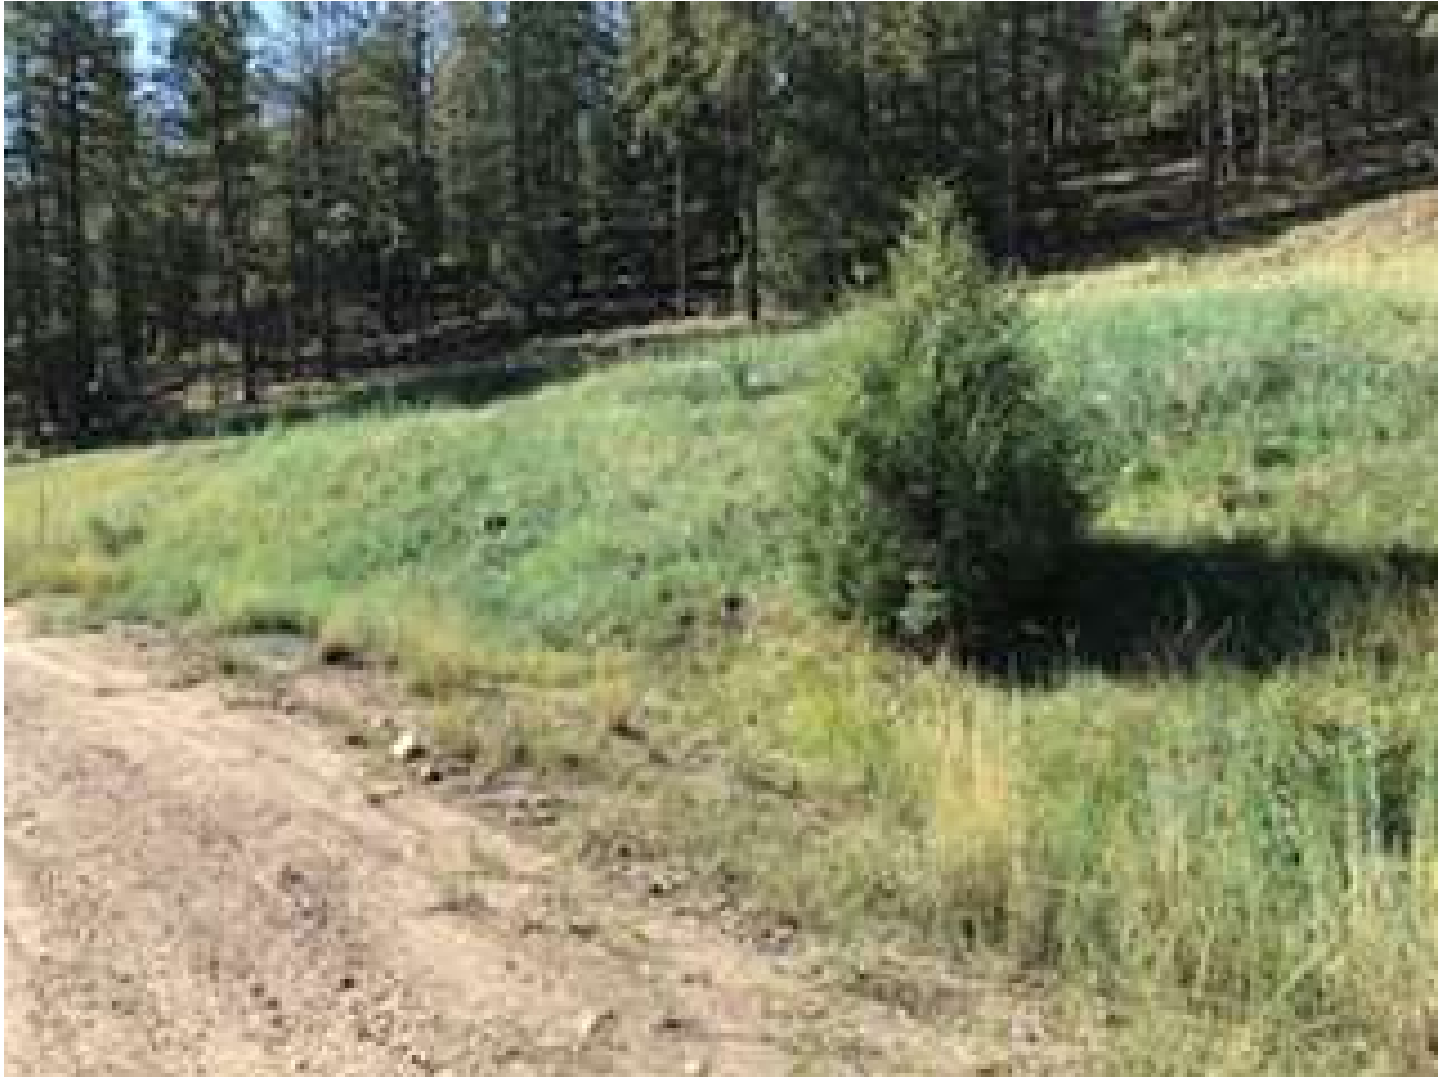
PHOTO 7: NOXIOUS WEEDS ALONG THE LEASE ROAD WERE TREATED ON 08/05/20.

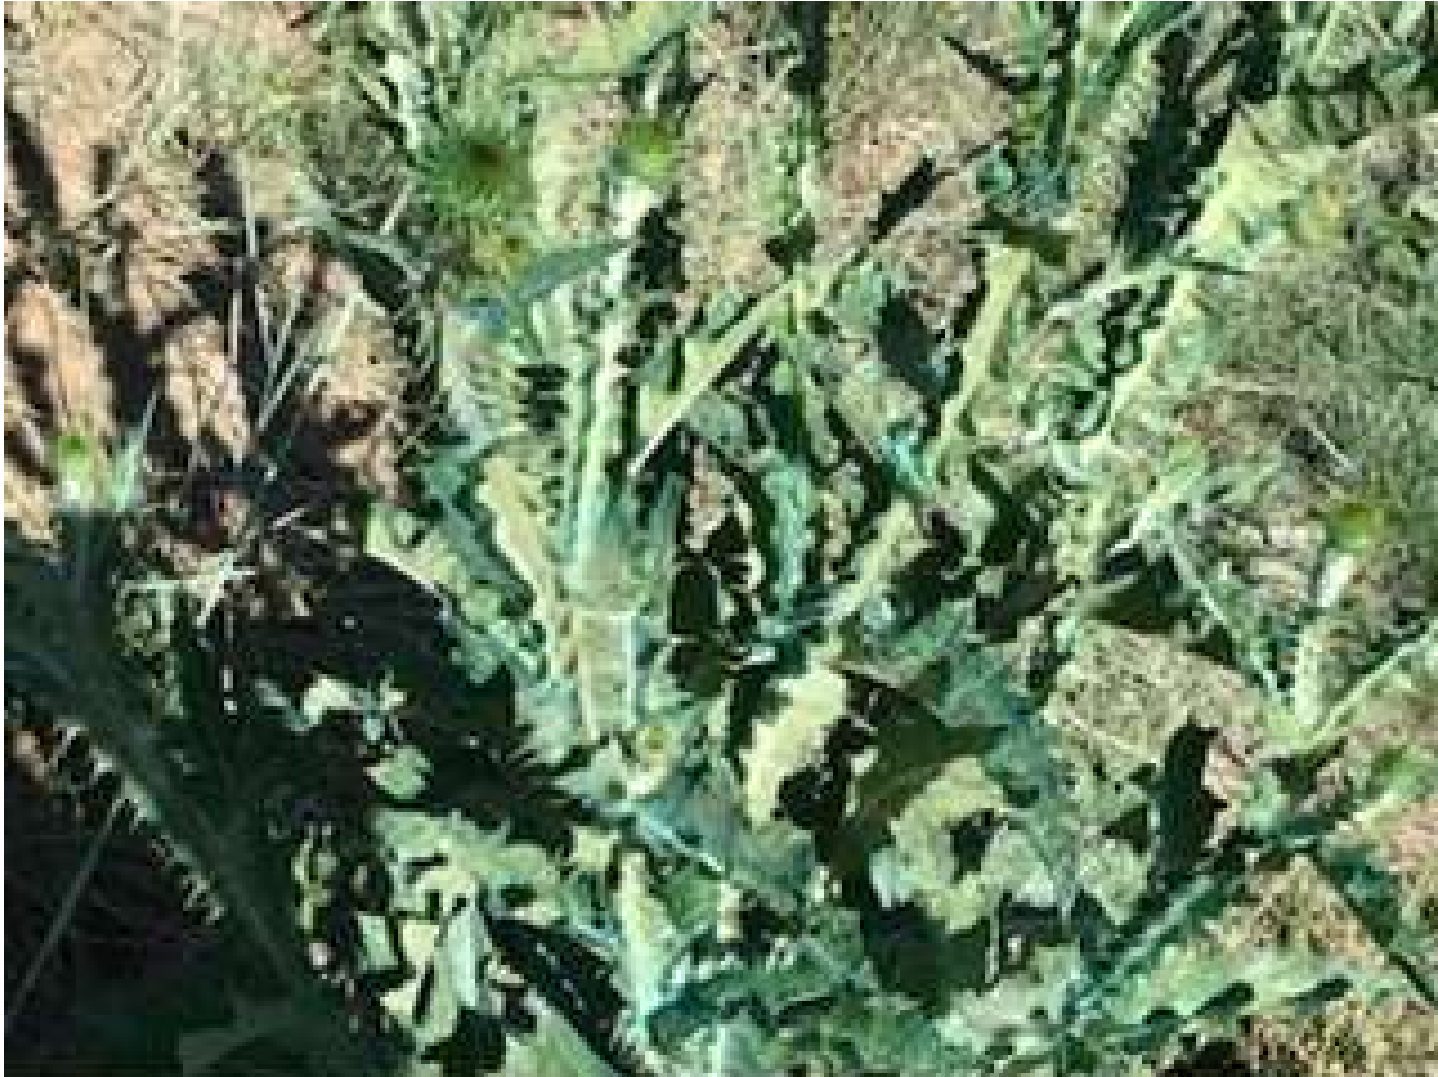
PHOTO 8: NOXIOUS WEEDS ALONG THE LEASE ROAD WERE TREATED ON 08/05/20.

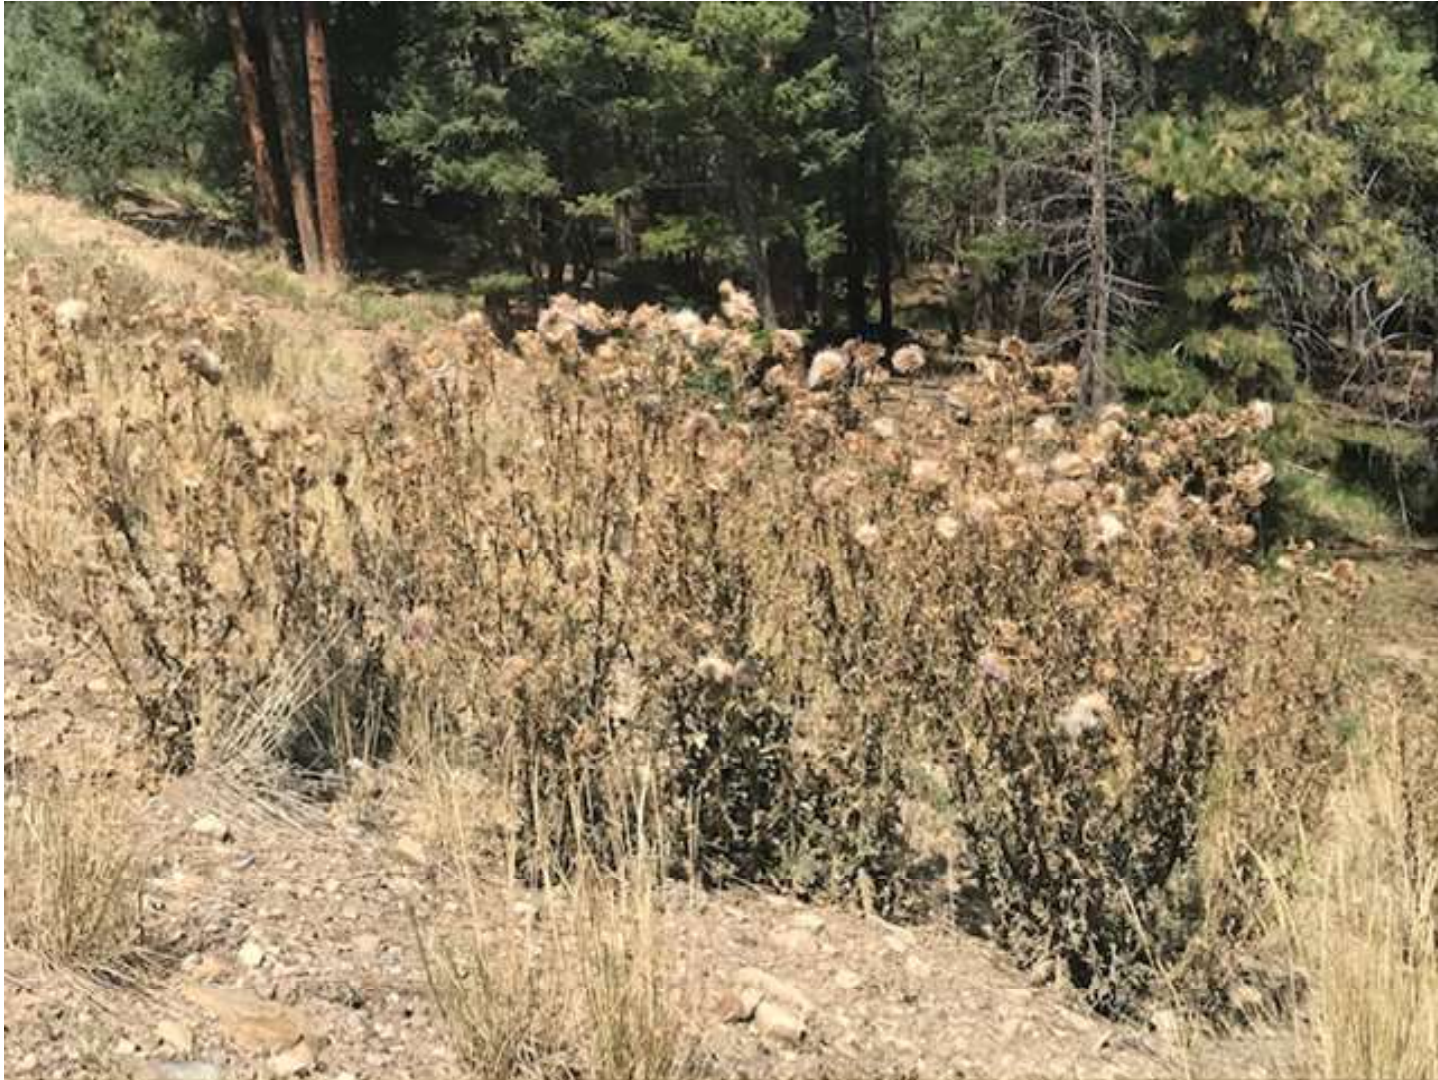
PHOTO 9: CONDITION OF THE BULL THISTLE 08/26/20.
