Location Name: VALLEJO 44-5 V, API #: 071-08844, Insp. #:695103359

PHOTO 1: LOCATION

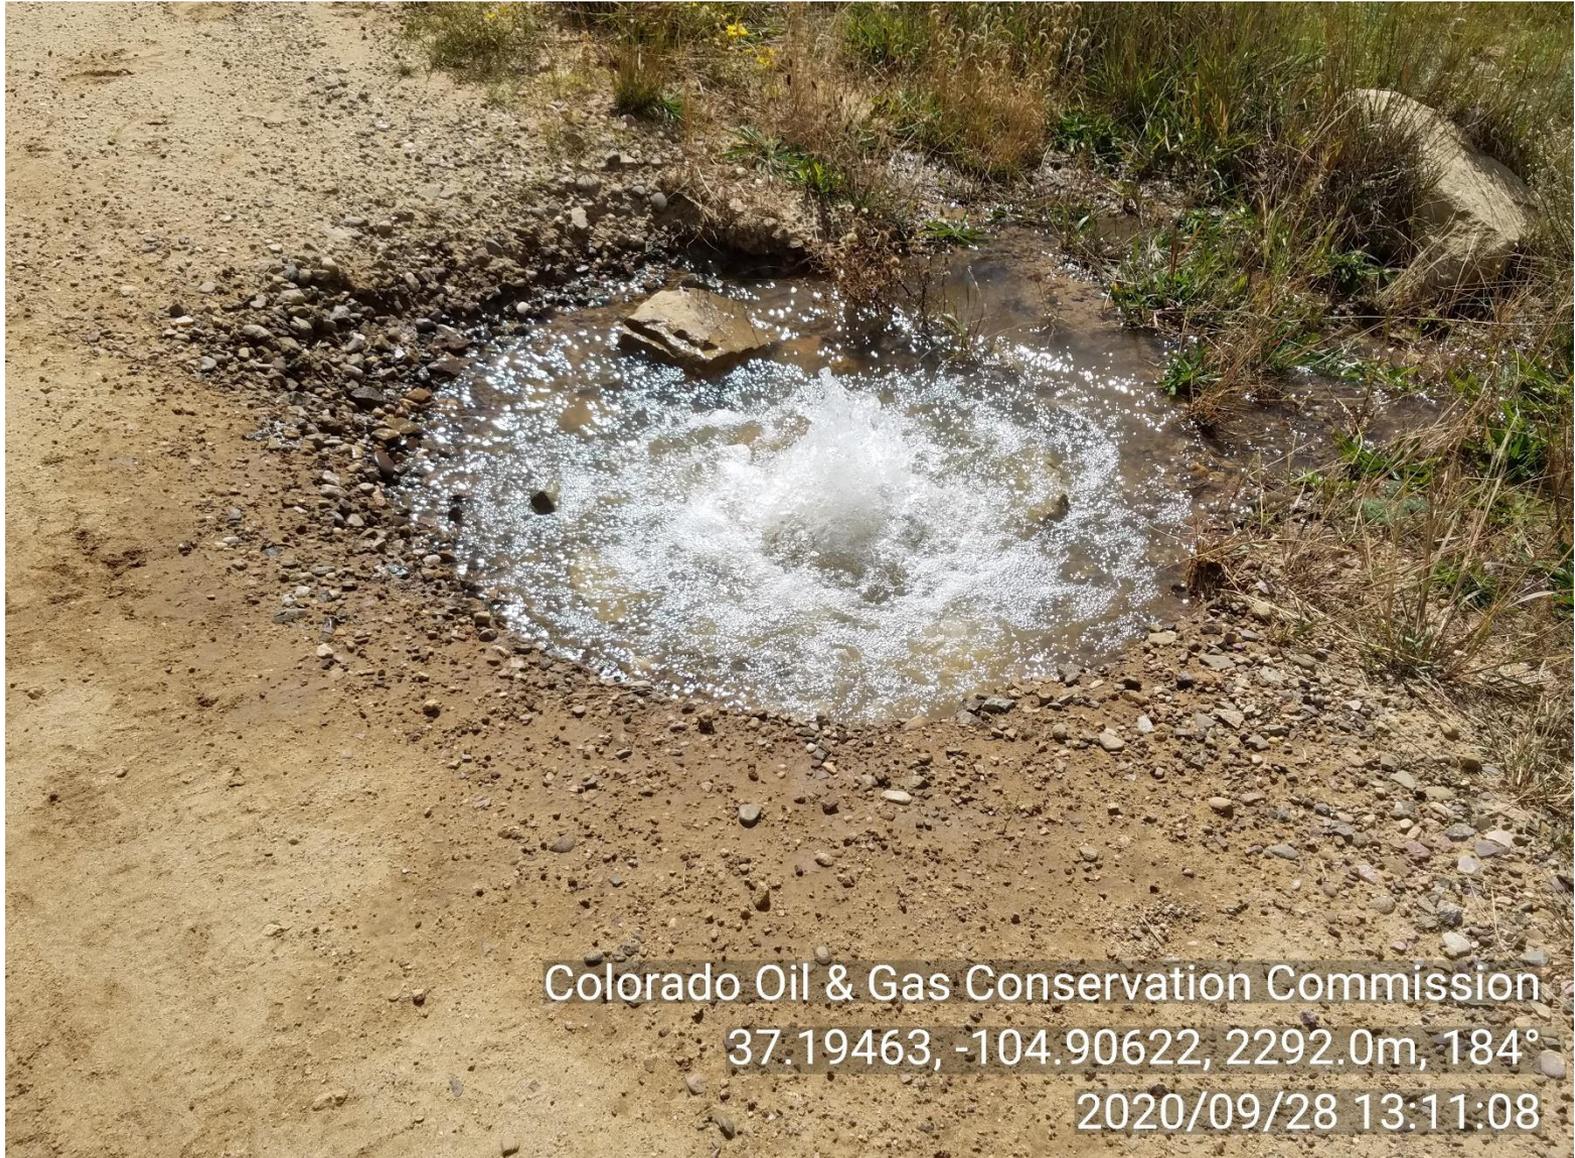
PHOTO 3: APPEARS THAT A PRODUCED WATER GATHERING LINE IS LEAKING APP. 70' TO THE NORTH OF LOCATION ON ROW. E&P Waste not properly stored, handled, transported, treated, recycled, or disposed per Rule 907. Contact COGCC EPS staff. CA DATE 9-30-20.

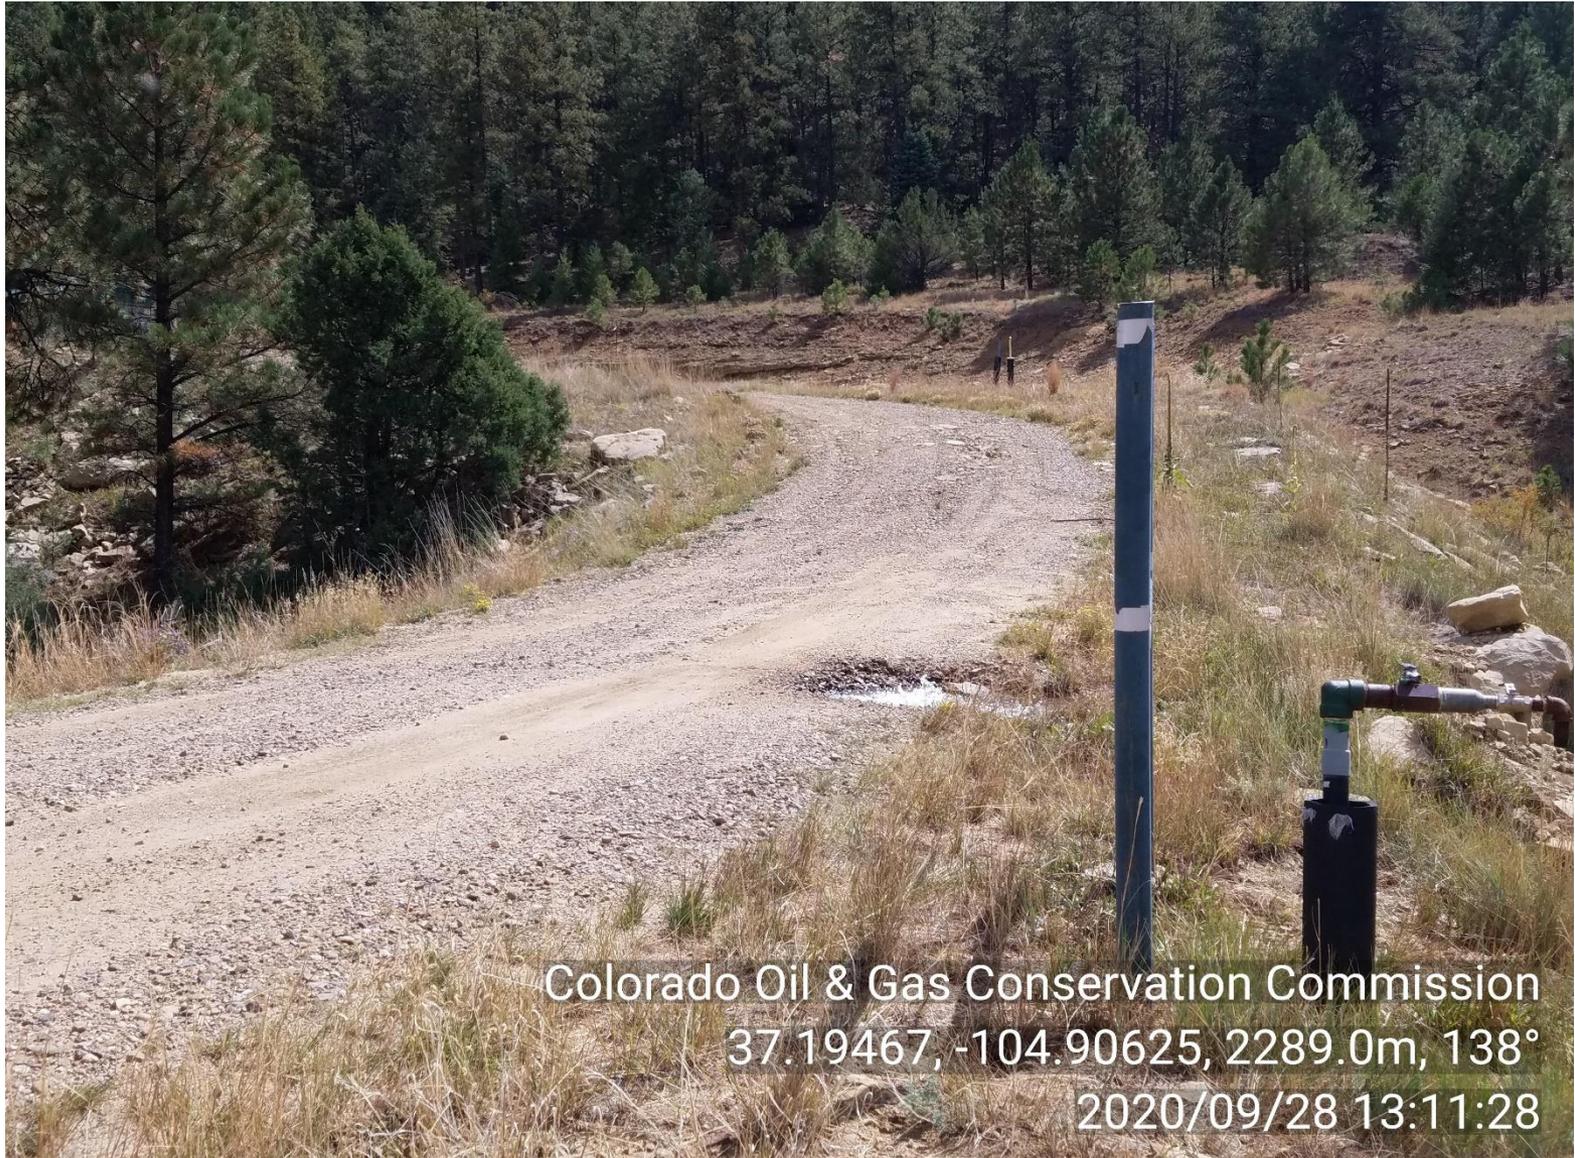
[PHOTO 4: IMAGE SHOWING PROXIMITY OF THE LEAK IN RELATION TO THE LOCATION. PRODUCED WATER RAN TO THE WEST INTO THE DRY DITCH AND THEN RAN EAST APP. 75 YARDS.]
