Inspection Photos

10/19/2020

Operator: LARAMIE ENERGY LLC # 10433

Location ID: 311744

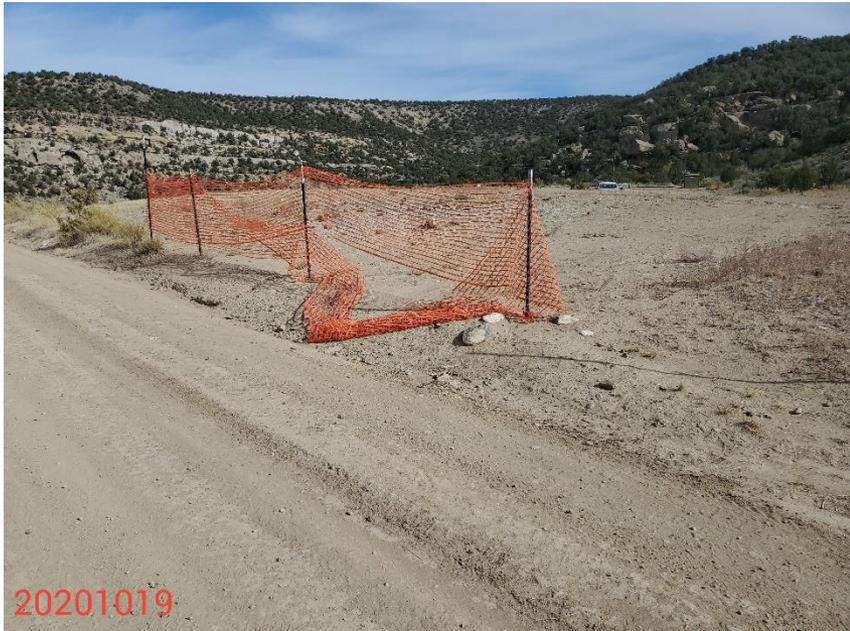
Photo 1: Photo taken from the west end of the Location, facing northeast. Photo shows fence has been installed to prevent access to road traveling though Location. Access road through Location has not been reclaimed in accordance with COGCC 1004 rules.

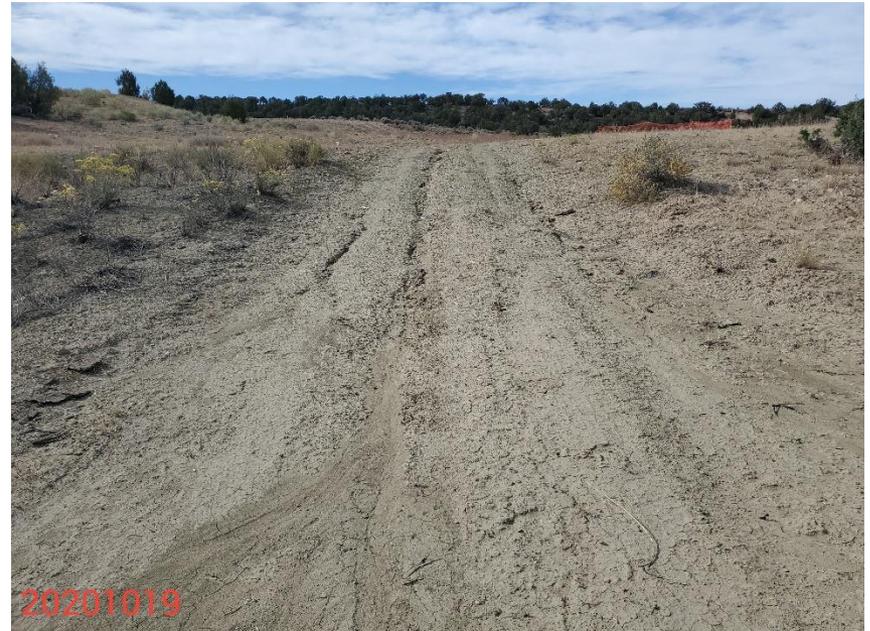
Photo 2: Photo taken from the east end of the Location, facing southwest. Photo shows access road through the Location has not been reclaimed.

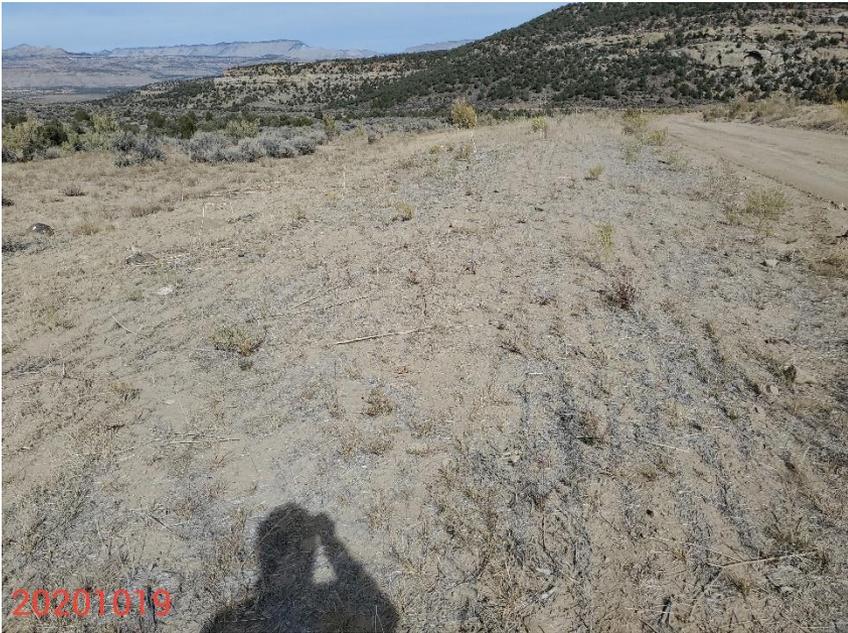
Photo 3: Photo taken from the west end of the Location, facing north. Photo shows areas where reclamation is in process.

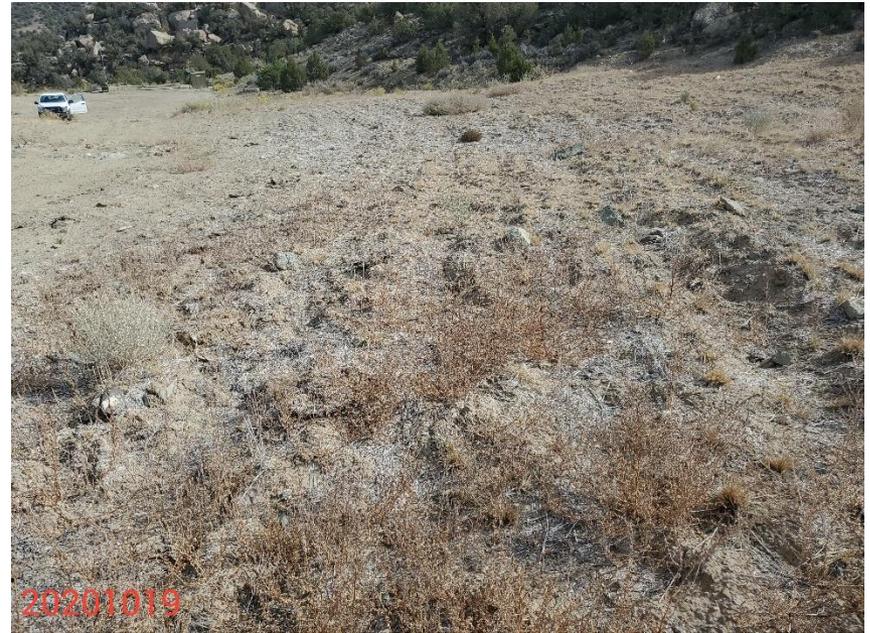
Photo 4: Photo taken from the south end of the Location, facing northeast. Photo shows areas where reclamation is in process.
