Location Name: ADAMIC 1-20, API #: 043-06020, Insp. #:695103790

Adamic 1-20 Well  
API #043-06020  
NESE 20-T19S-R69W  
Fremont County, Colorado

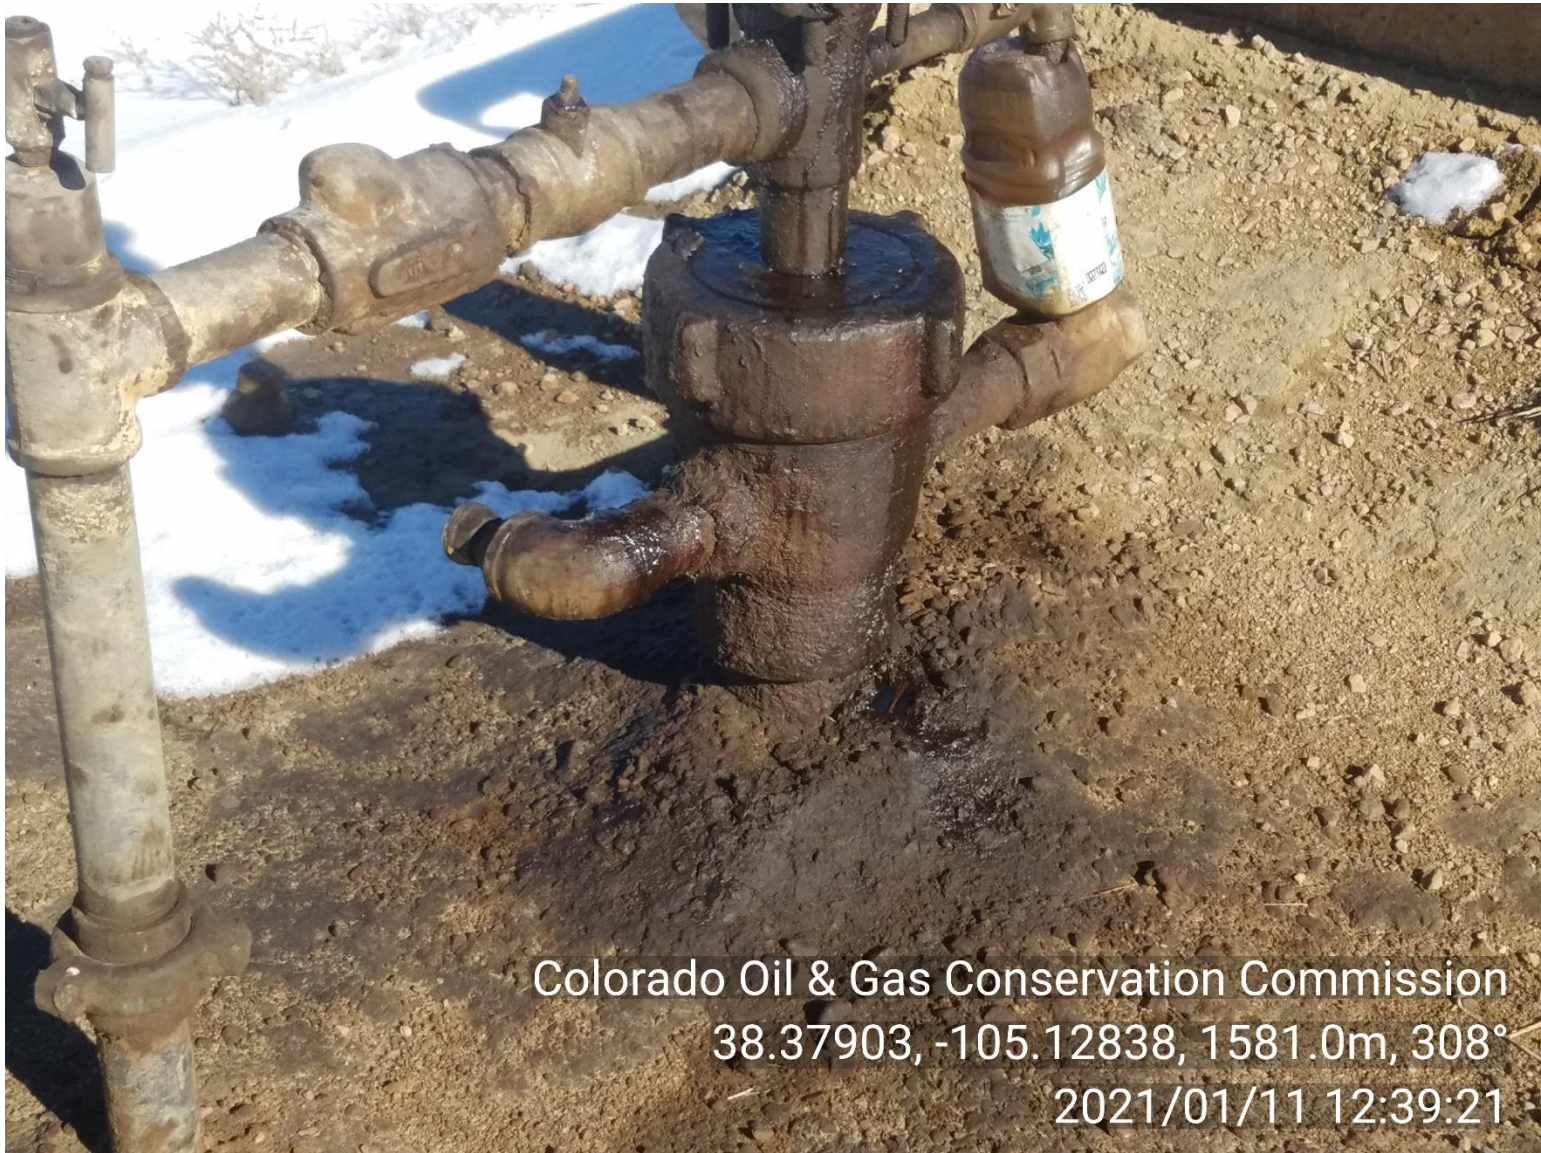
**Phone 3: BRADENHEAD IS NOT PLUMBED TO SURFACE. PLUMB BRADENHEAD TO SURFACE, COMPLY WITH RULE 341. CA DATE 3-11-21.**

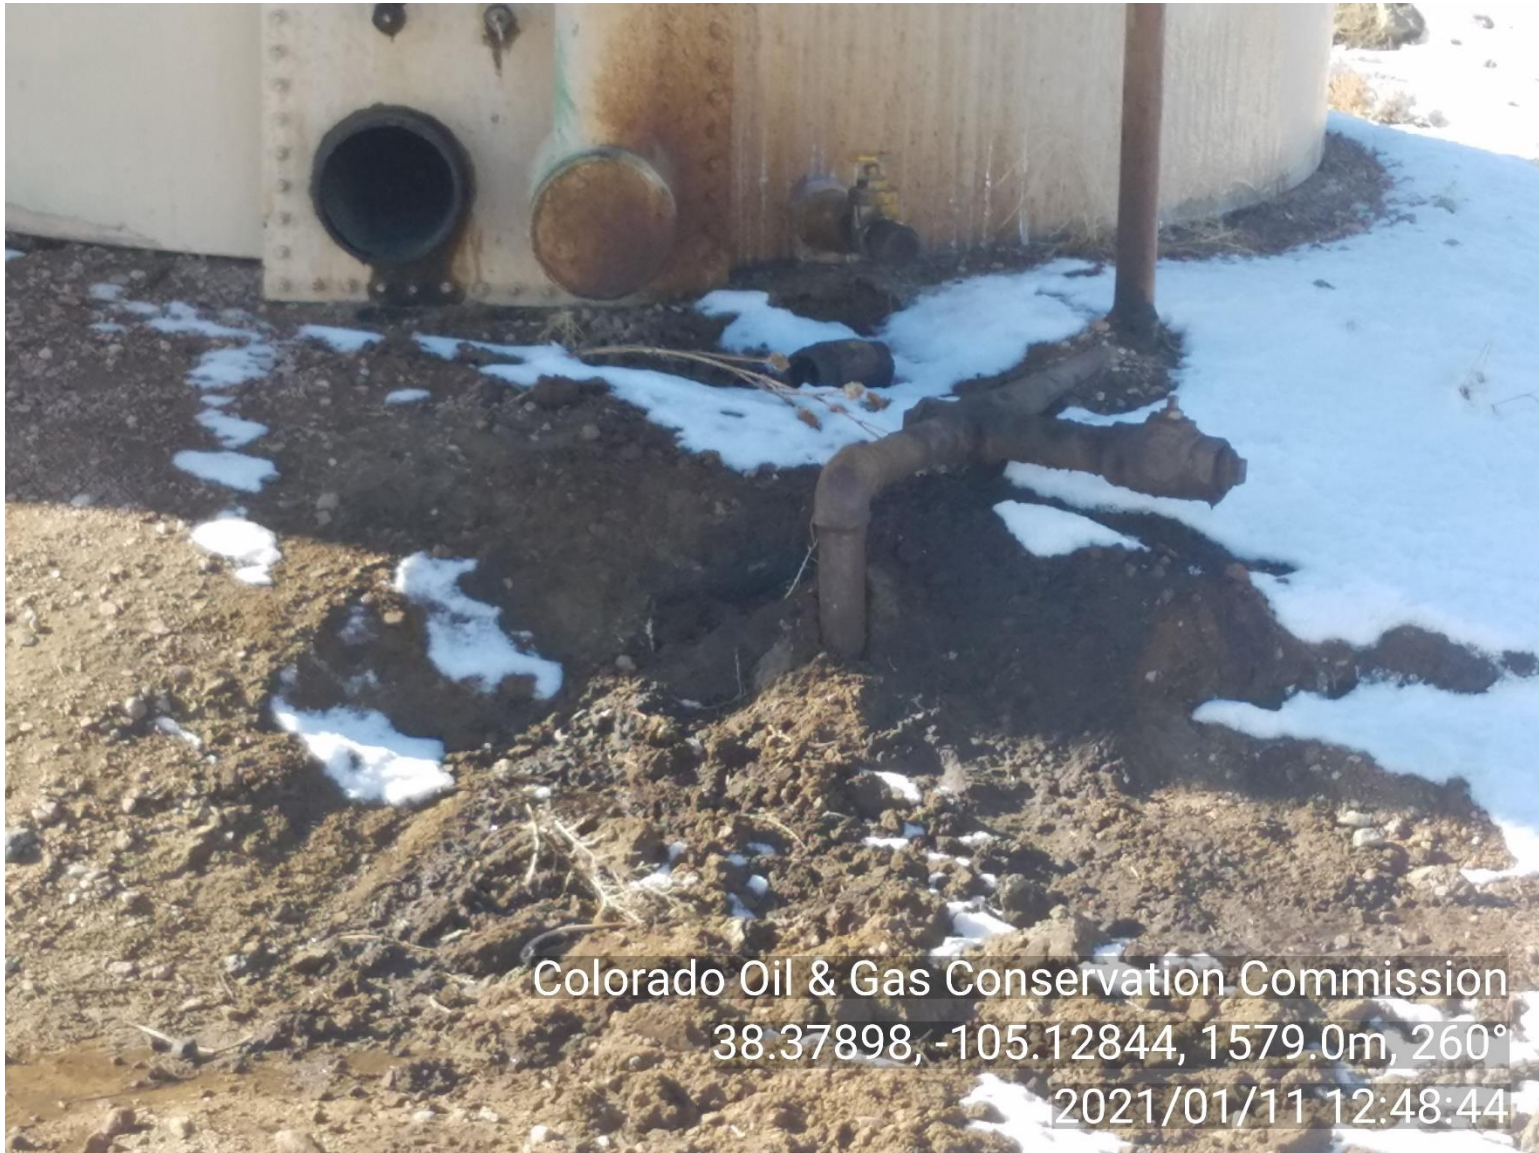
**Phone 4: IT APPEARS WELLHEAD IS LEAKING THERE IS AN AREA OF IMPACTED SOIL APP. 6' X 3' AROUND WELLHEAD.**  
**Securely fasten all valves, pipes, and fittings to ensure good mechanical condition, inspect at regular intervals and maintain in good mechanical condition per Rule 605.d. Properly treat or dispose of oily waste in accordance with 907.e.**  
**CA DATE 3-11-21.**

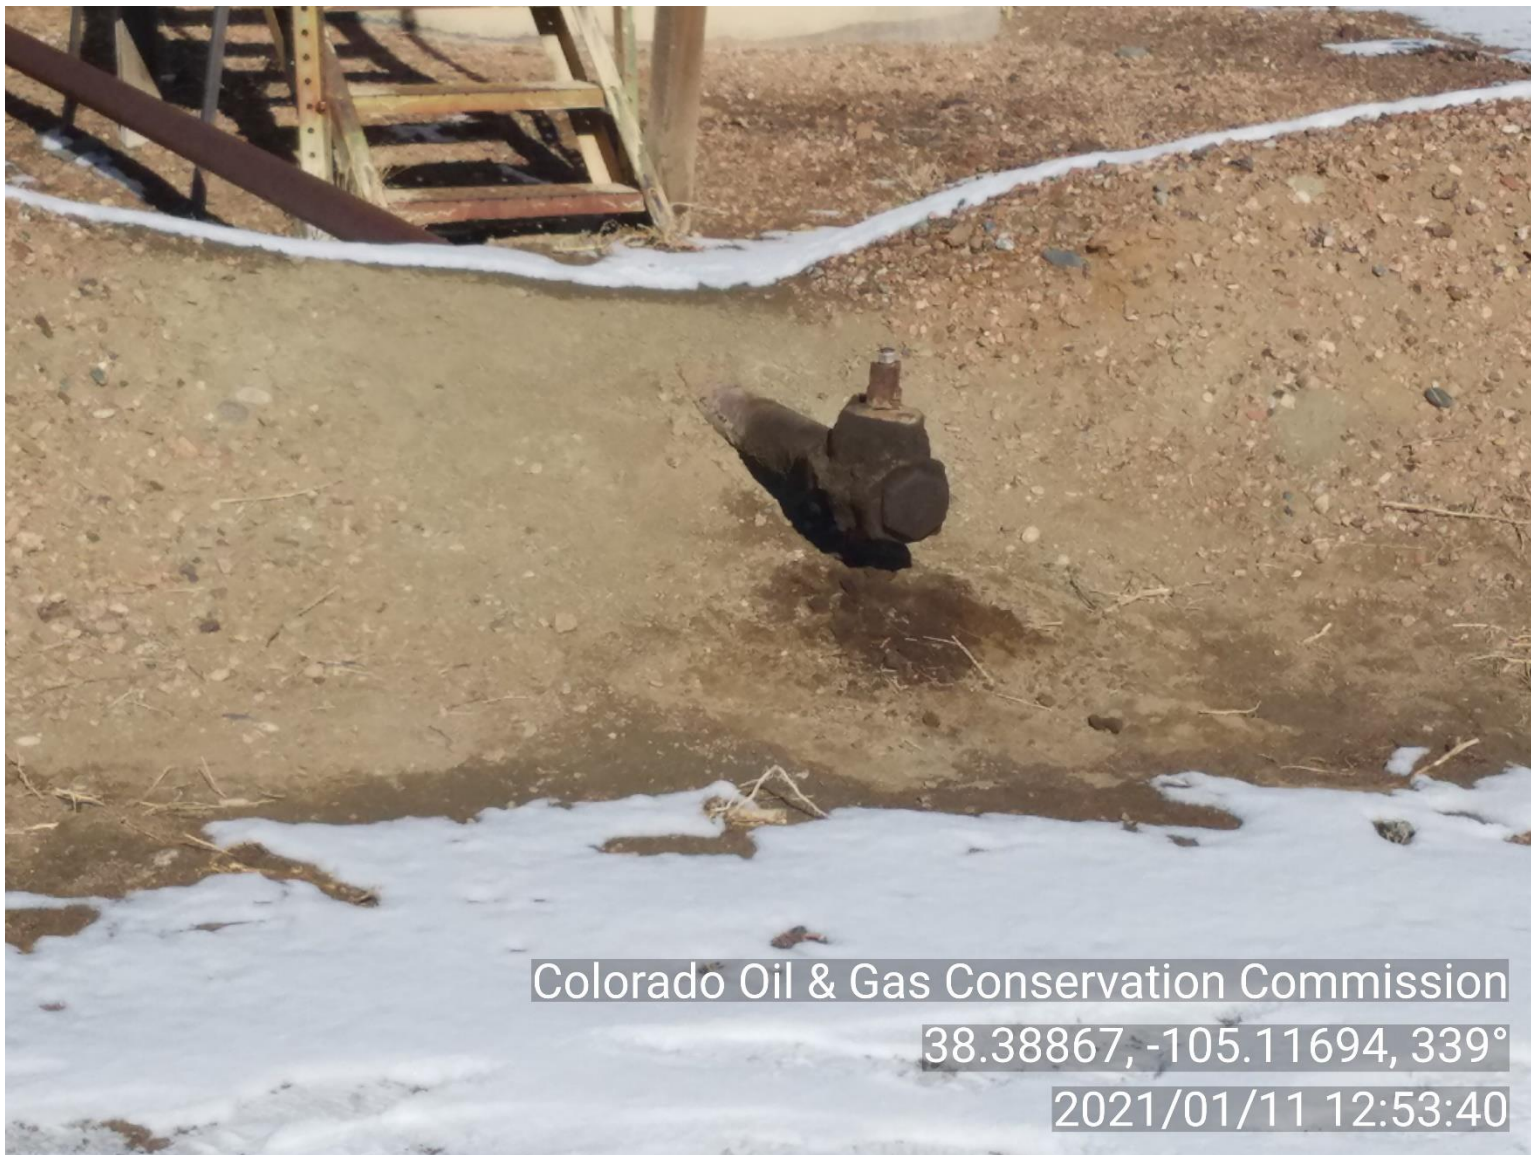
Phone 5: THERE IS AN AREA OF IMPACTED SOIL NEAR NORTHERN MOST CRUDE OIL TANK APPEARS VALVE HAS BEEN REPLACED BUT NOT ALL THE IMPACTED SOIL HAS BEEN REMOVE. **Securely fasten all valves, pipes, and fittings to ensure good mechanical condition, inspect at regular intervals and maintain in good mechanical condition per Rule 605.d. Properly treat or dispose of oily waste in accordance with 907.e. CA DATE 3-11-21.**

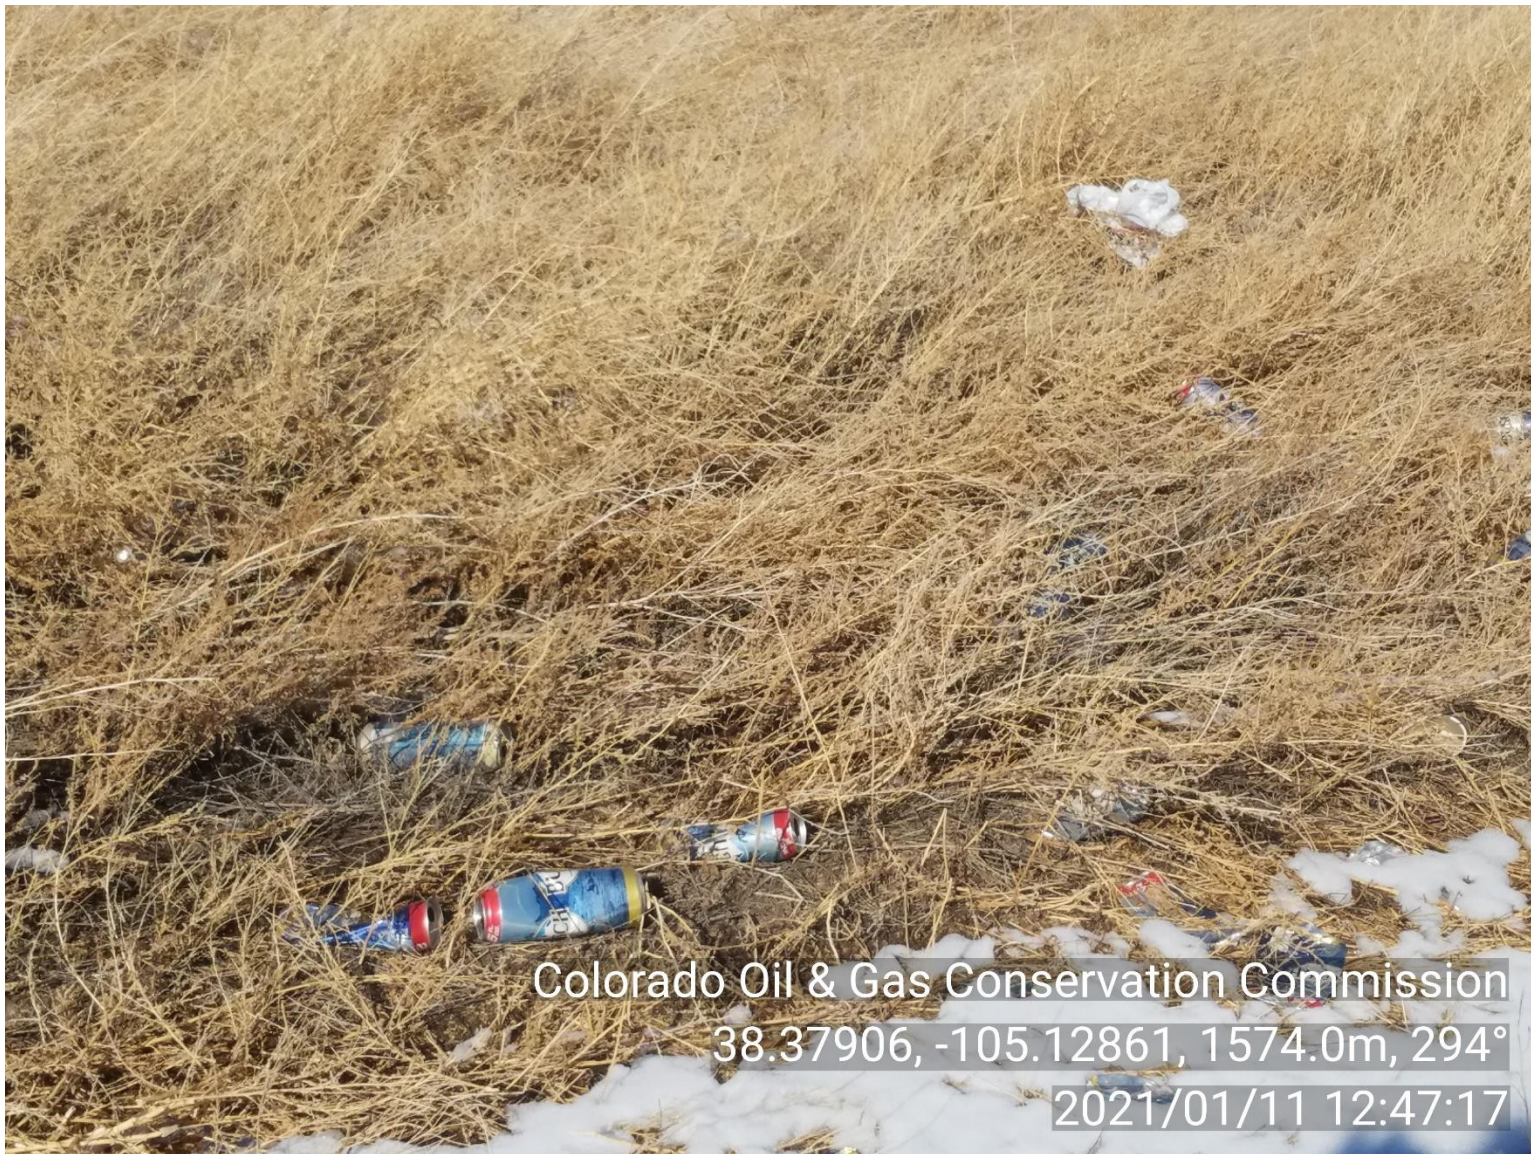
**Phone 6: AREA OF IMPACTED SOIL NEAR CRUDE OIL LOADOUT. Securely fasten all valves, pipes, and fittings to ensure good mechanical condition, inspect at regular intervals and maintain in good mechanical condition per Rule 605.d. Properly treat or dispose of oily waste in accordance with 907.e. CA DATE 3-11-21.**

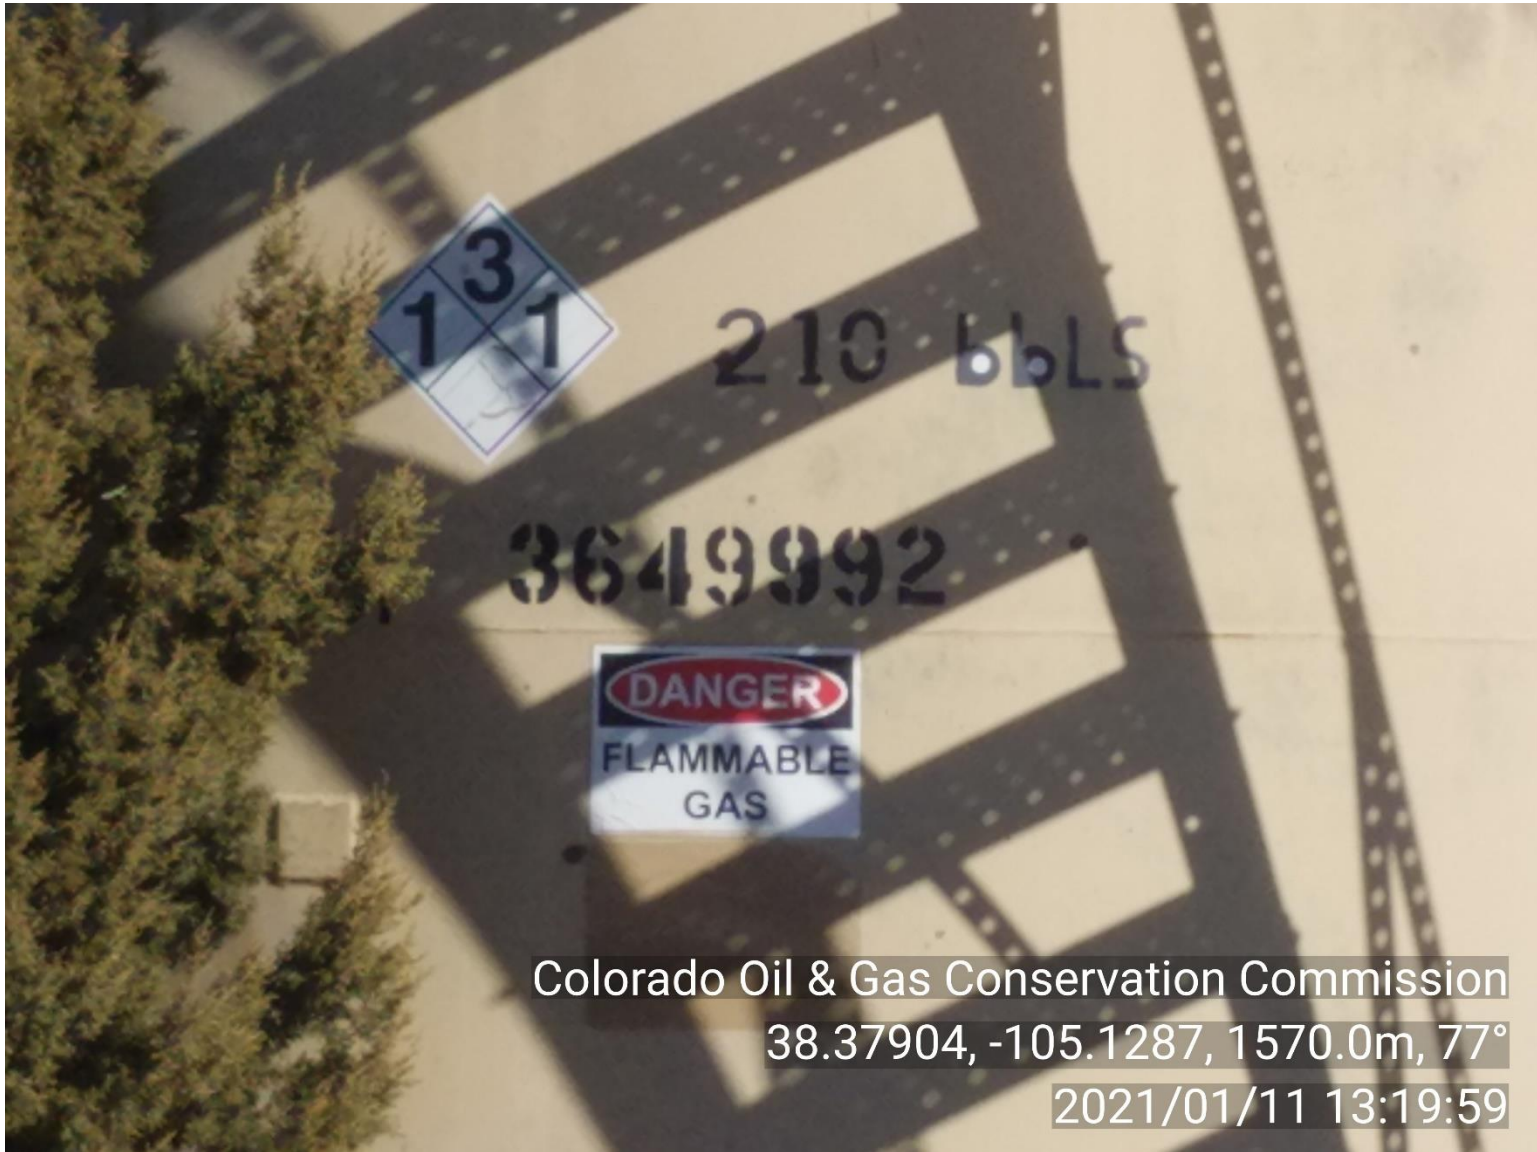
Phone 8: CRUDE OIL SIGN IS DAMAGED ON NORTHERN MOST CRUDE OIL TANK. **POST SIGN, COMPLY WITH RULE 210. d.**  
**CA DATE 3-11-21.**
