Form Name:	<b>Compliance Follow Up Form</b>
Submitter Name:	Kenny Canterbury
Submission Date:	1/18/2021
Server Receive Date:	1/6/2021
Reference Number:	N/A
Location:	Clovis A2

Name	Kenny Canterbury
Date of work completion:	1/15/2021
Well Name	Clovis A2
API Number	05-067-08794
Select State	Colorado
Work type	COGCC Inspection
Inspection Number (Inspection # from SOW)	693902169
Special Notes: Recontouring, seeding, mulching and installation of erosion blankets. Action Complete	
Other *must specify in notes*	
Photo of above state work completion

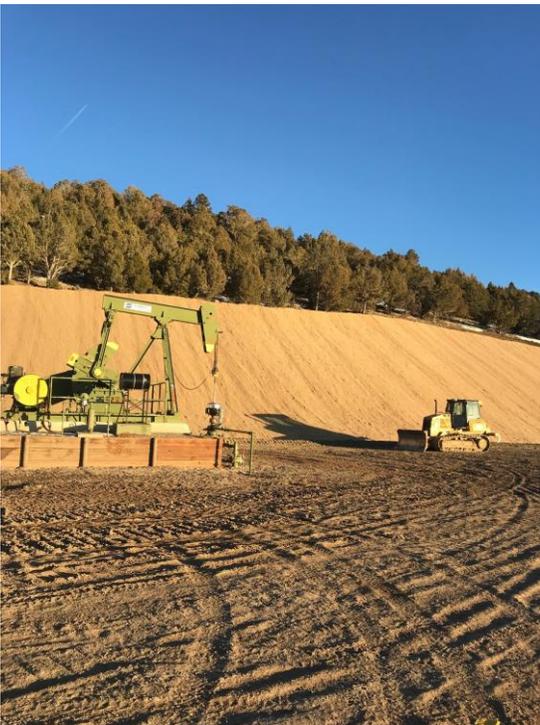
Photo of North end of cut slope after soils from fill slope were moved into cut to reduce slope and increase potential for seed germination and vegetation establishment.

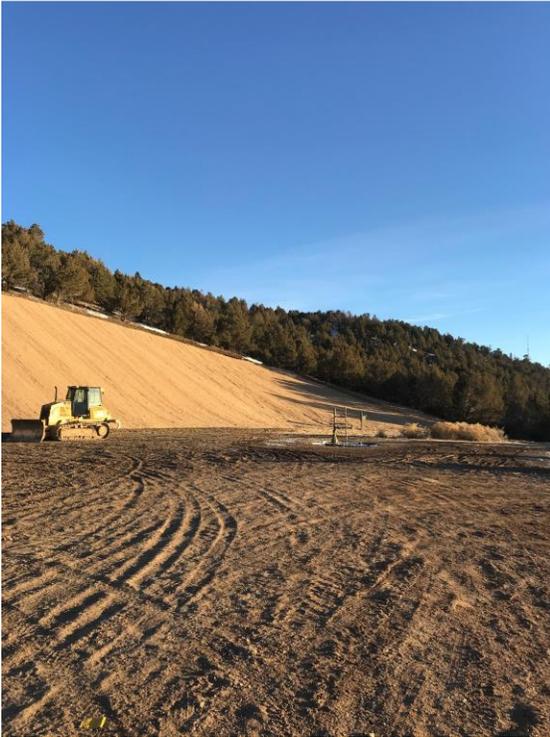
Photo of south end of cut slope after recontour as near as practicable, seeding, mulching and installation of 100% biodegradable ECB.

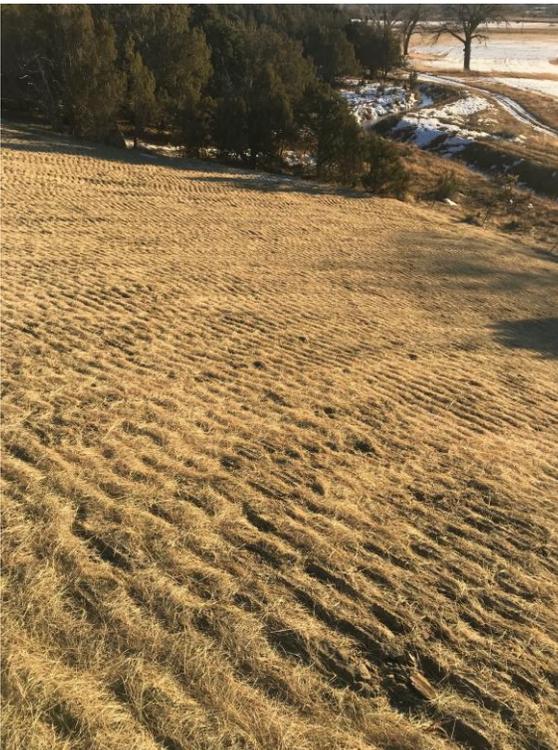
Photo of south end of cut slope after recontour as near as practicable, seeding, mulching and installation of 100% biodegradable ECB.
