Location Name: BALBOA 11-3, API #: 071-08969, Insp. #:695103950

EVERGREEN
NATURAL RESOURCES LLC

BALBOA No. 11-3

API No. 05-071-08969

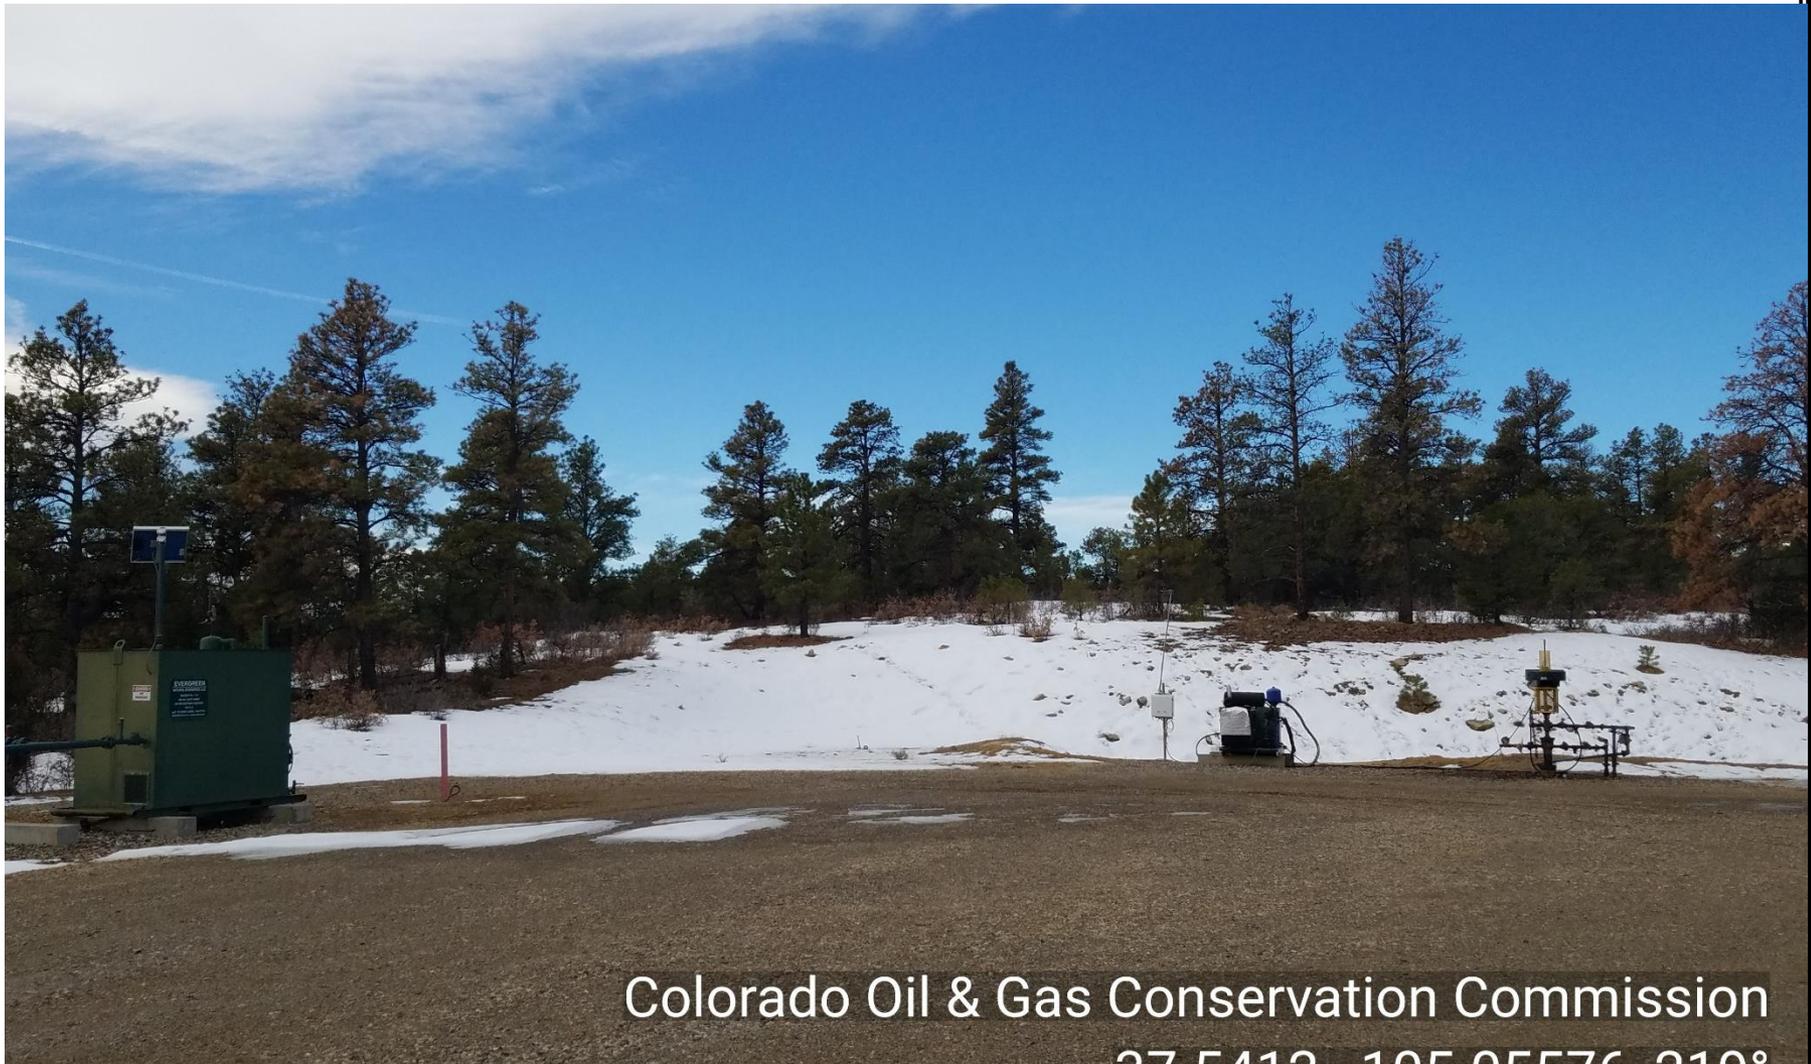
Phone 1: LOCATION

NW NW SECTION 3-32S-66W

CR 41.6

LAT. 37.29297 / LONG. -104.77515

WDID 1810070 / PERMIT #72128-F

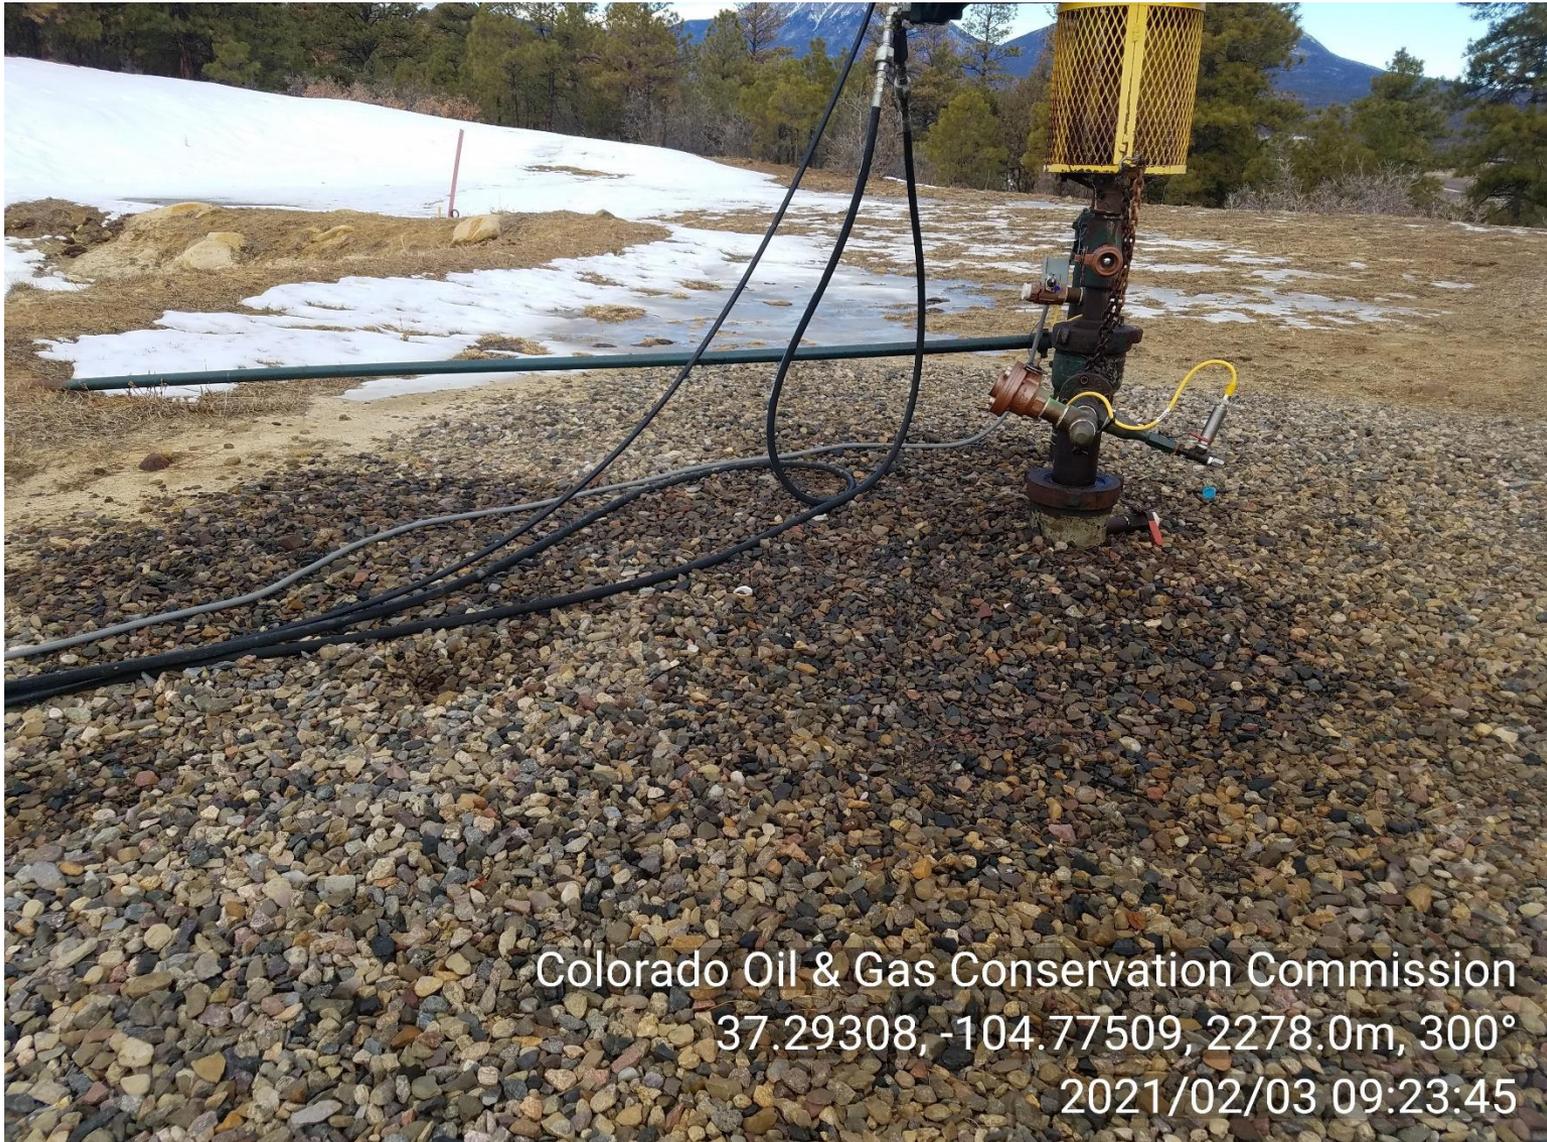
Phone 3: AREA OF IMPACTED SOIL UNDER DRIVEHEAD MOTOR. COMPLY WITH RULE 906. COMPLY WITH 901.b IN HANDLING SOLID WASTE MATERIAL (i.e.. IMPACTED SOIL). CA DATE 3-3-21.

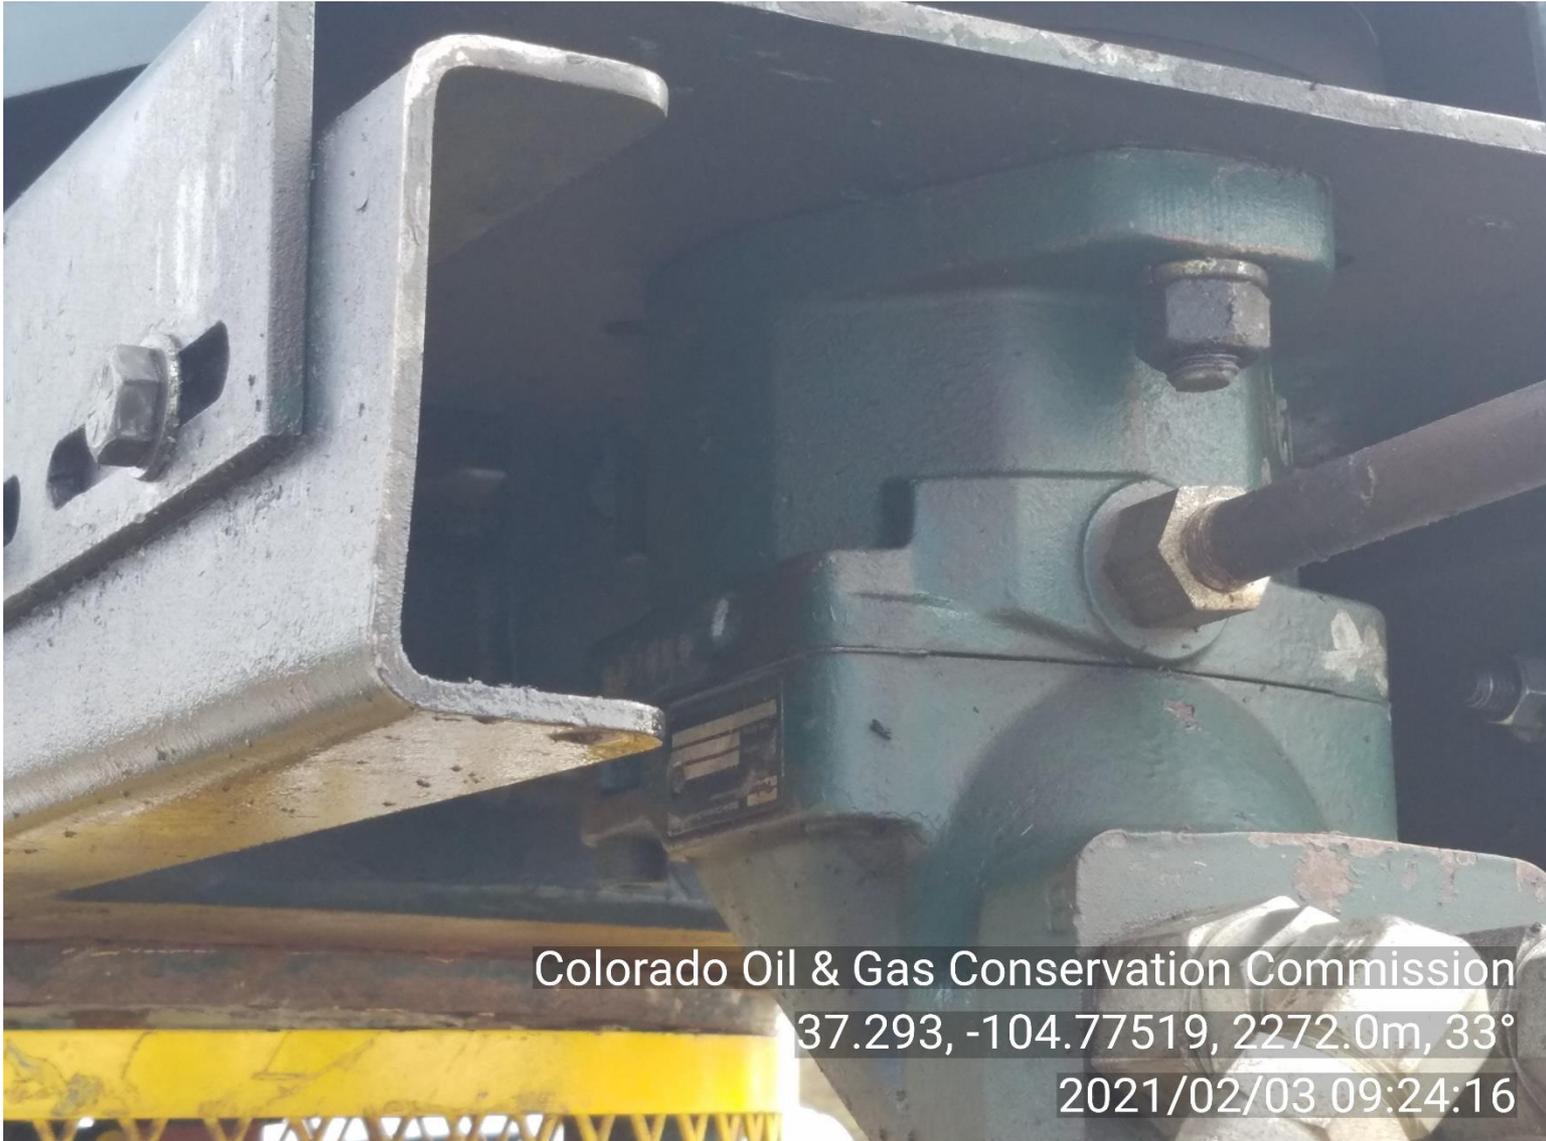
Phone 4: DRIVEHEAD IS LEAKING HYDRAULIC OIL AND IMPACTING SOIL BELOW. COMPLY WITH RULE 608.e. INSPECT AND REPAIR LEAKS AT REGULAR INTERVALS. CA DATE 3-3-21.
