Final Reclamation Inspection

Operator: NOBLE ENERGY INC - #100322

Location ID: 447038

Location Name: ROSKOP 10-1,7,8, C 10-17 Tank battery

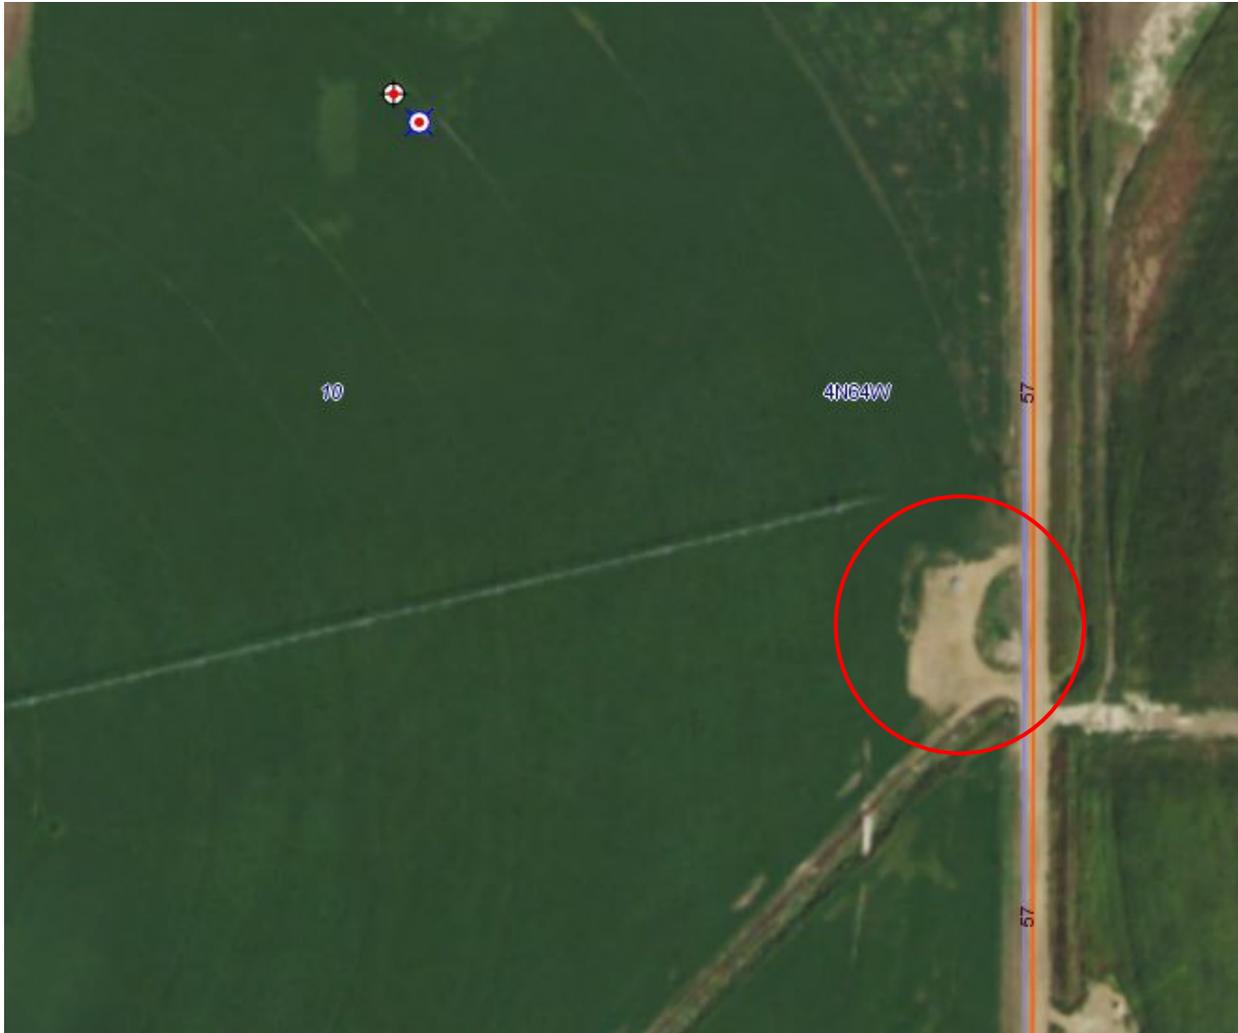
Photo 1. Aerial imagery from 2019. Photo illustrates the former ROSKOP 10-1,7,8, C 10-17 Tank battery (red circle). This location is inside of the pivot circle.

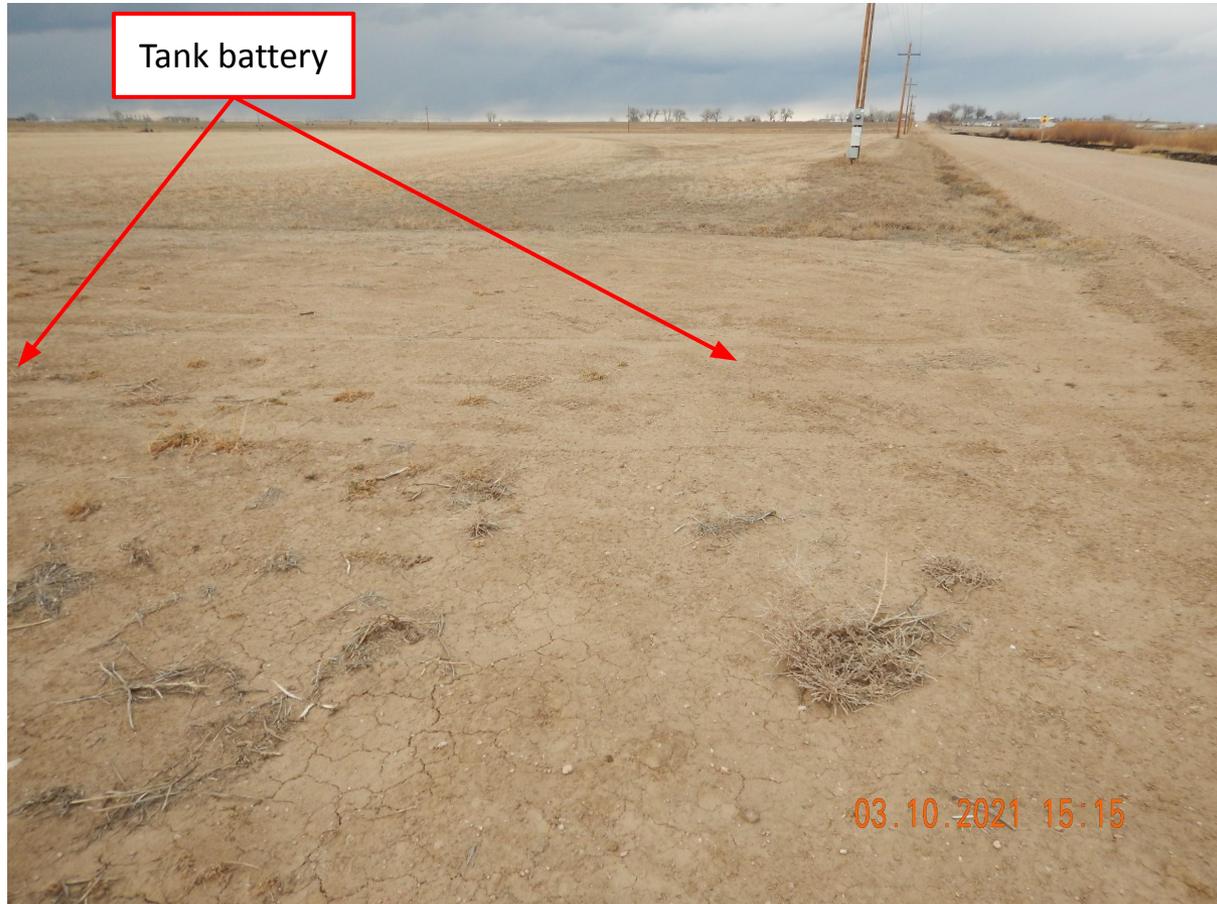
Photo 2. Photo taken from the eastern tank battery location, facing North. Photo illustrates all equipment has been removed from the tank battery. However, it does not appear the tank battery was properly contoured to the surrounding area and does not have any establishment of alfalfa along the northeastern portion of the location.

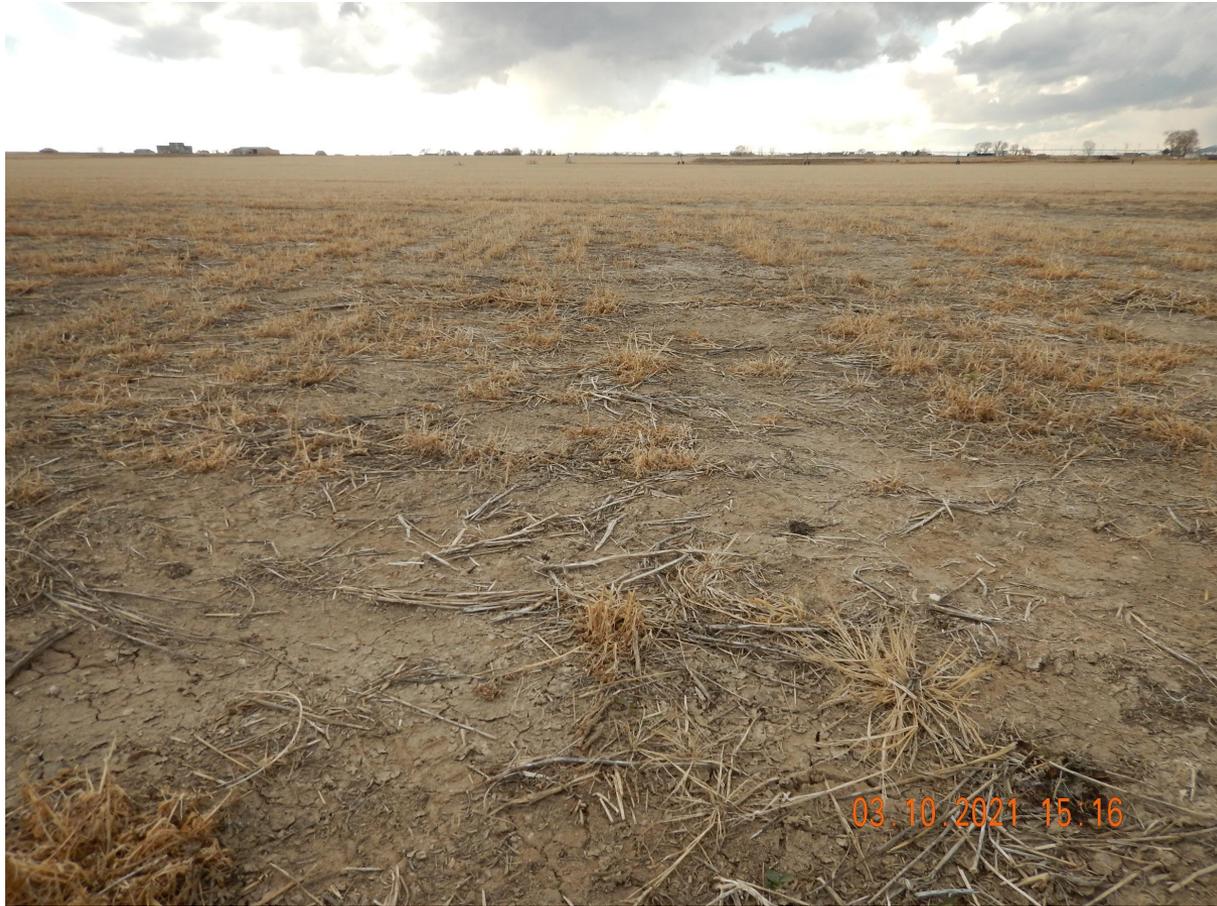
Photo 3. Photo taken from the eastern tank battery location, facing West. Photo illustrates some establishment of alfalfa but bare patches are evident.

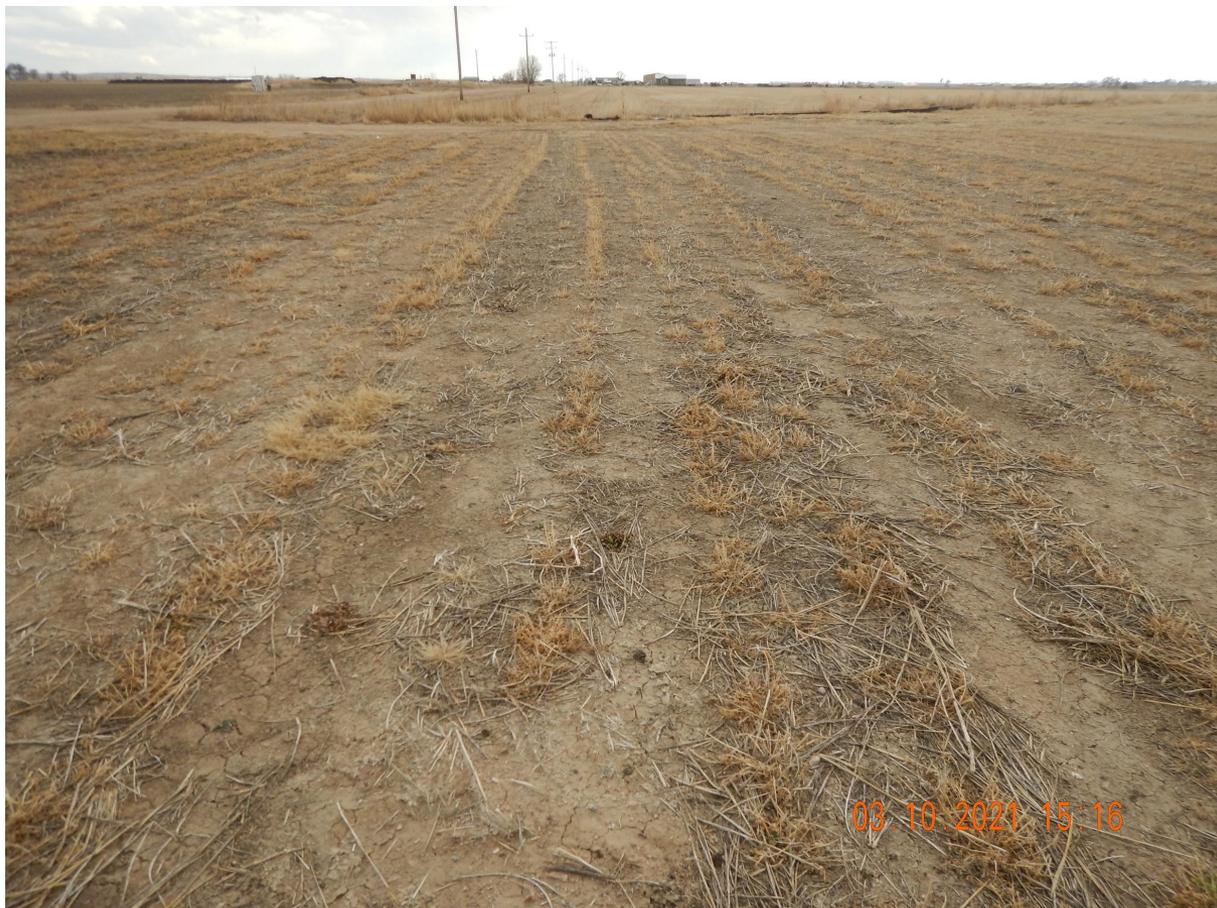
Photo 4. Photo taken from the central tank battery location, facing South. See comments under Photo 3.

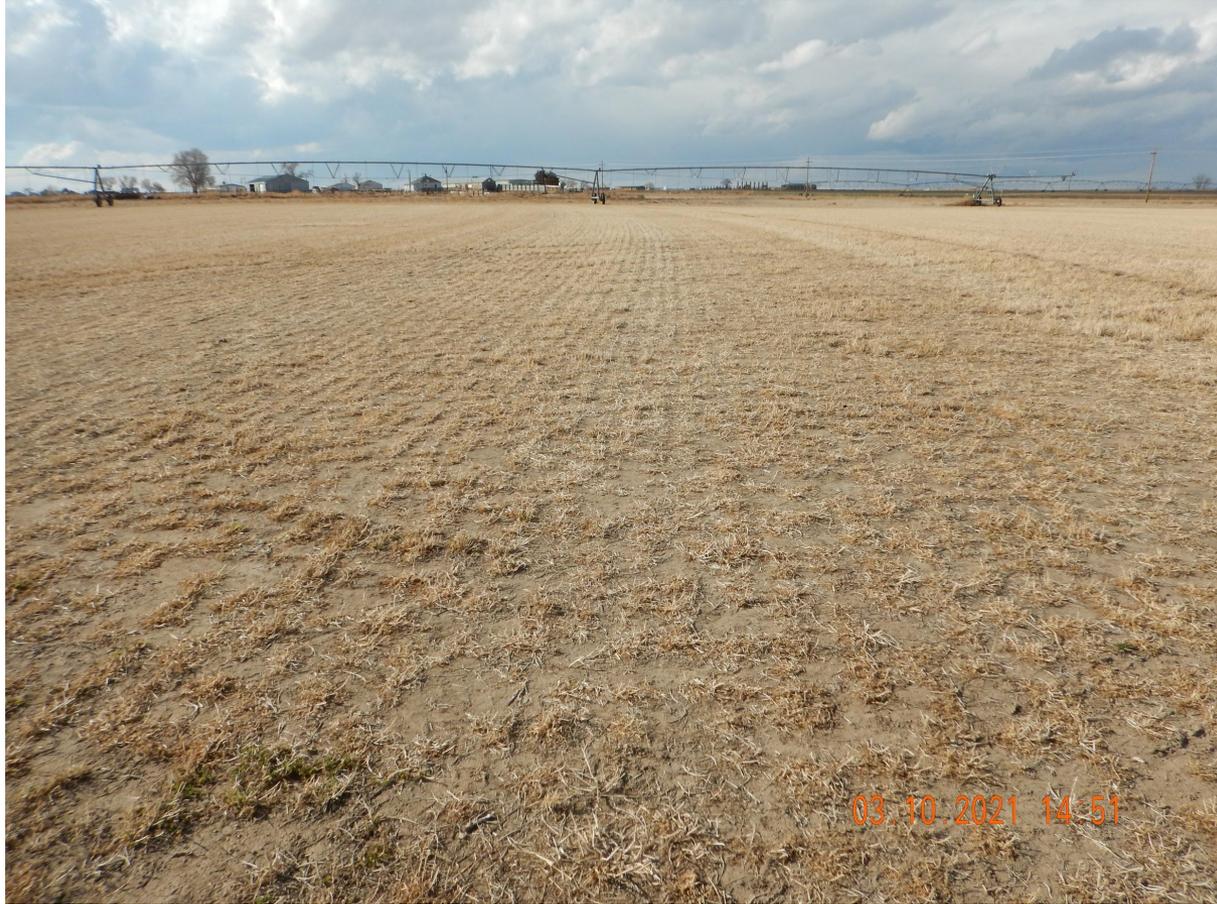
Photo 5. Reference crop vegetation.
