Location Name: MAZATLAN 23-25 5/24/21, API #: 071-09498, Insp. #:695104370

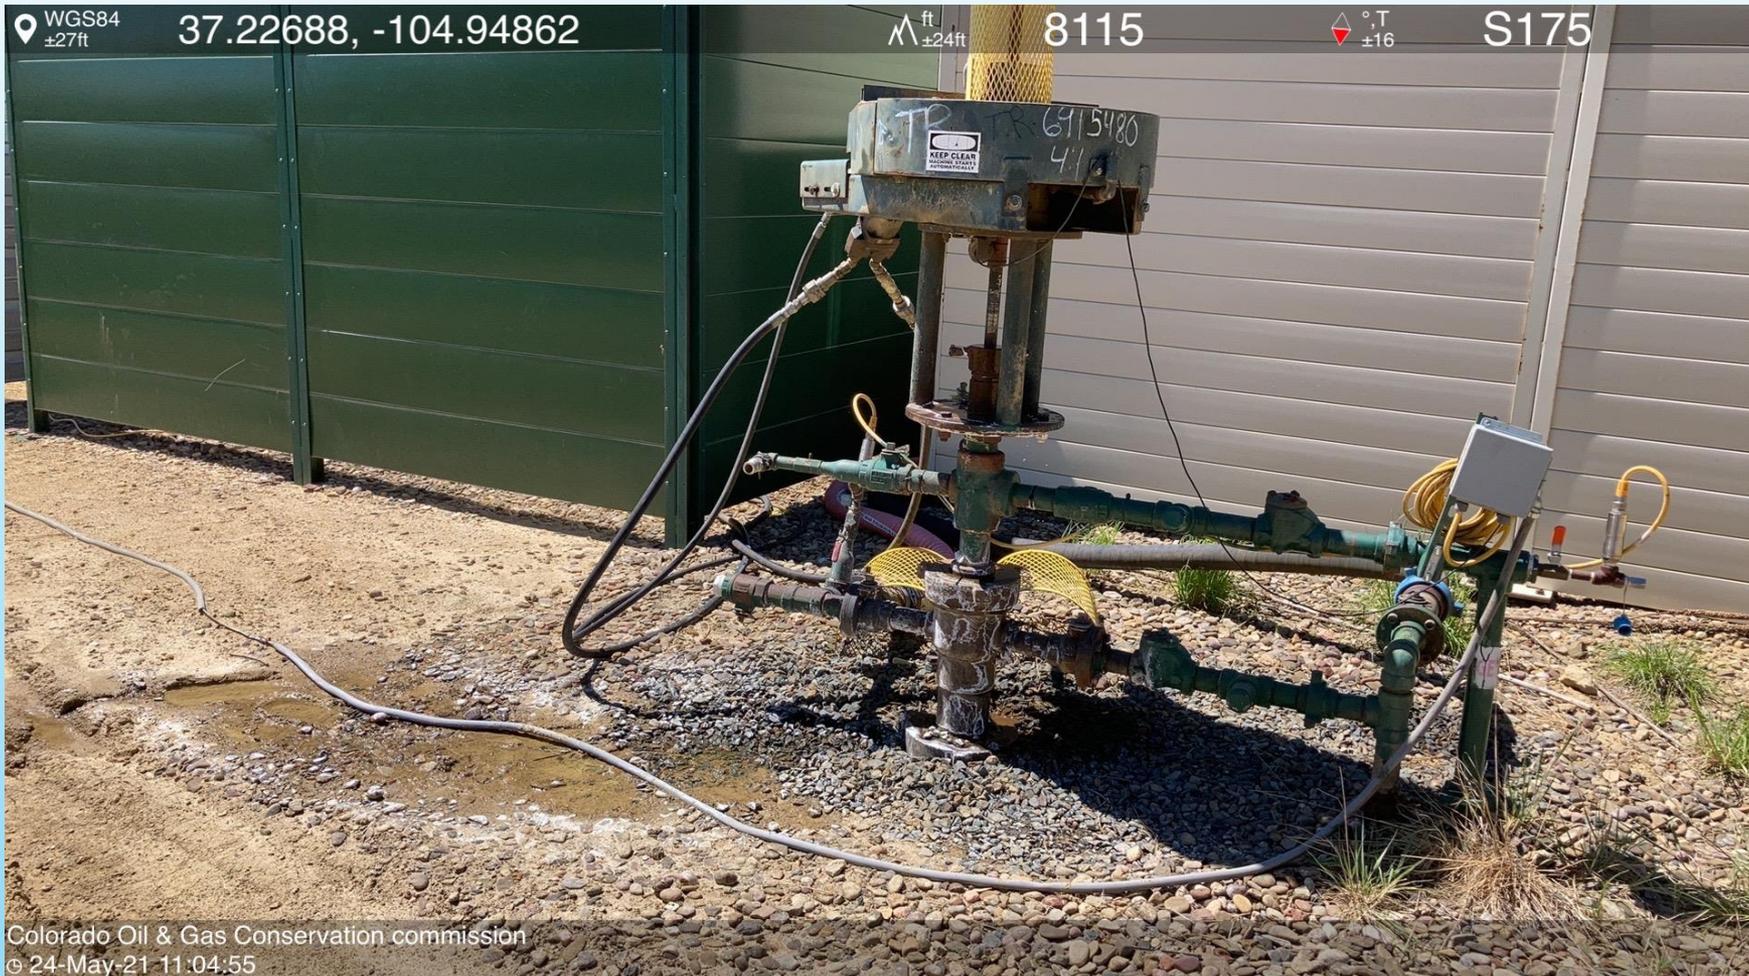
**PHOTO 3: DRIVEHEAD IS LEAKING PRODUCED WATER (SPOKE WITH DAVE BACA WITH OPERATOR BY PHONE). Control and contain spills/releases and clean up per Rule 912.a. CA DATE 5/25/21.**
