North Platte 21-24 Production Facility

Location ID 470676

Decommissioning Assessment

May 2021

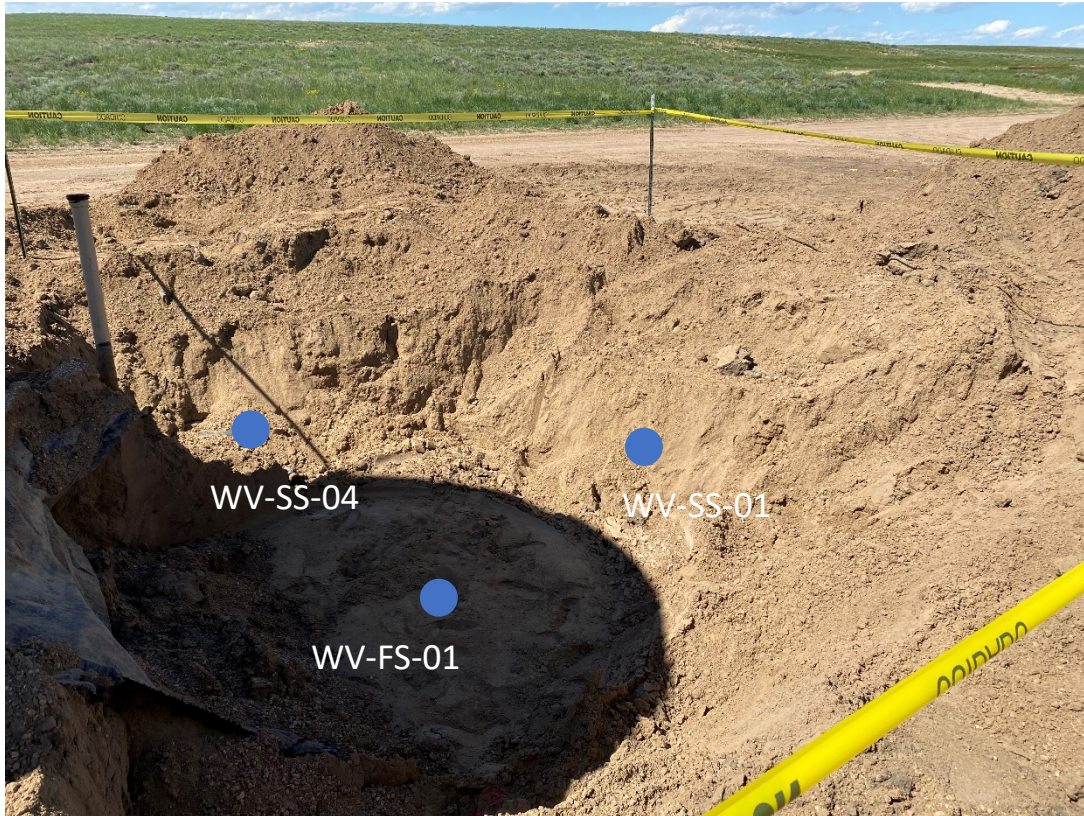
Looking north
Produced water vault excavation – vault removed prior to arrival
No petroleum hydrocarbon staining or odor observed
Samples collected:
WV-SS-01@3' – 1.3 ppm-v
WV-SS-04@3' – 4.6 ppm-v
WV-FS-03@6.5' – 5.2 ppm-v

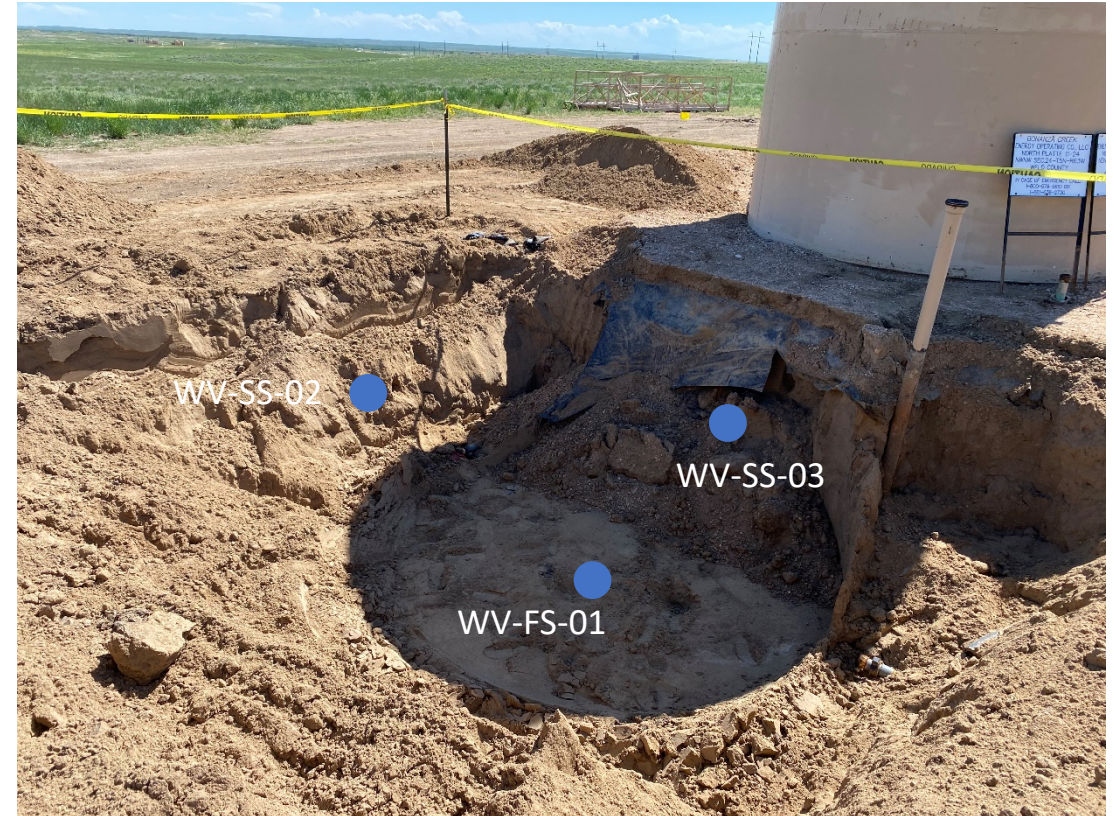
Looking south
Produced water vault excavation – vault removed prior to arrival
No petroleum hydrocarbon staining or odor observed
Samples collected:
WV-SS-02@3' – 8.1 ppm-v
WV-SS-03@3' – 8.5 ppm-v
WV-FS-03@6.5' – 5.2 ppm-v

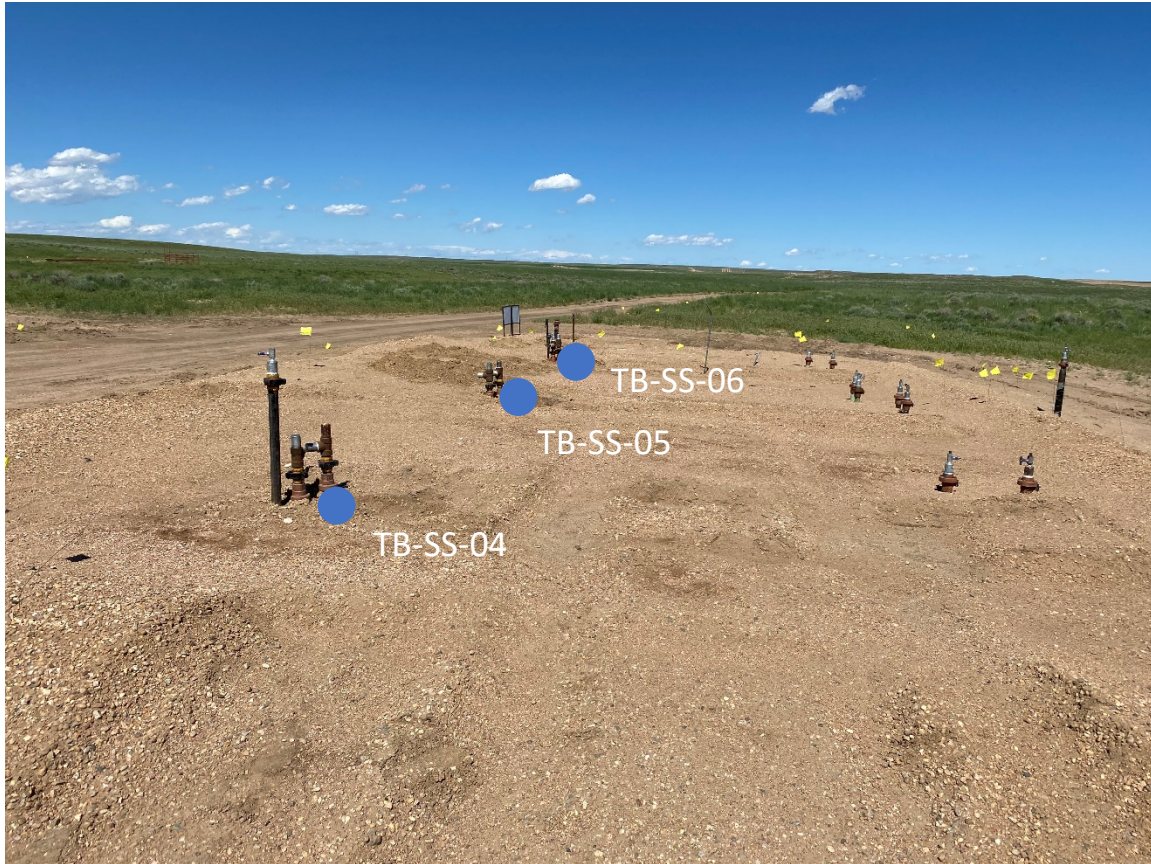
Looking east-northeast
Separator containment area – separators removed prior to arrival
No petroleum hydrocarbon staining or odor observed
Samples collected:
TB-SS-04@0-0.25' – 6.1 ppm-v
TB-SS-05@0-0.25' – 5.5 ppm-v
TB-SS-06@0-0.25' – 15.6 ppm-v

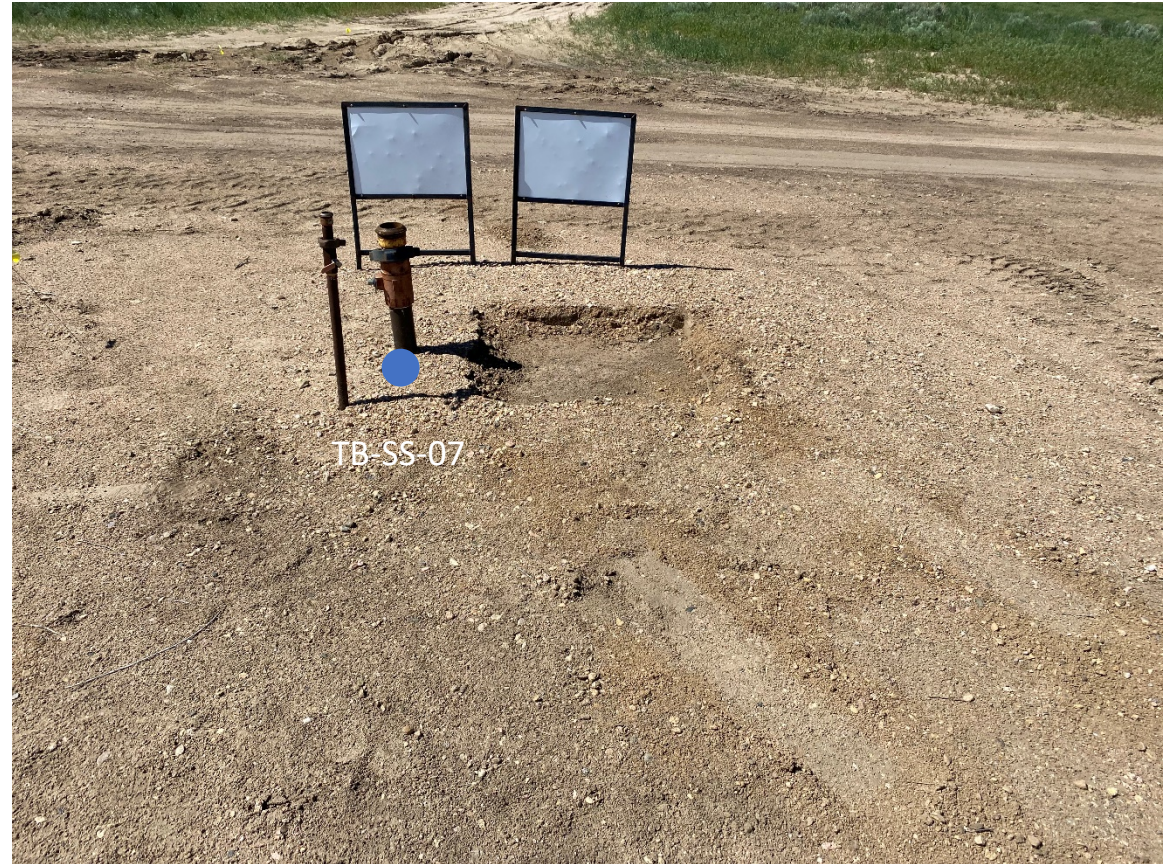
Looking north-northwest
Former ECD locations – removed prior to arrival
No petroleum hydrocarbon staining or odor observed
Samples collected:
TB-SS-07@0-0.25' – 2.3 ppm-v

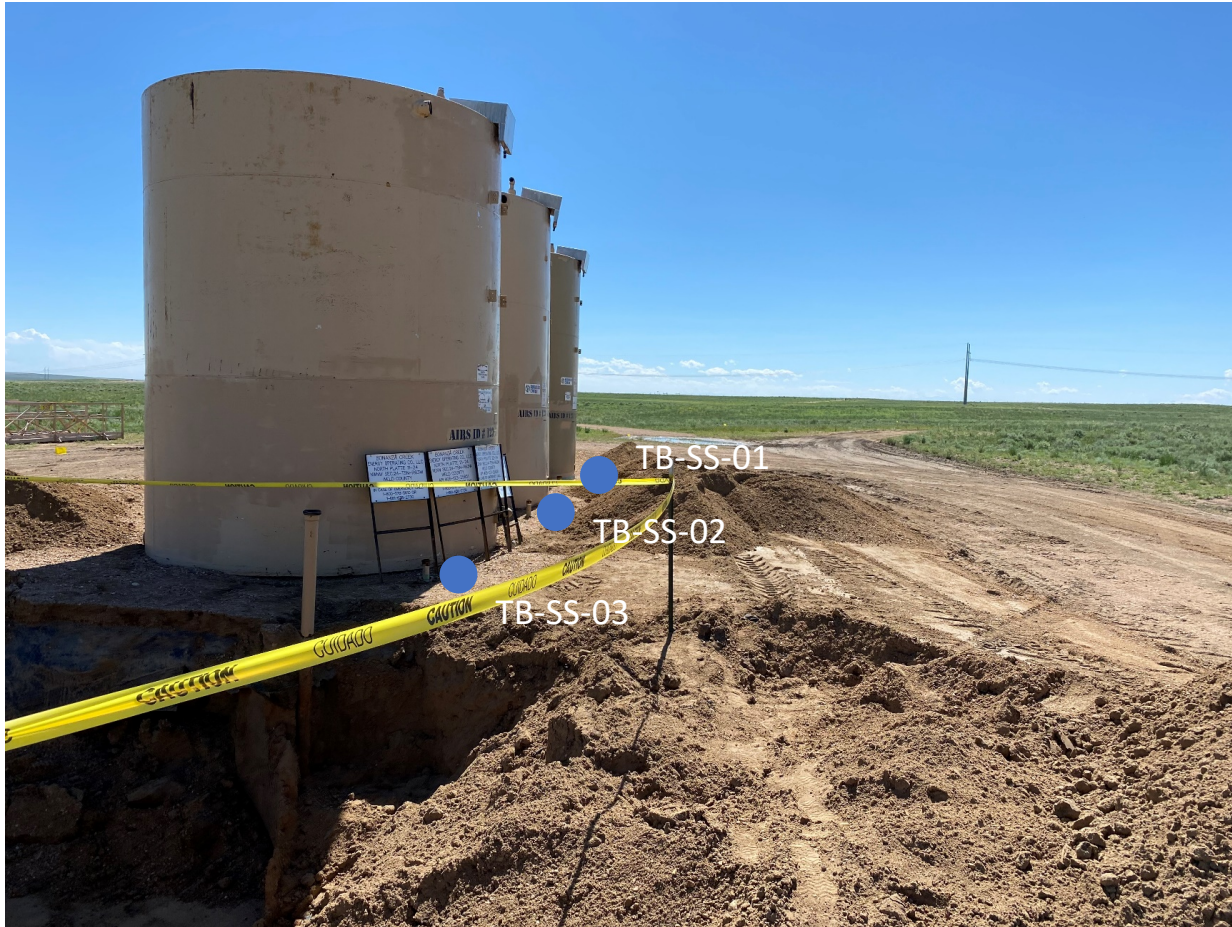
Looking west-southwest

Production tank connection points

Tanks appeared in good condition

No petroleum hydrocarbon staining or odor observed

Soil samples collected:

TB-SS-01@0-0.25' – 9.3 ppm-v

TB-SS-02@0-0.25' – 7.1 ppm-v

TB-SS-03@0-0.25' – 7.8 ppm-v
