Inspection Photos

API: 055-06306

Operator: MANZANO LLC

Inspection Date: 10/5/2021

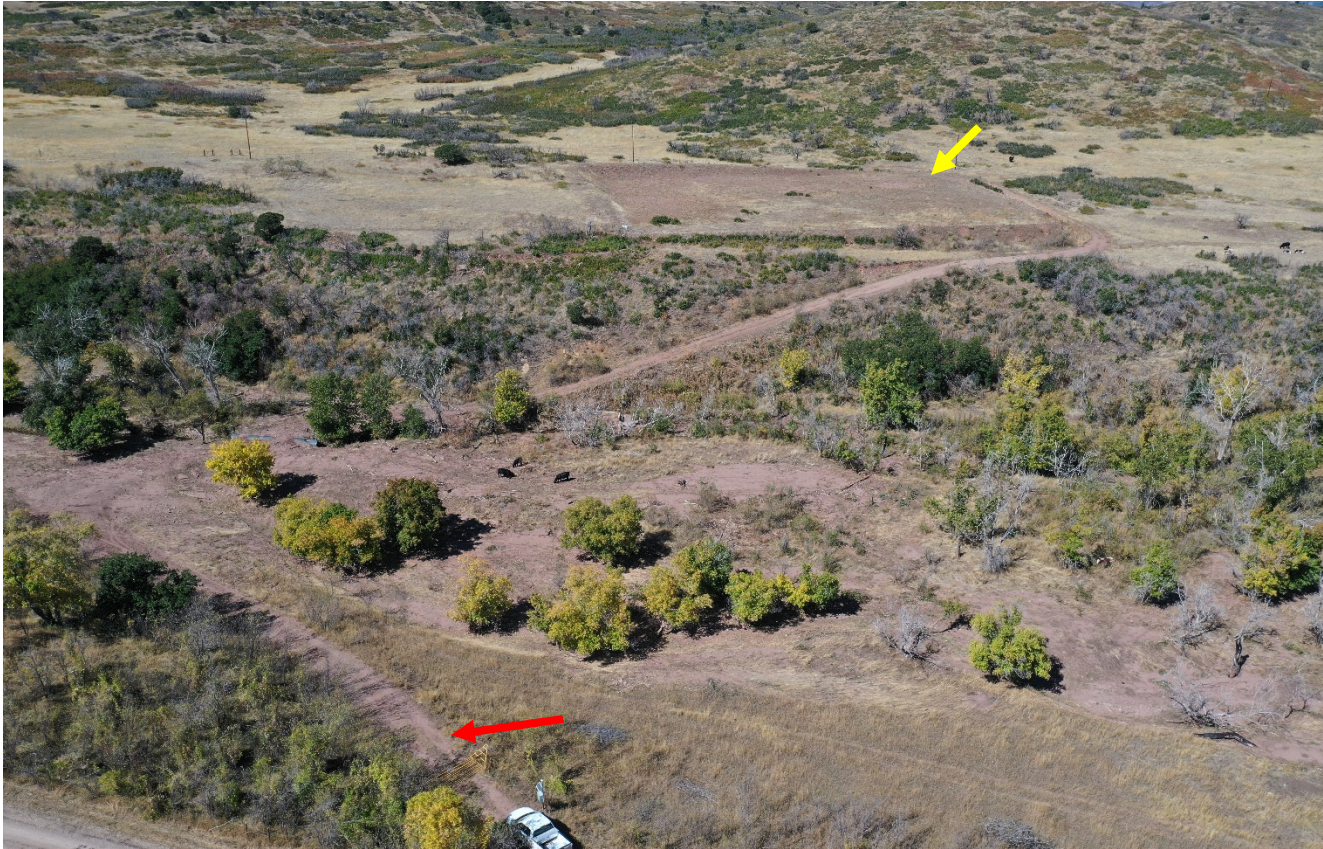
Photo 1. Drone aerial photo facing northwest toward the access road and the location. Red arrow points the the access road and yellow arrow points to the location which have not been reclaimed per rule 1004.

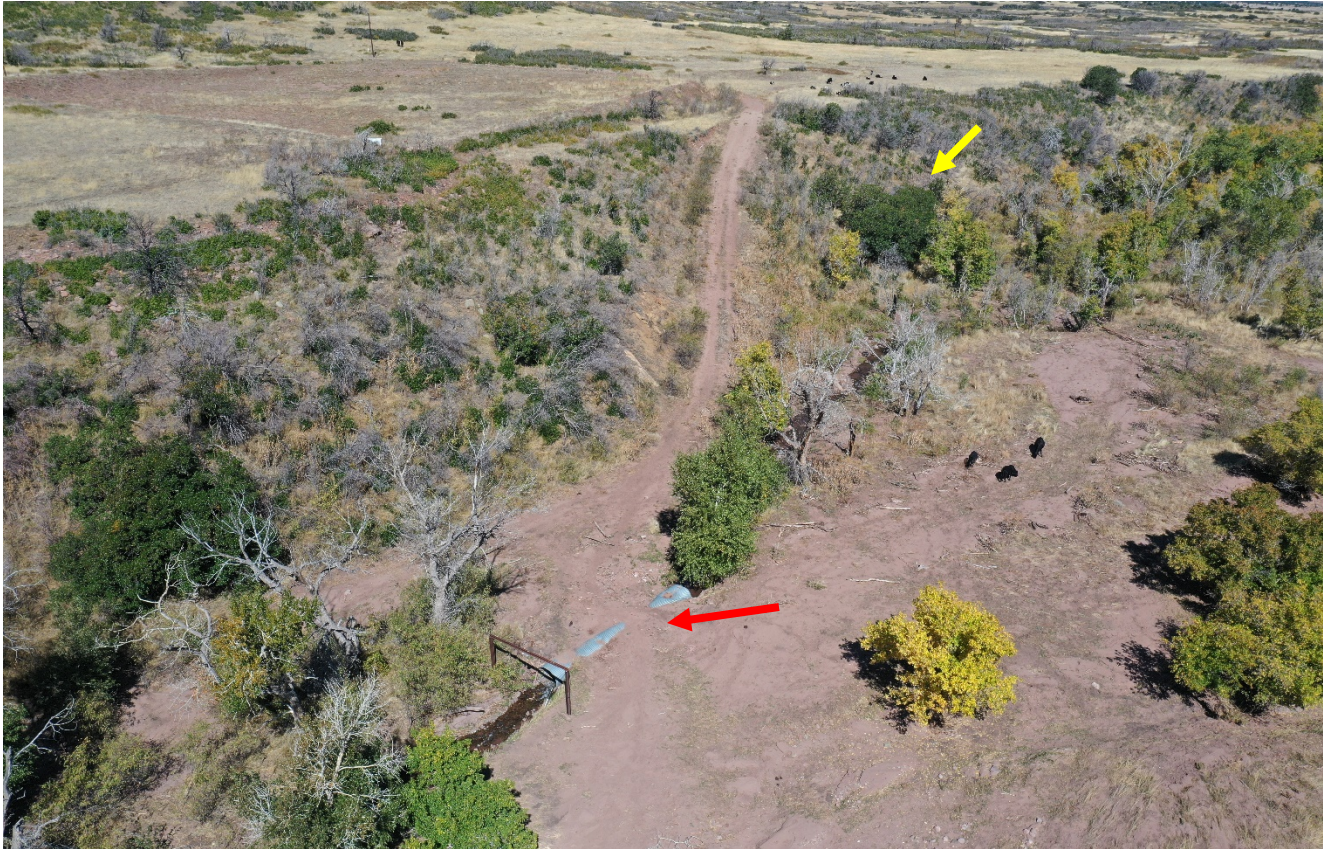
Photo 2. Drone aerial photo facing northeast toward the access road which crossing the perennial stream. The culvert has become exposed due to erosion and is susceptible to further erosion.

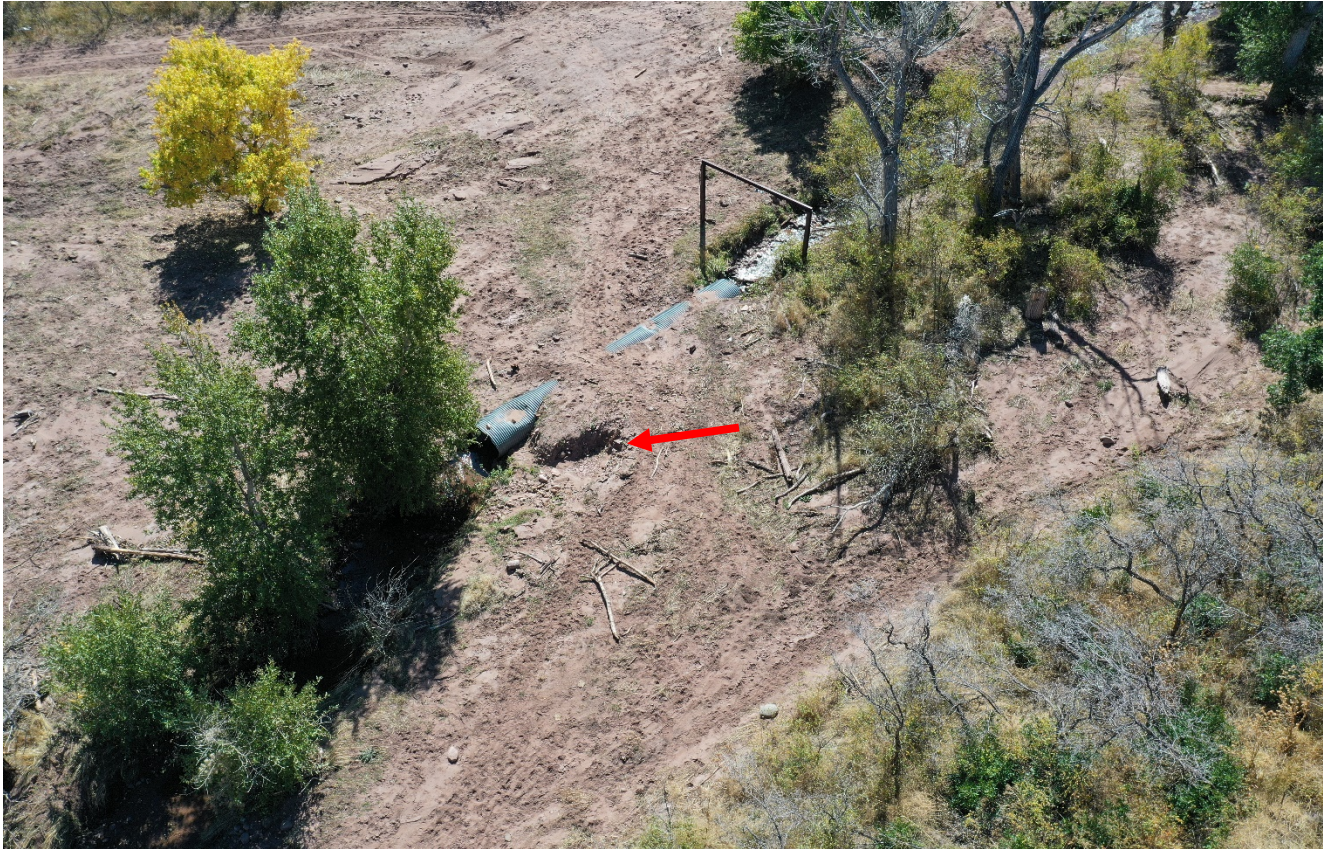
Photo 3. Facing down toward the stream crossing which has eroded around the culvert and may become washed out with the next storm event or snow melt runoff.

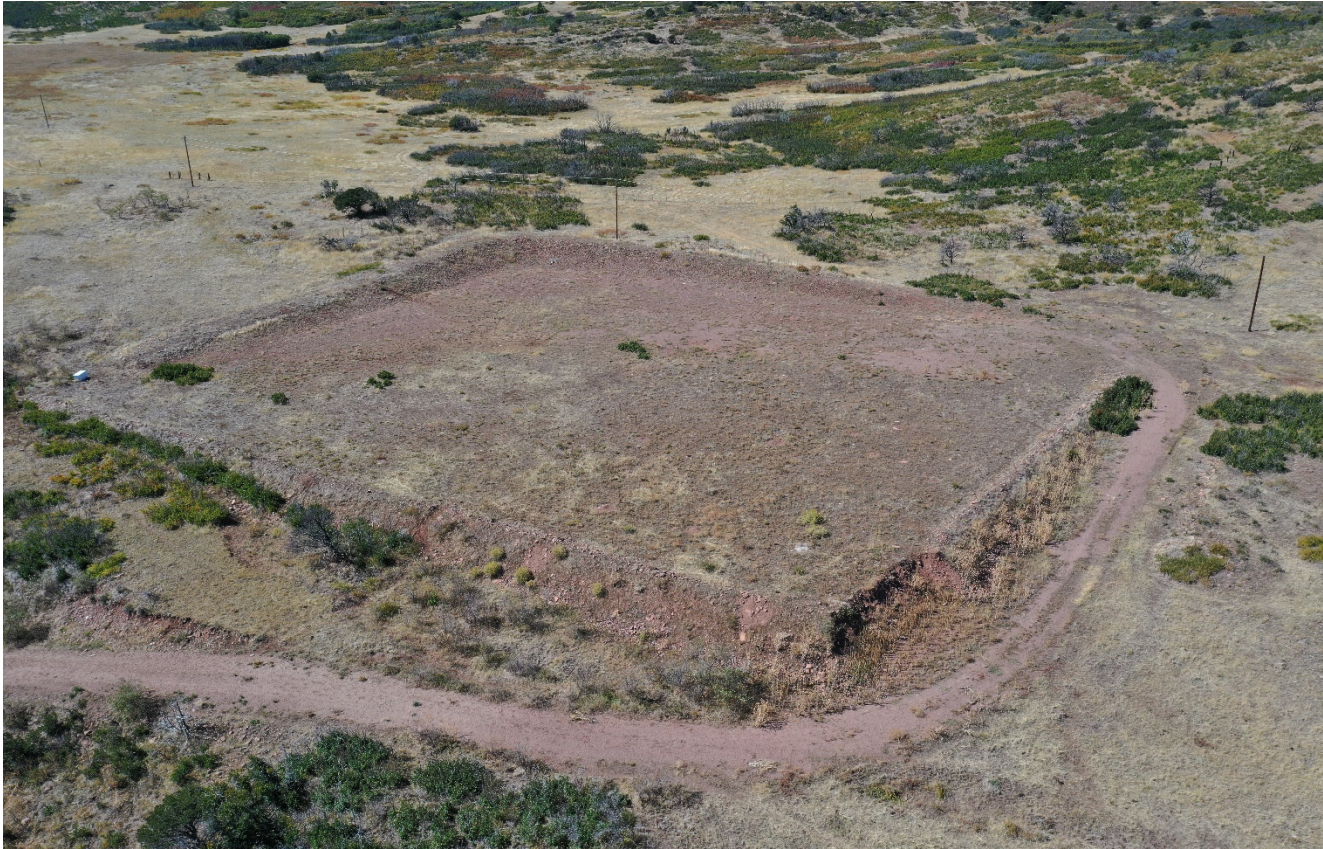
Photo 4. Facing northwest overlooking the location disturbance which is approximately 2.3 acres in size. Aerial image of the location shows the location has not been recontoured and reclaimed.

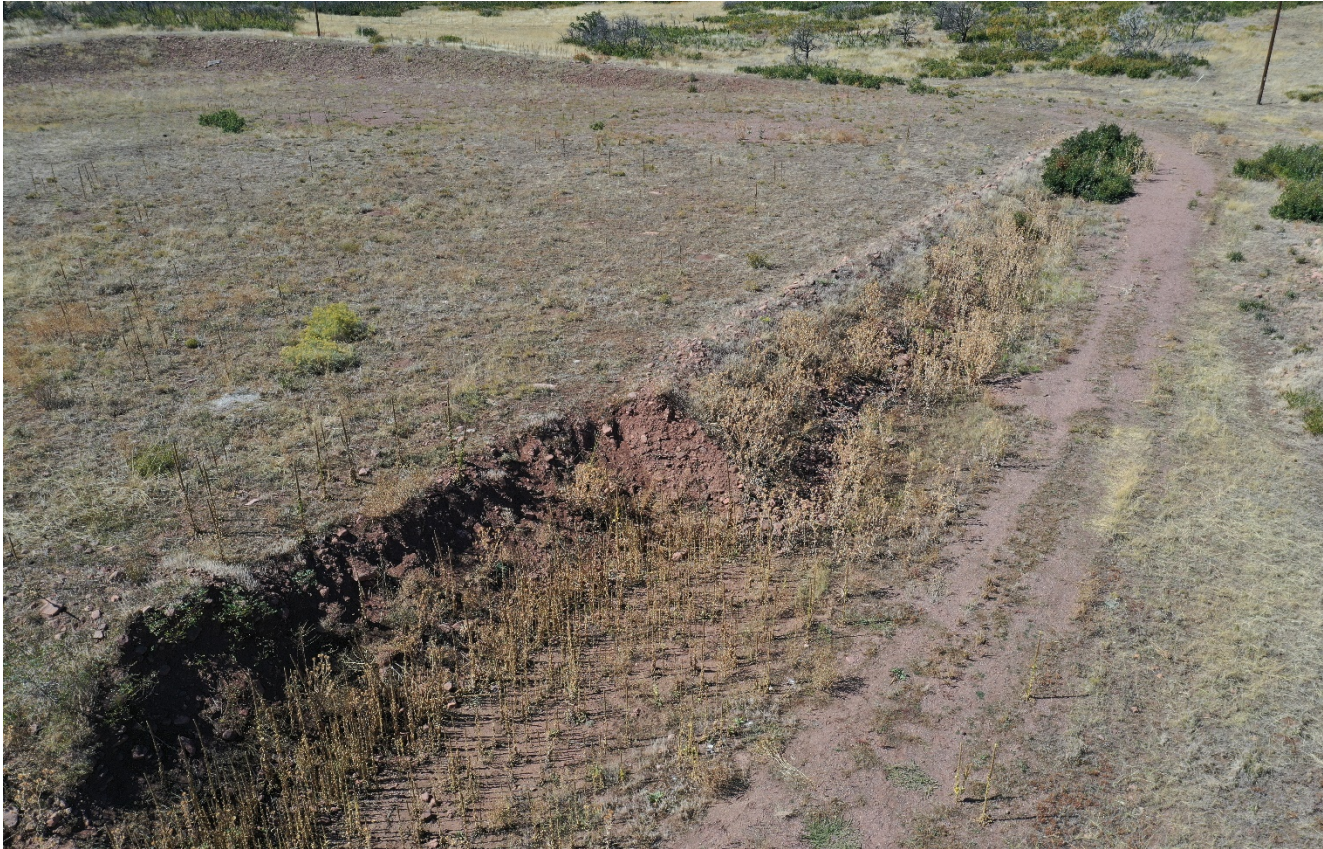
Photo 5. Facing northwest along the fill slope. There are numerous noxious weeds shown along the fill slope and the location. Noxious weeds observed include: Common mullien, Musk thistle, Plumeless thistle, and Scotch thistle.

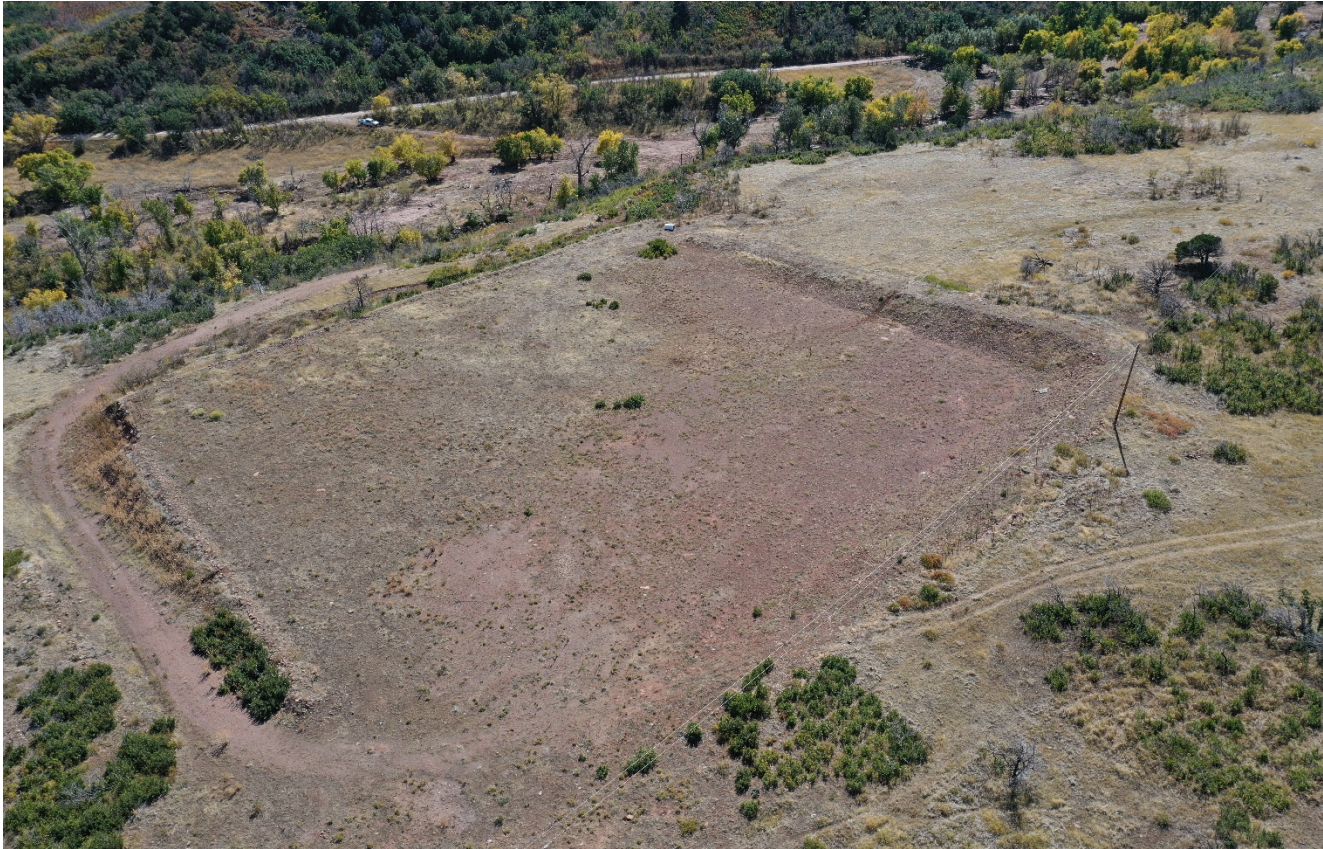
Photo 6. Facing south overlooking the location disturbance which is approximately 2.3 acres in size.
