SG INTERESTS DAILY COMPLETION REPORT

COMPANY		AFE NUMBER	COMPANY REP.	CONSULTANT	
SG Interests		LOE	Bud Guffey	Garrett Stagg	
WELL NAME		COUNTY, STATE		DATE	DAYS
Federal 11-90-35 #1		Gunnison, CO		September 11, 2021	4
PRESENT OPERATION		CONTRACTOR AND RIG NO.		TOOL PUSHER/FOREMAN	
P&A		Hurricane 23		Cesar El Mundo	
API NO:	05-051-06059	PROPERTY NO.:

Inspection Photos
Location Name: Federal 11-90-35 #1
API: 05-051-06059

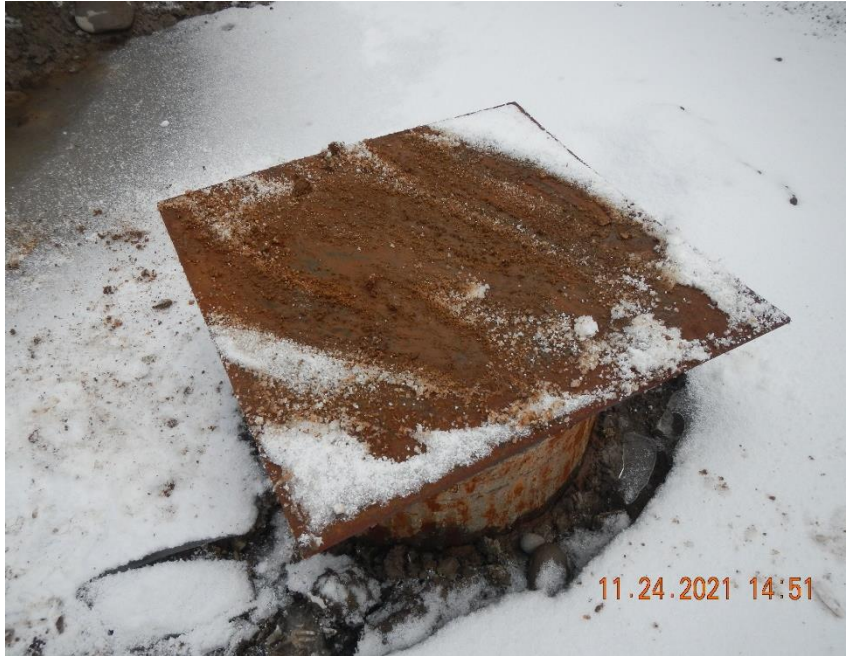
Identifying information is not present on steel plate.

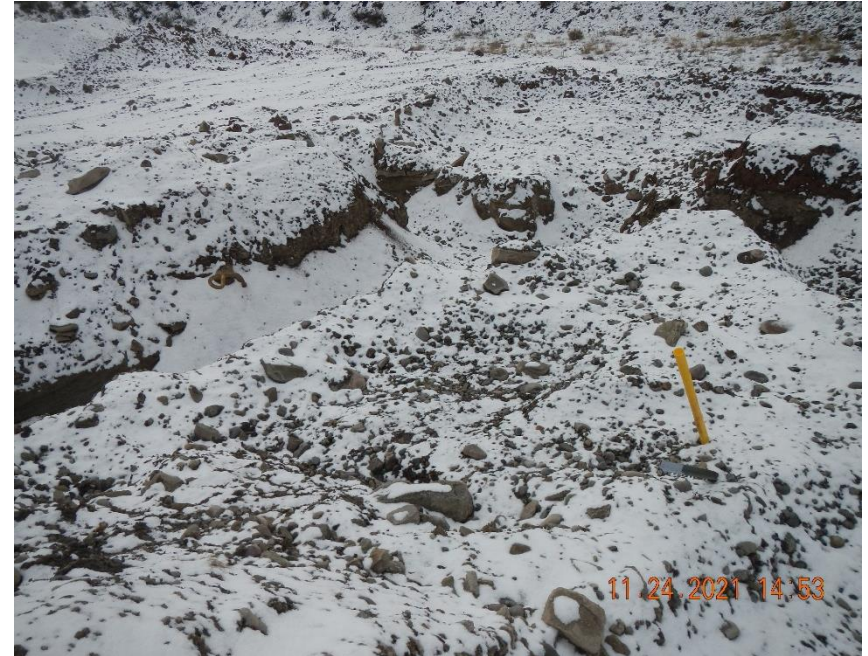
Guy line anchor and marker observed during this inspection.
