Interim Reclamation Inspection

Operator: KERR MCGEE OIL & GAS ONSHORE LP #47120

Location ID: 323207

Inspection Document #: 697503550

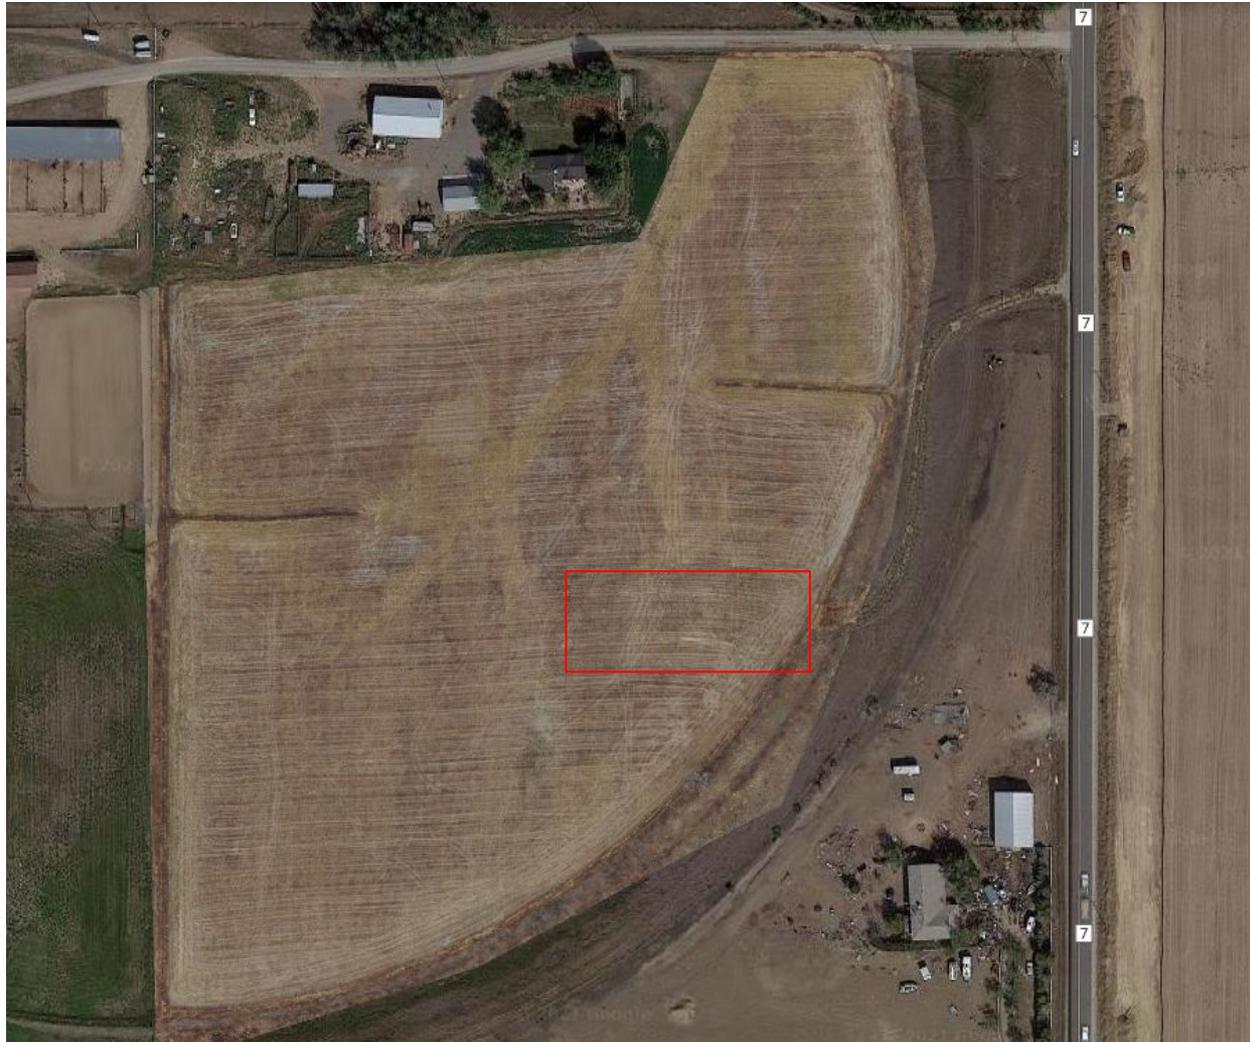
Photo 1. COGCC drone aerial imagery illustrating the approximate well location (red box) for the subject complaint matter.

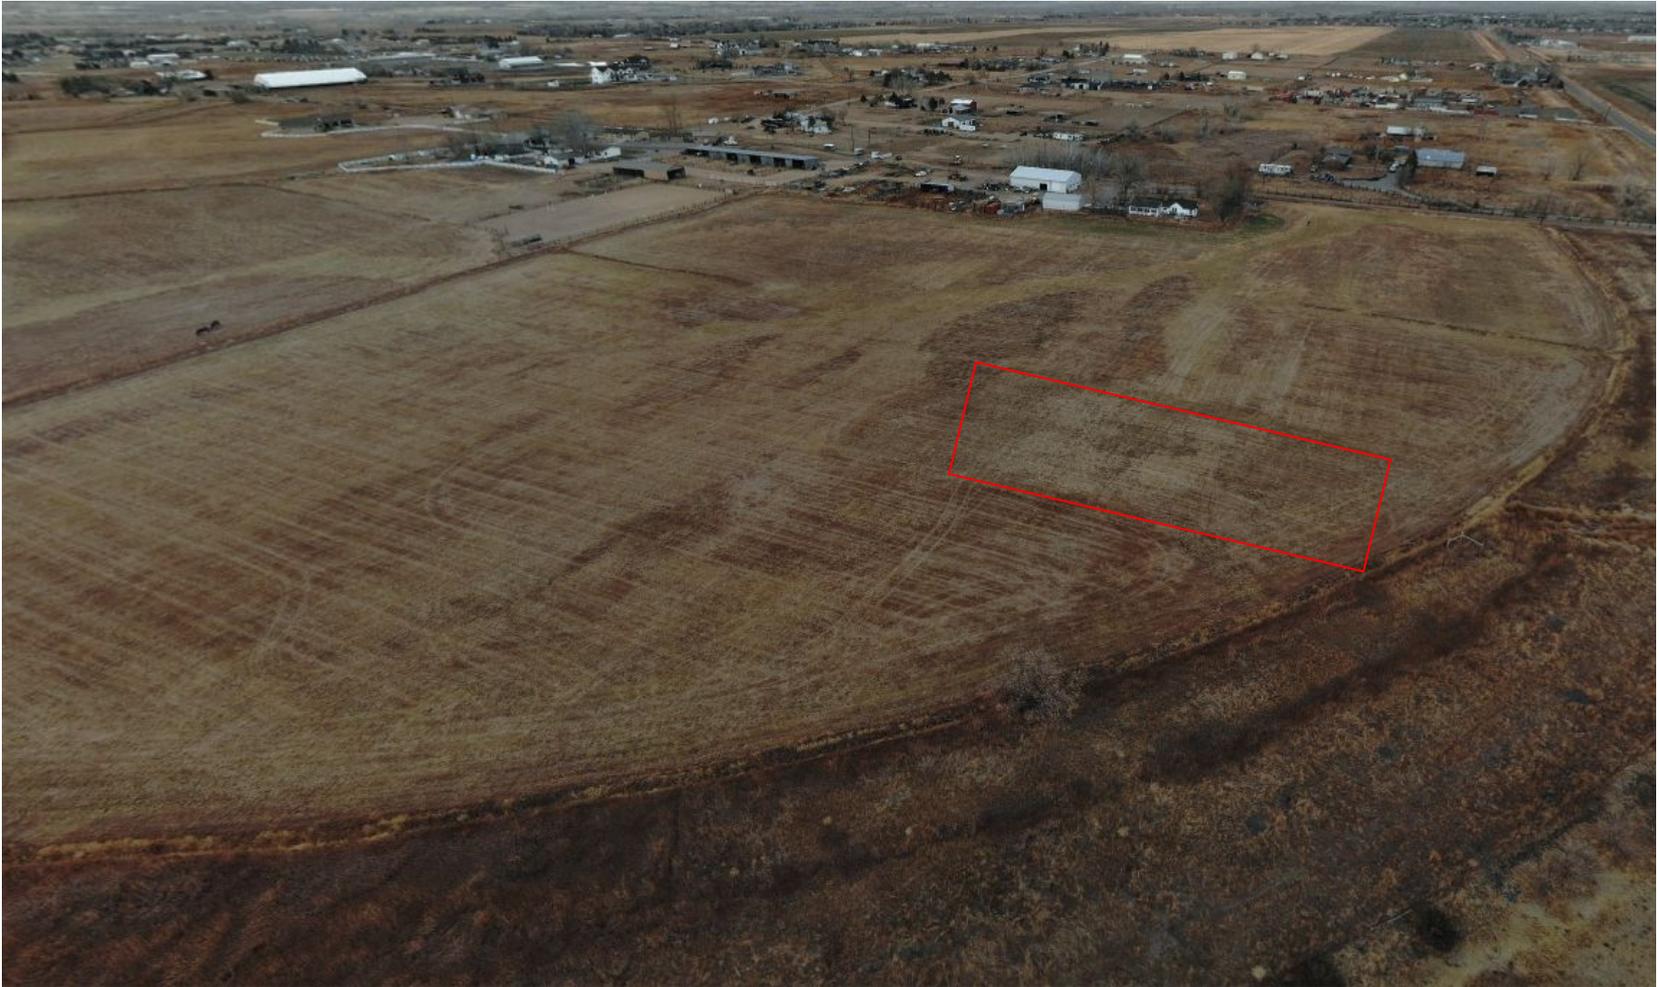
Photo 2. COGCC drone aerial imagery illustrating the approximate well location (red box) for the subject complaint matter.

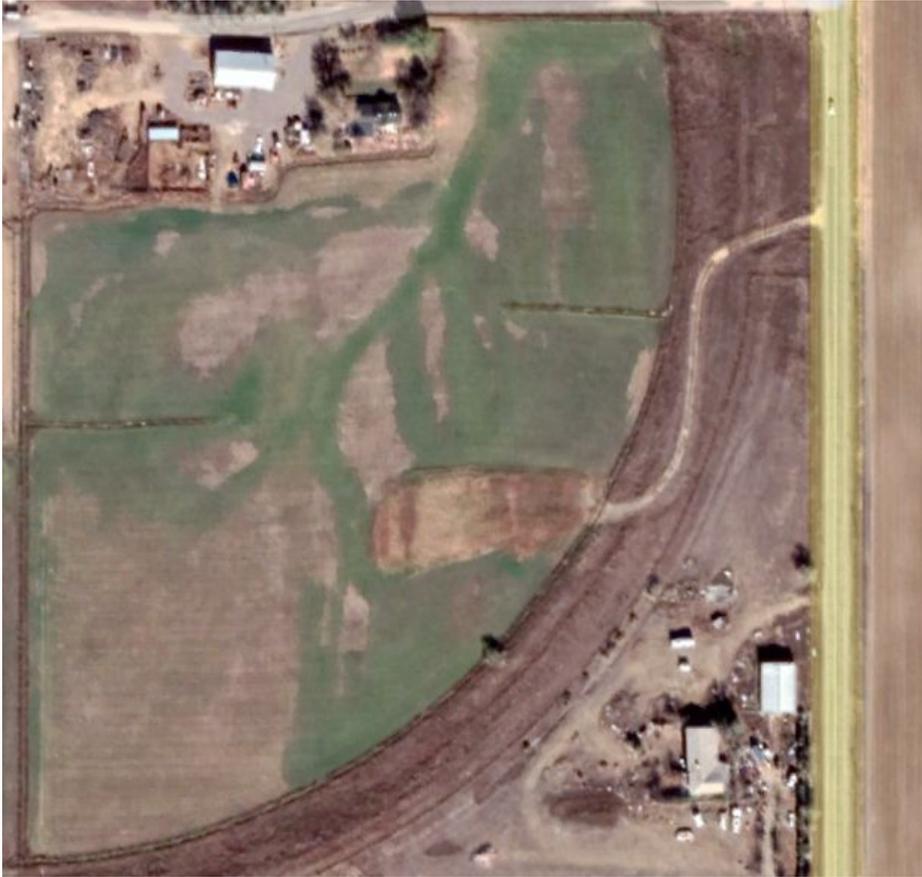
Photo 3. Google Earth aerial imagery from 10/25/2019. Photo illustrates the well location.

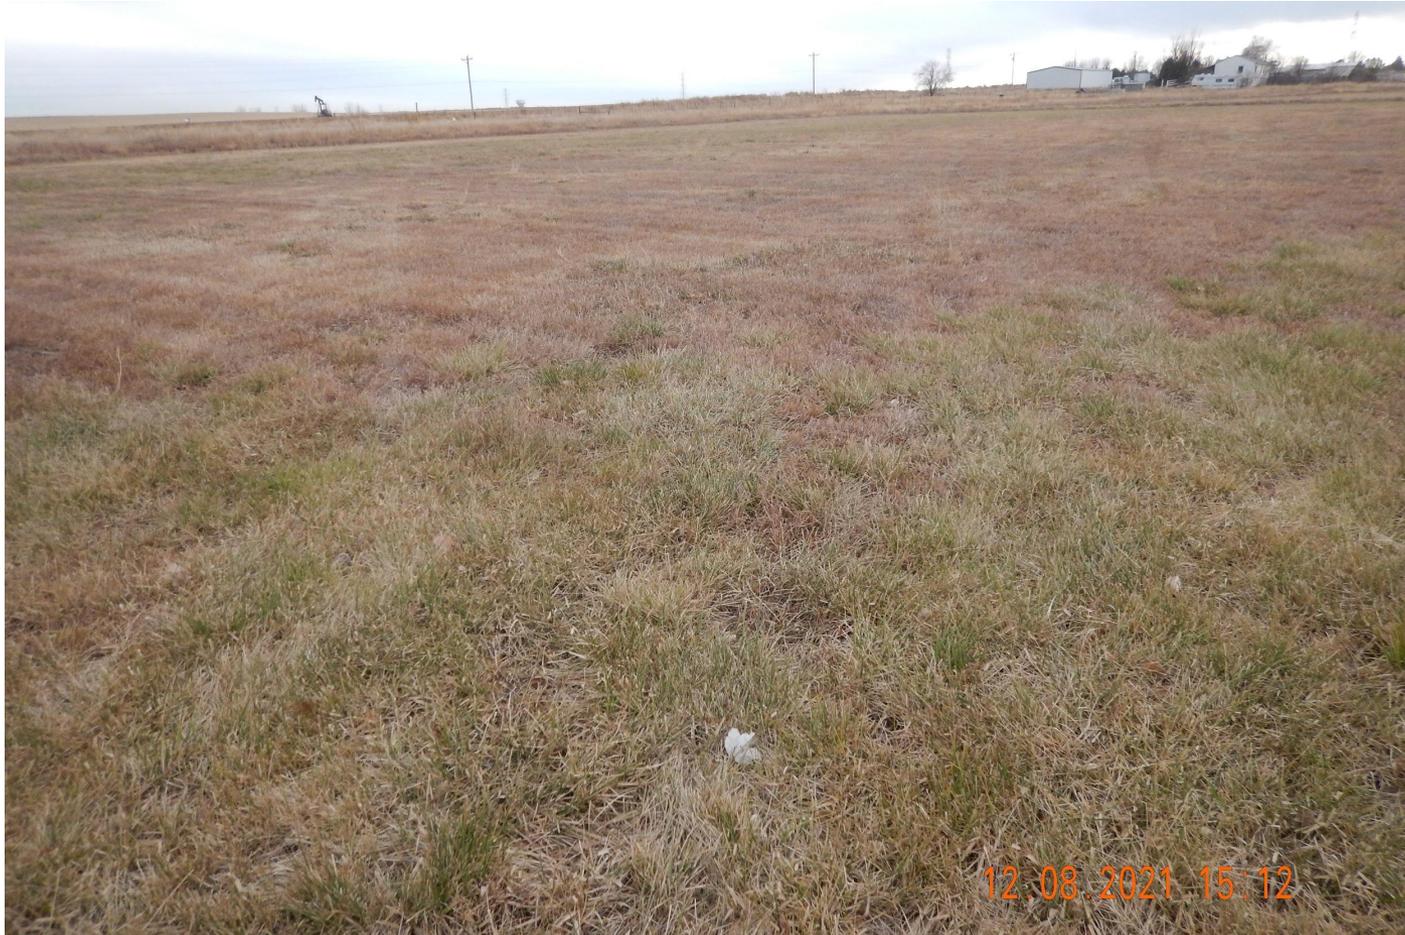
Photo 5. Photo taken north of the well location, facing Southeast. Photo illustrates the current vegetation conditions that are reflective at the time of this inspection. Vegetation consists of brome grass, orchard grass, ryegrass, fescue and some alfalfa.

The reddish vegetation consists of brome grass and the greenish vegetation is orchard grass, ryegrass and fescue.
