# Final Reclamation Inspection

Operator: NOBLE ENERGY INC - #100322

Location ID: 306526

Inspection Photos  
Location Name: LOCKMAN #4-14  
Location ID: 306526

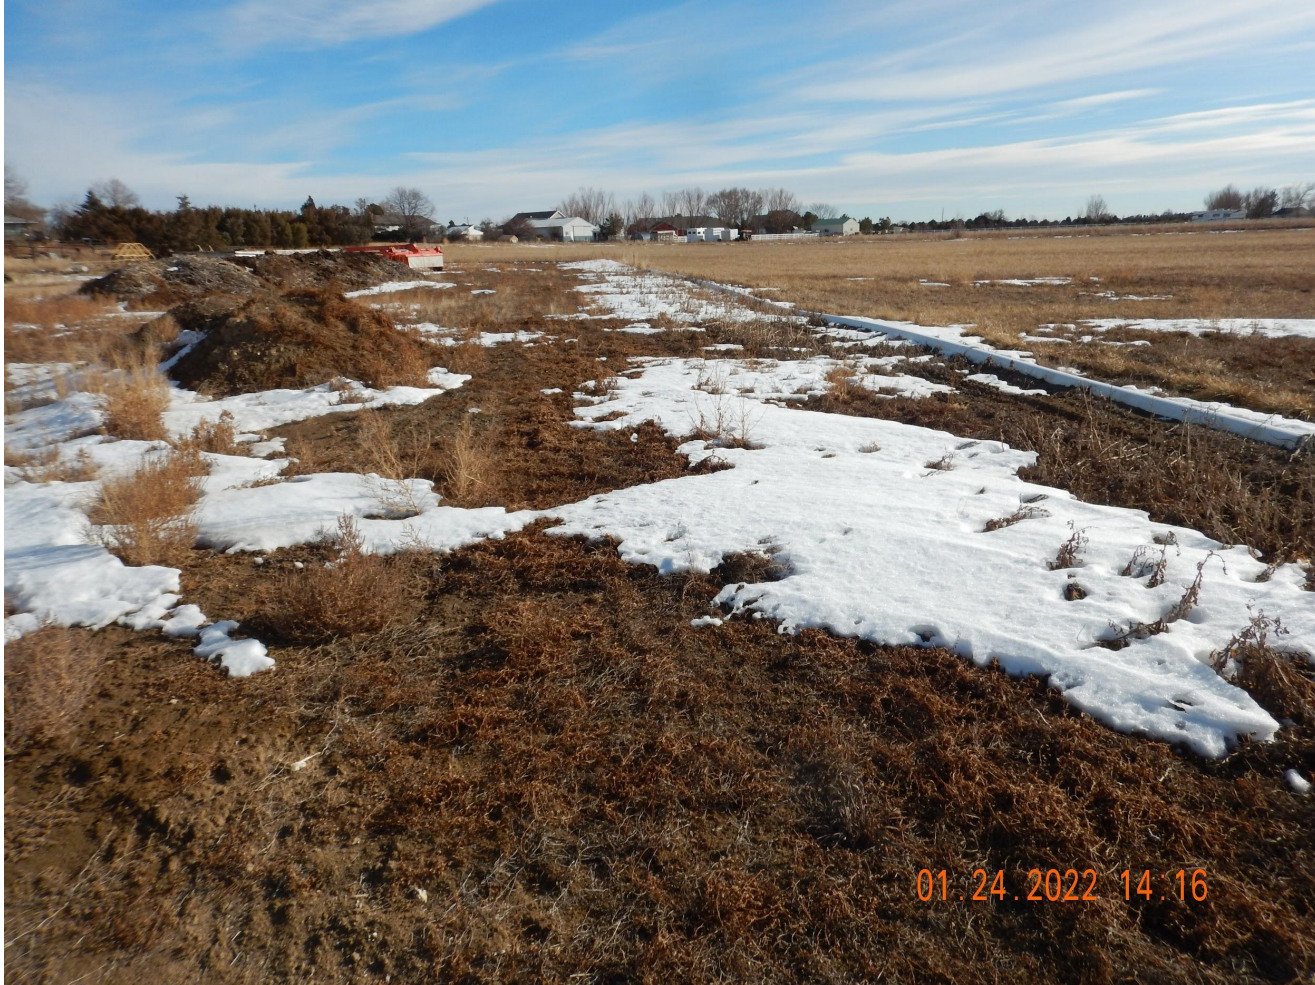
**Photo 1.** Photo taken from the well location, facing Southeast. Photo illustrates the well location is outside of the agricultural field and is not part of the surface owners agricultural production. There is no stormwater erosion and no observed noxious weeds.

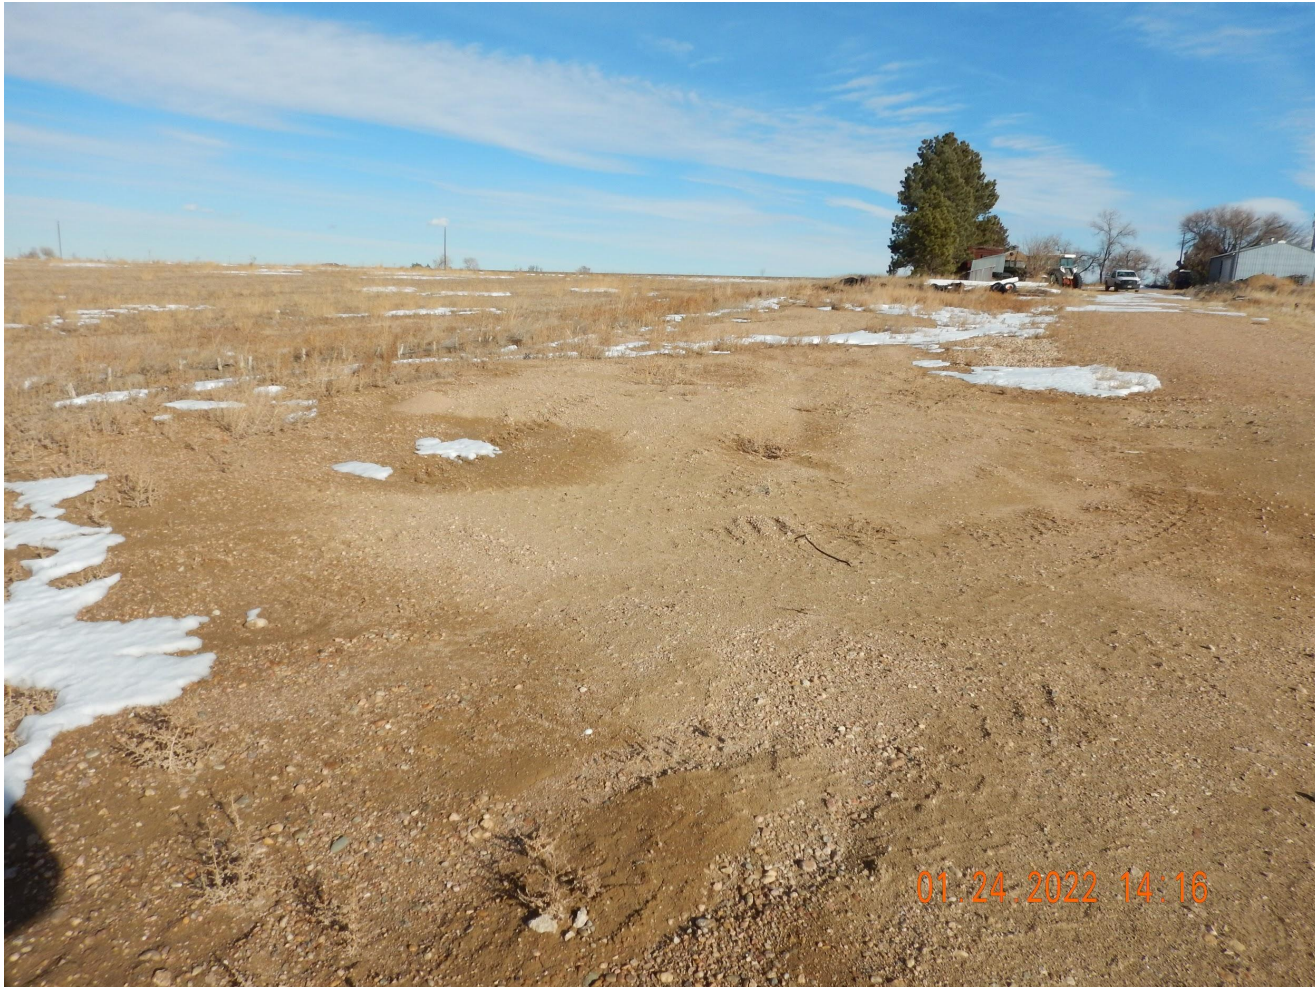
**Photo 2.** Photo taken from the associated tank battery, facing East. Photo illustrates the tank battery is stabilized with gravel and is also not part of the surface owners agricultural production. There is no stormwater erosion and no observed noxious weeds.

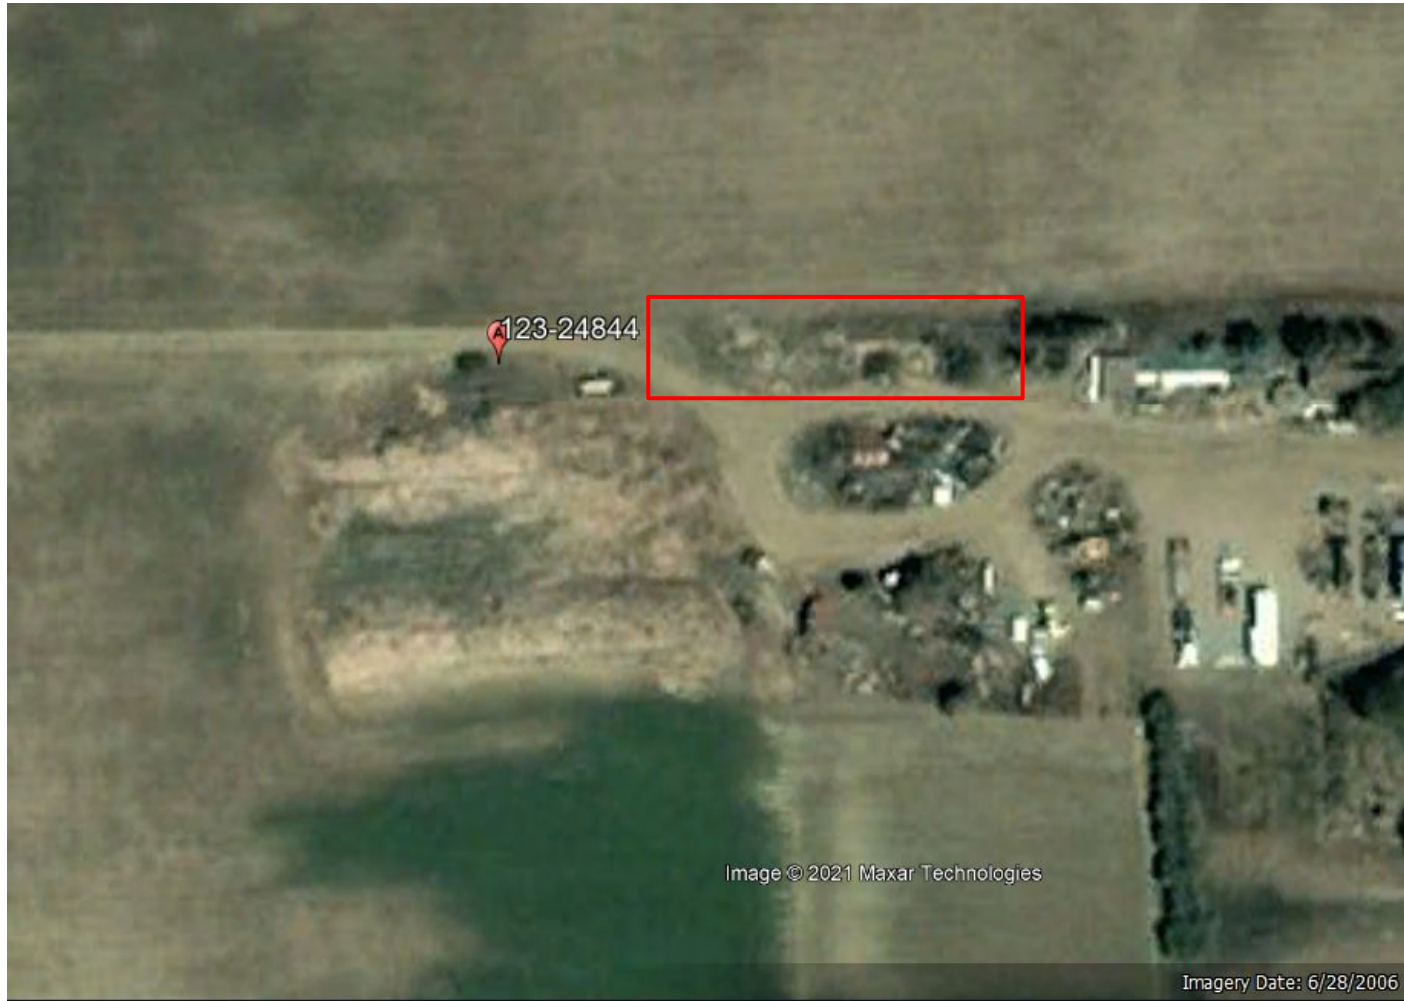
**Photo 3.** Google Earth aerial imagery from 6/28/2006 illustrates the well location and approximate tank battery location prior to oil and gas activities. This imagery confirms the well and tank battery location were never in agricultural production.
