Inspection Photos

API: 009-06668

Operator: JETTA OPERATING COMPANY

Inspection Date: 2/1/2022

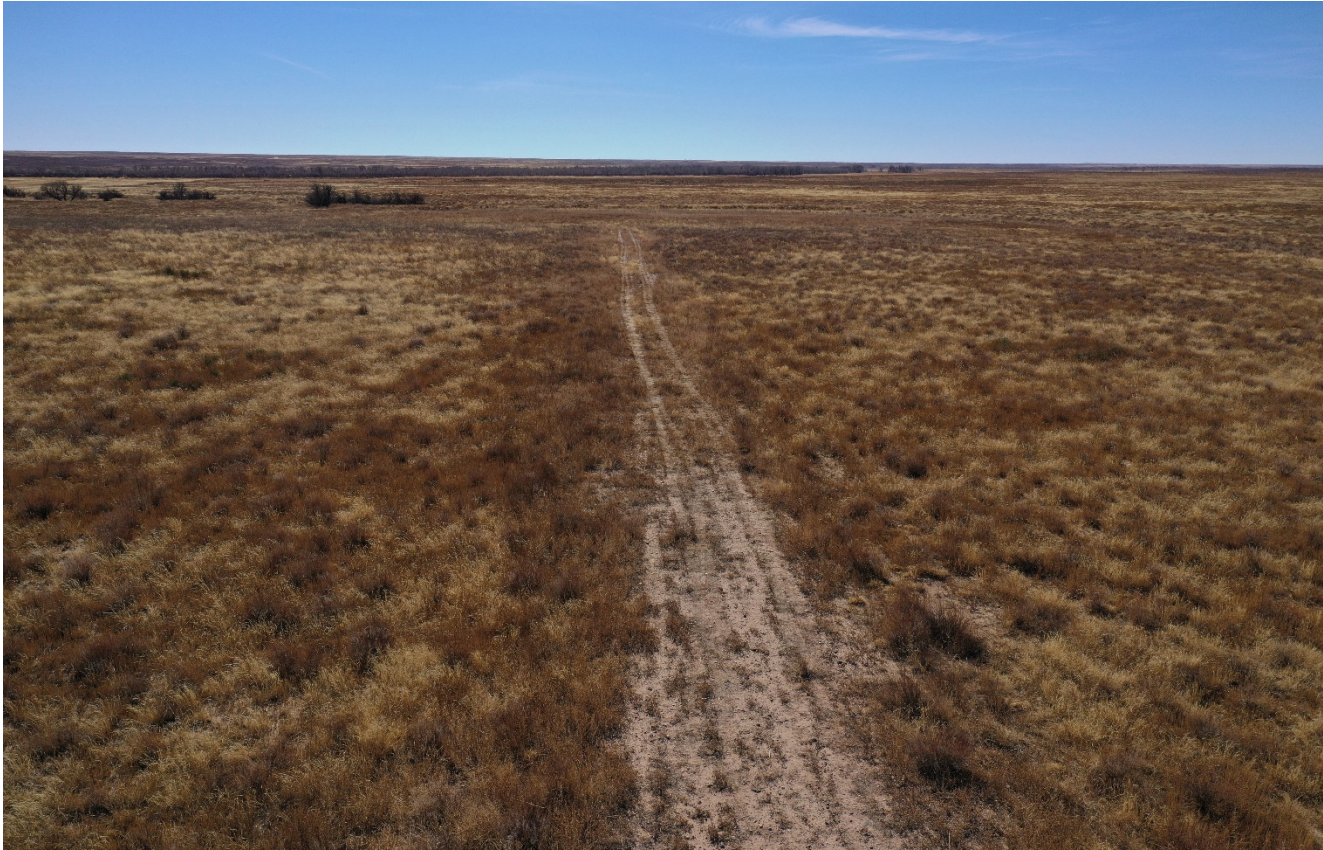
Photo 1. Drone aerial photo facing south toward the former access road. There are areas along the road that have not established vegetation.

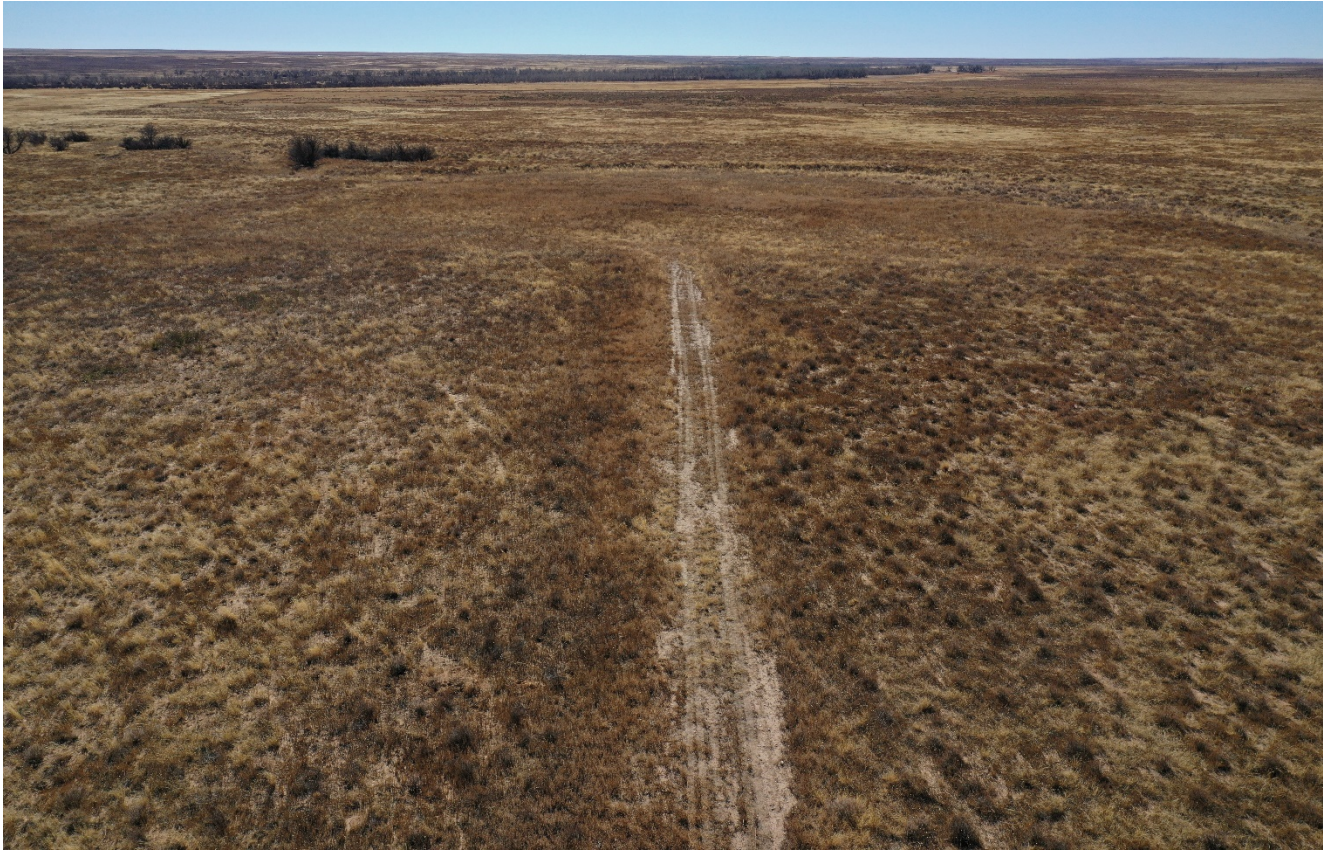
Photo 2. Drone aerial photo facing south toward the former access road. There are areas along the road that have not established vegetation.

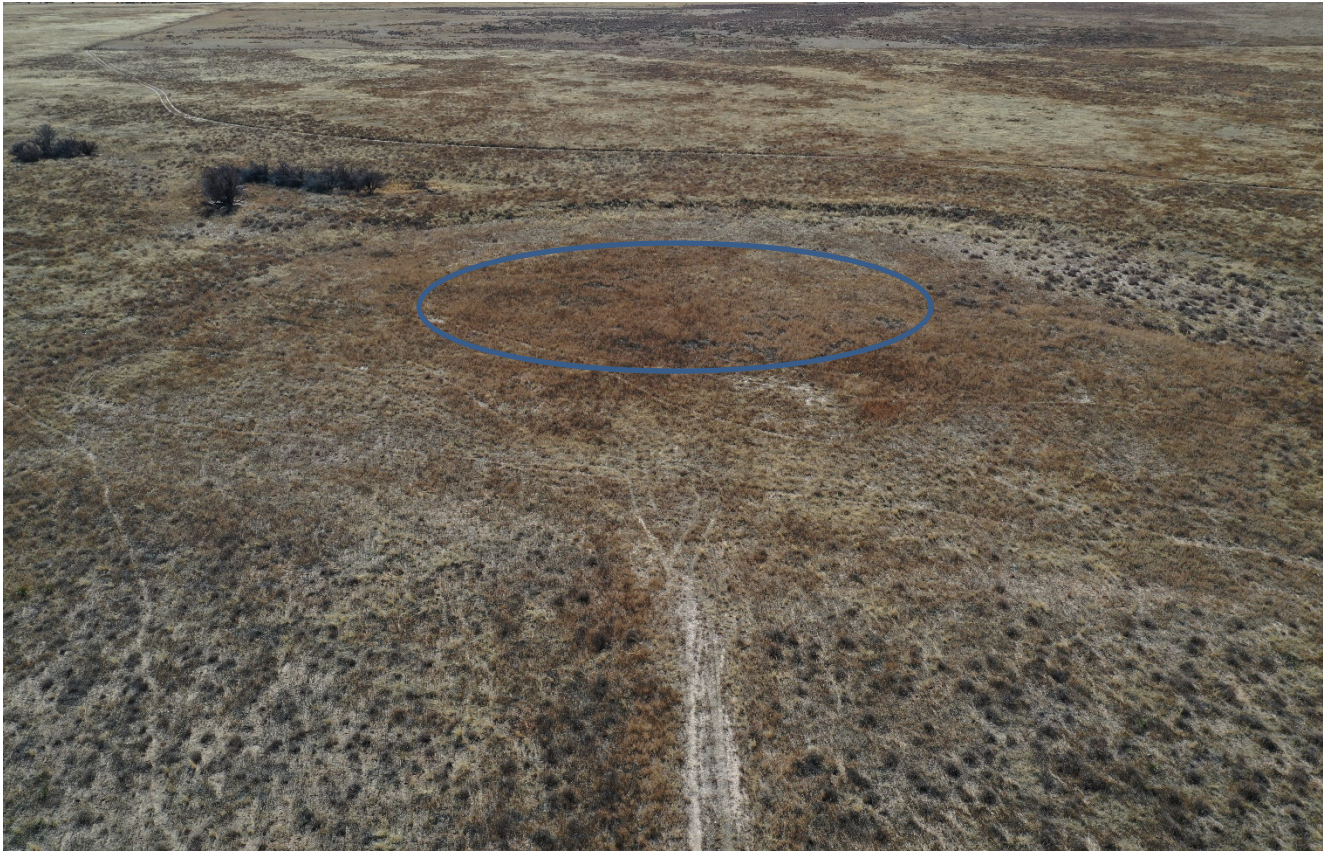
Photo 3. Drone aerial photo facing south toward the location. The area circled consists mostly of undesirable weeds with very little desirable vegetation.

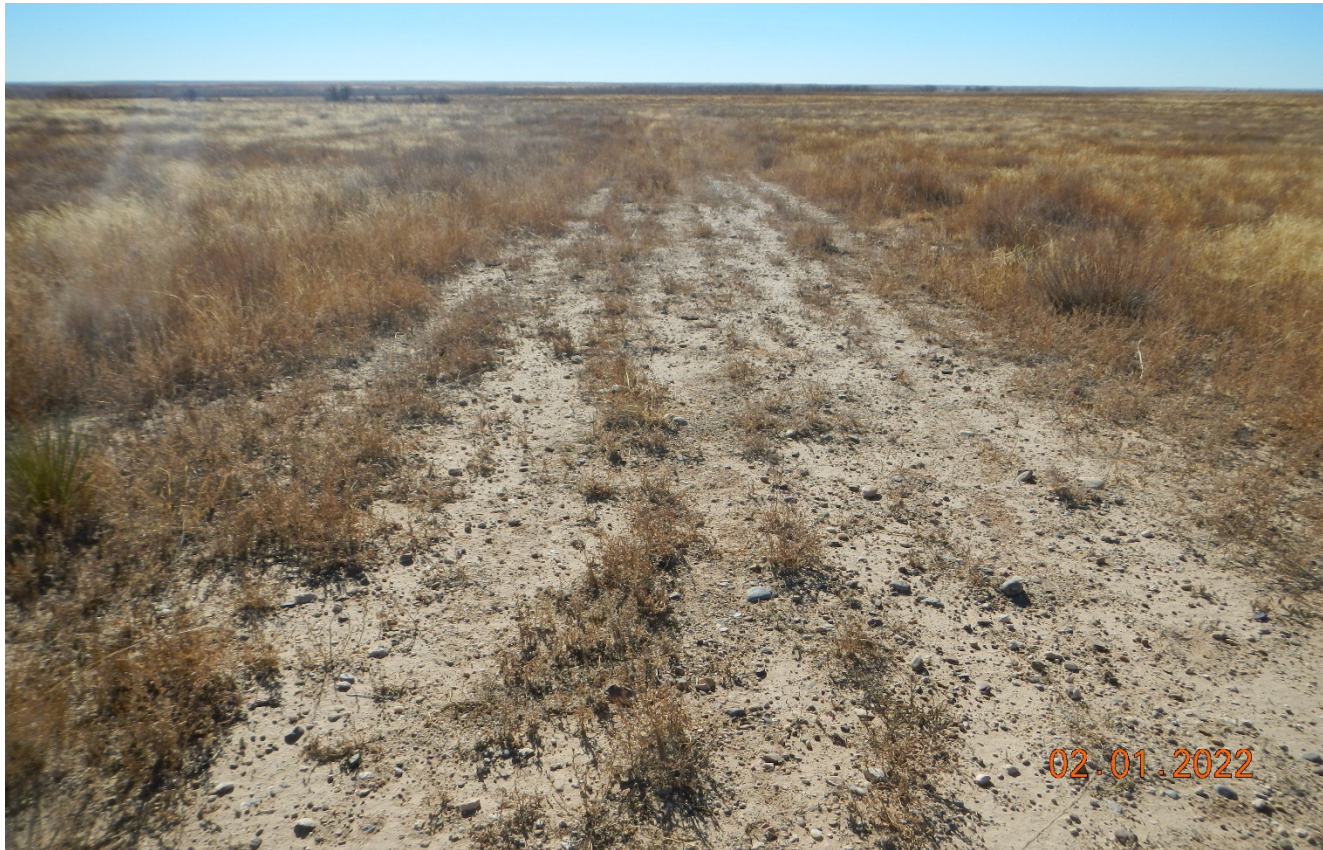
Photo 4. Facing south toward the access road. There are areas along the road that have not established vegetation.

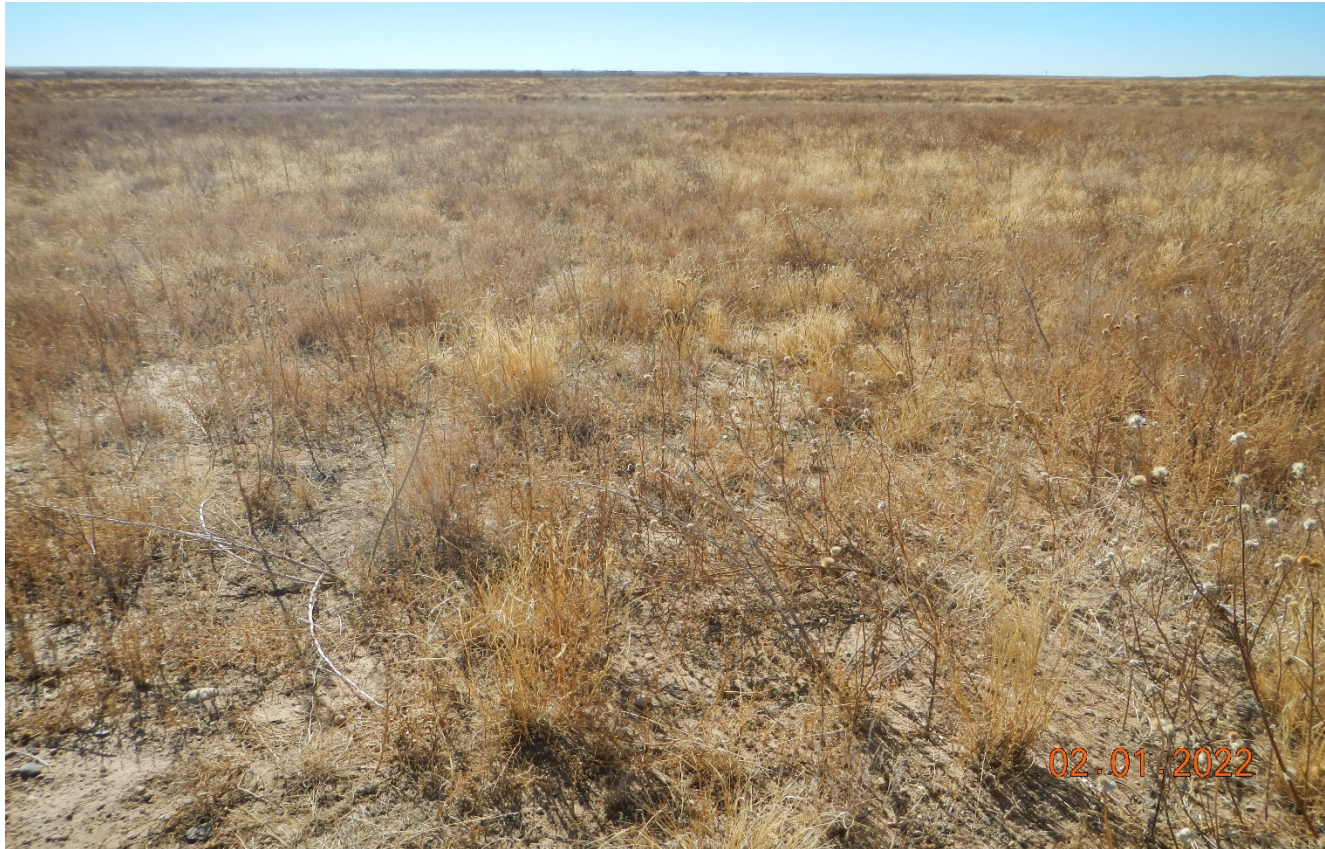
Photo 5. Facing south toward the location. The vegetation establishment has progressed but has not yet reached 80% of reference area levels.

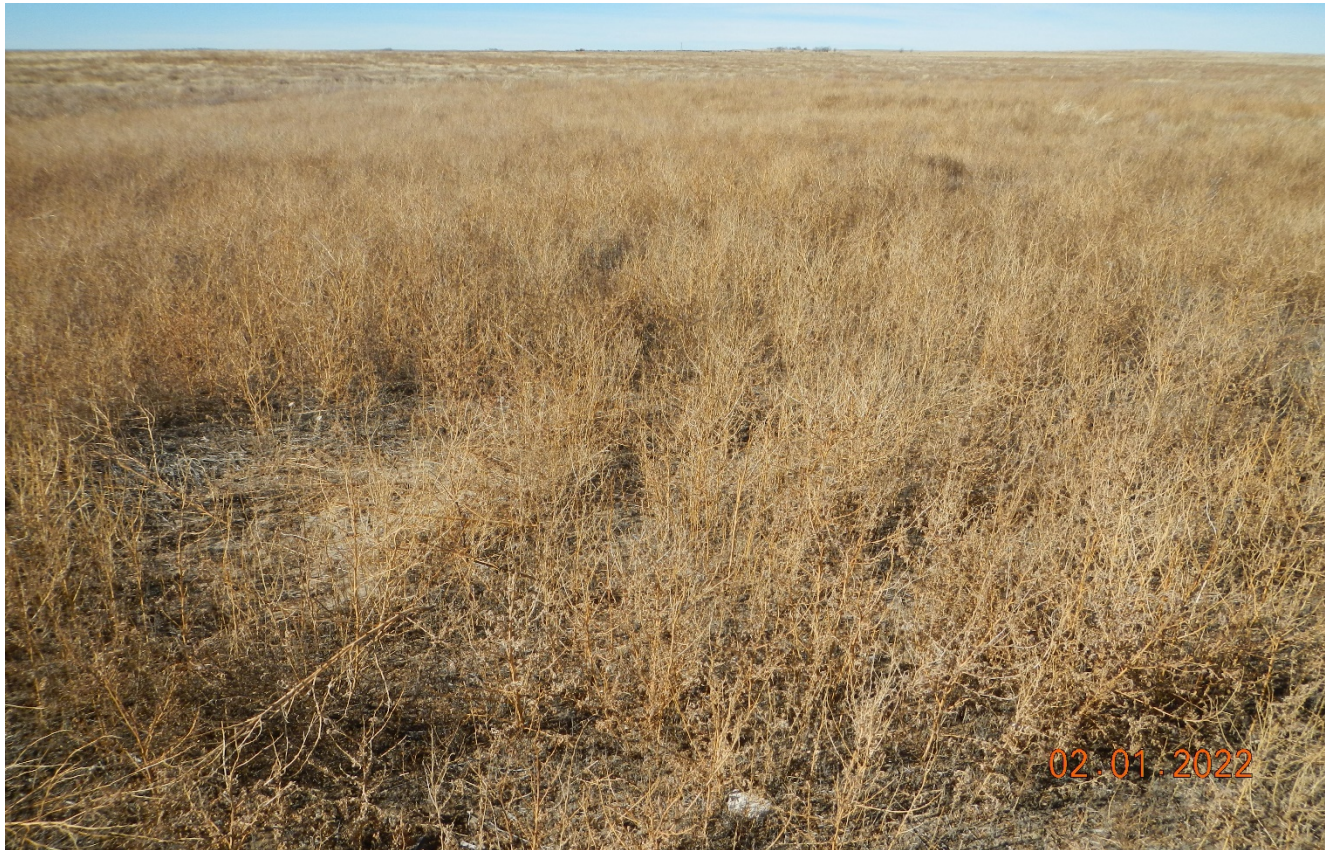
Photo 6. Facing west at the south side of location. This area consists almost entirely of undesirable weeds. (Kochia sp., Russian thistle)

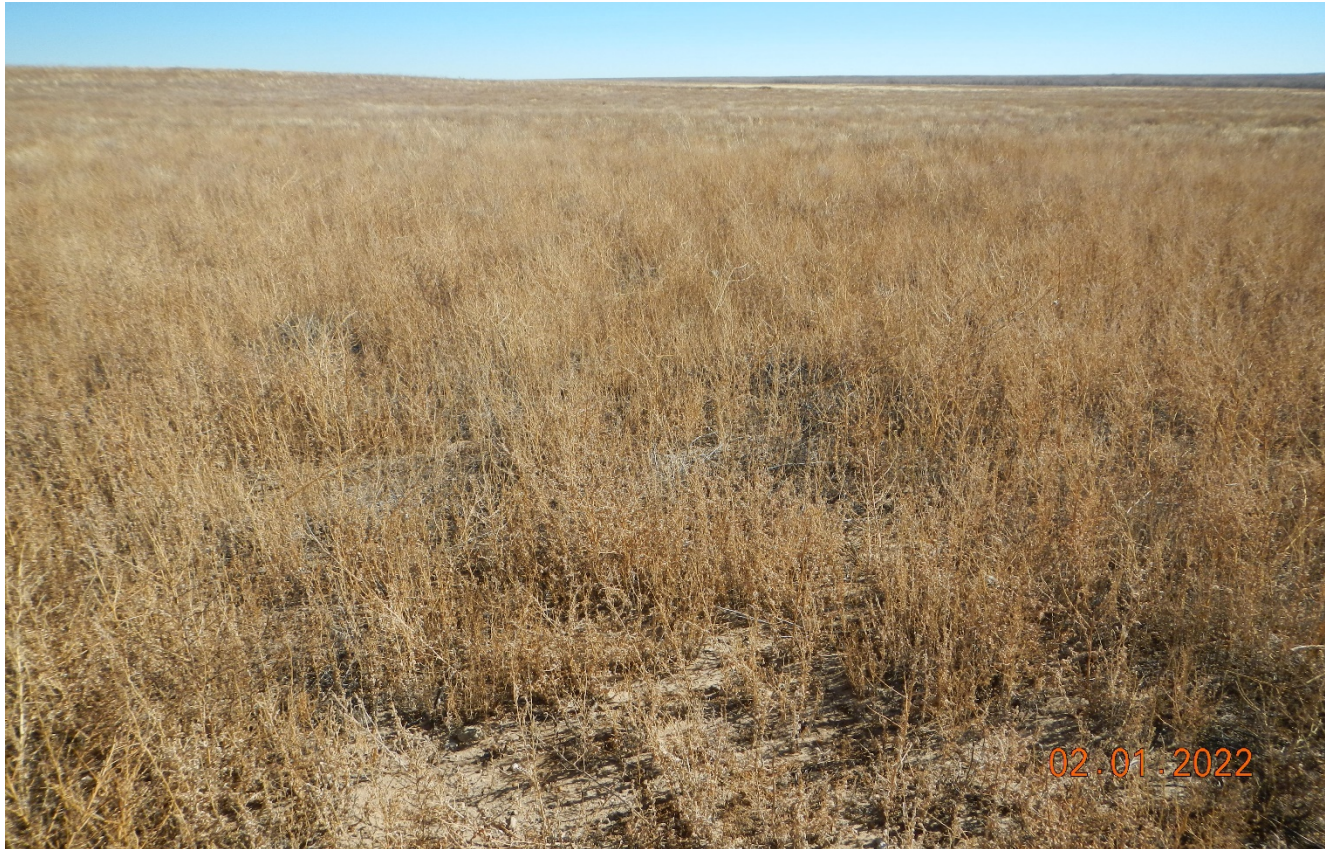
Photo 7. Facing east at the south side of location. This area consists almost entirely of undesirable weeds. (Kochia sp., Russian thistle)
