# Final Reclamation Inspection

Operator: TRANS TEXAS ENERGY INC. - #89161

Location ID: 377994

Inspection Photos  
Location Name: MURPHY #1-8  
Location ID: 377994

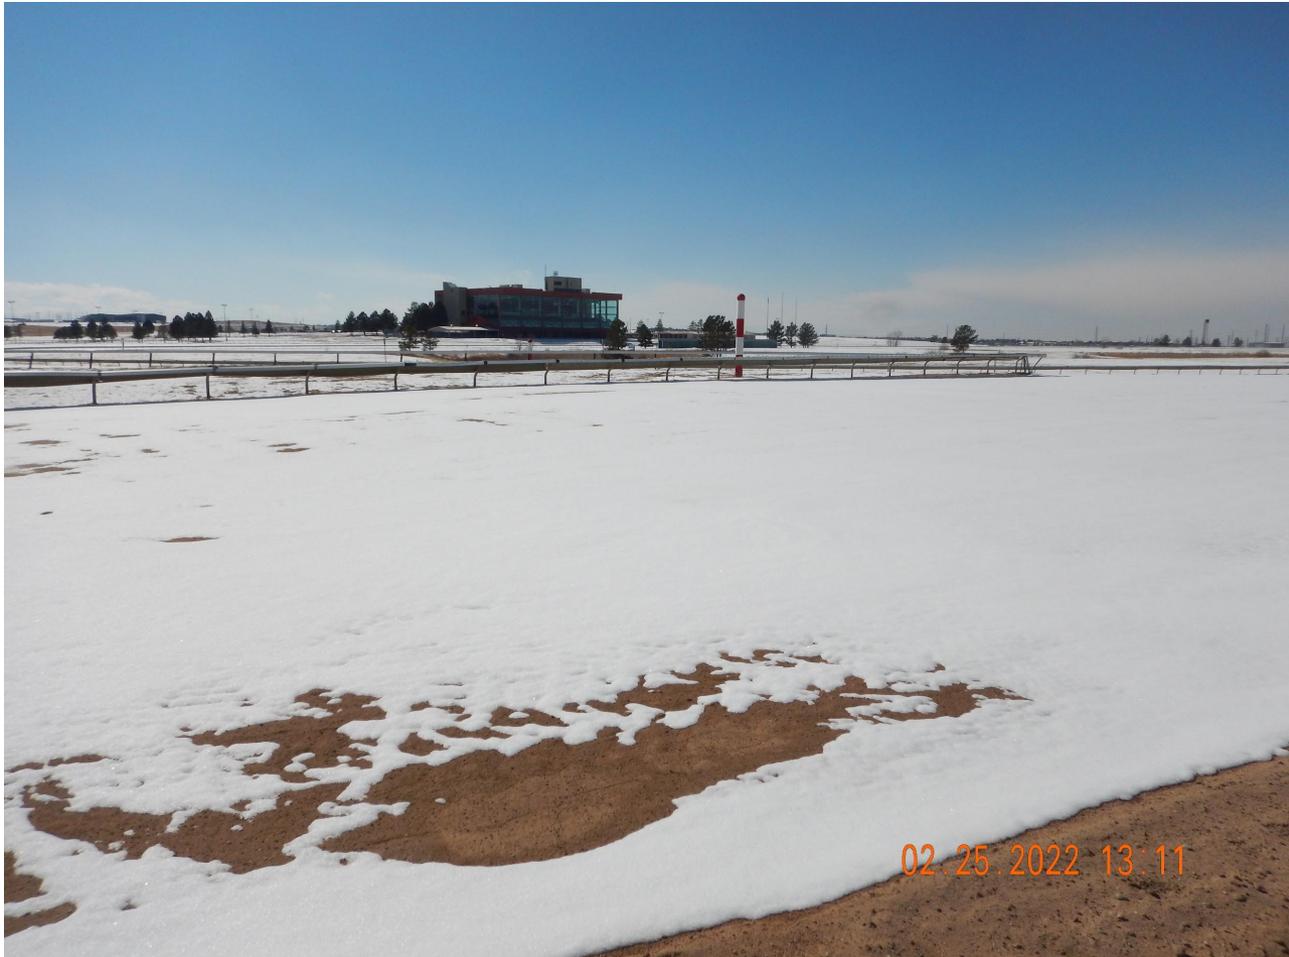
**Photo 1.** Photo taken from the well location, facing West. Photo illustrates all equipment has been removed. It appears smooth brome was initially seeded and now blue grama is starting to replace the smooth brome.
