# Inspection Photos

API: 073-06776

Operator: KODA EXPLORATION LLC

Inspection Date: 3/24/2022

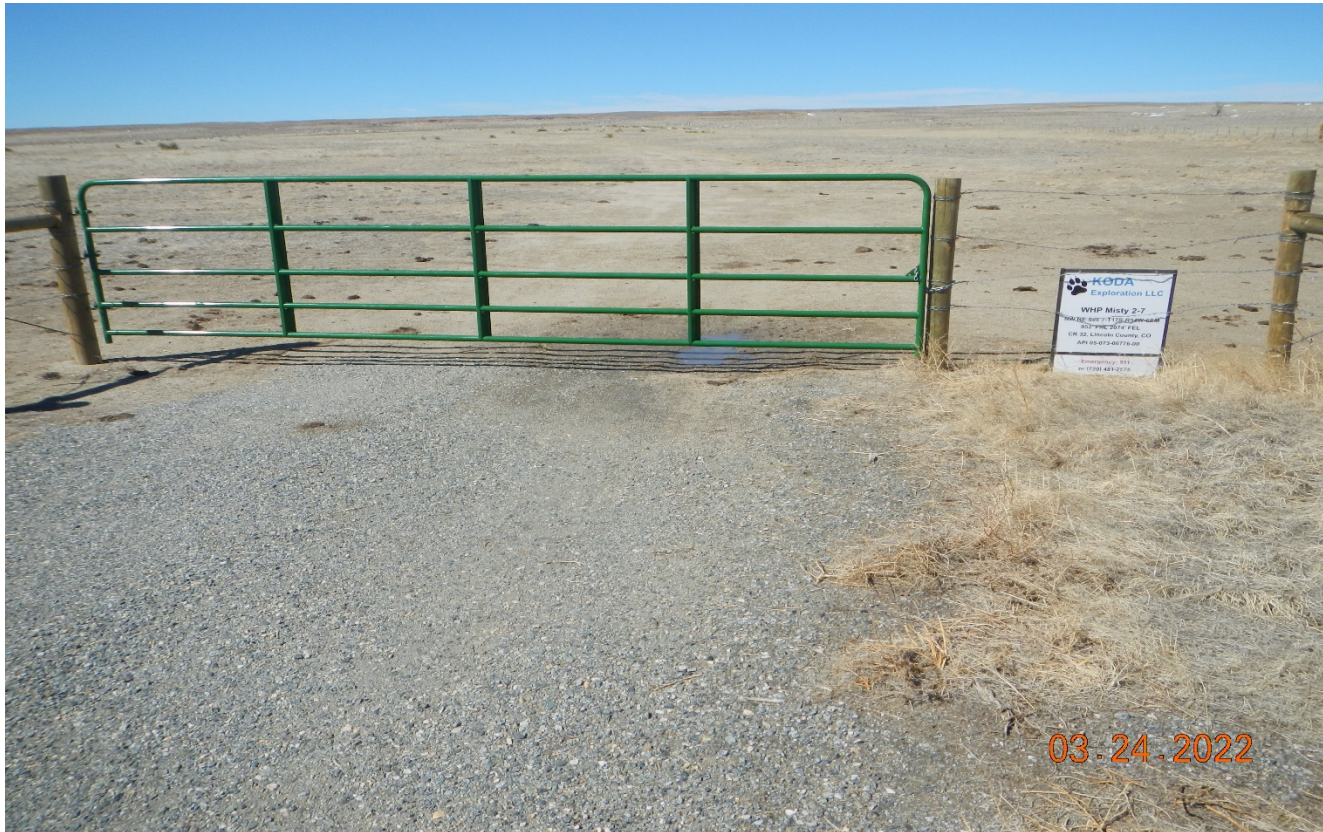
**Photo 1.** Facing southwest at the beginning of the access road. If well is plugged and abandoned the gravel will need to be removed and road will need to be reclaimed.

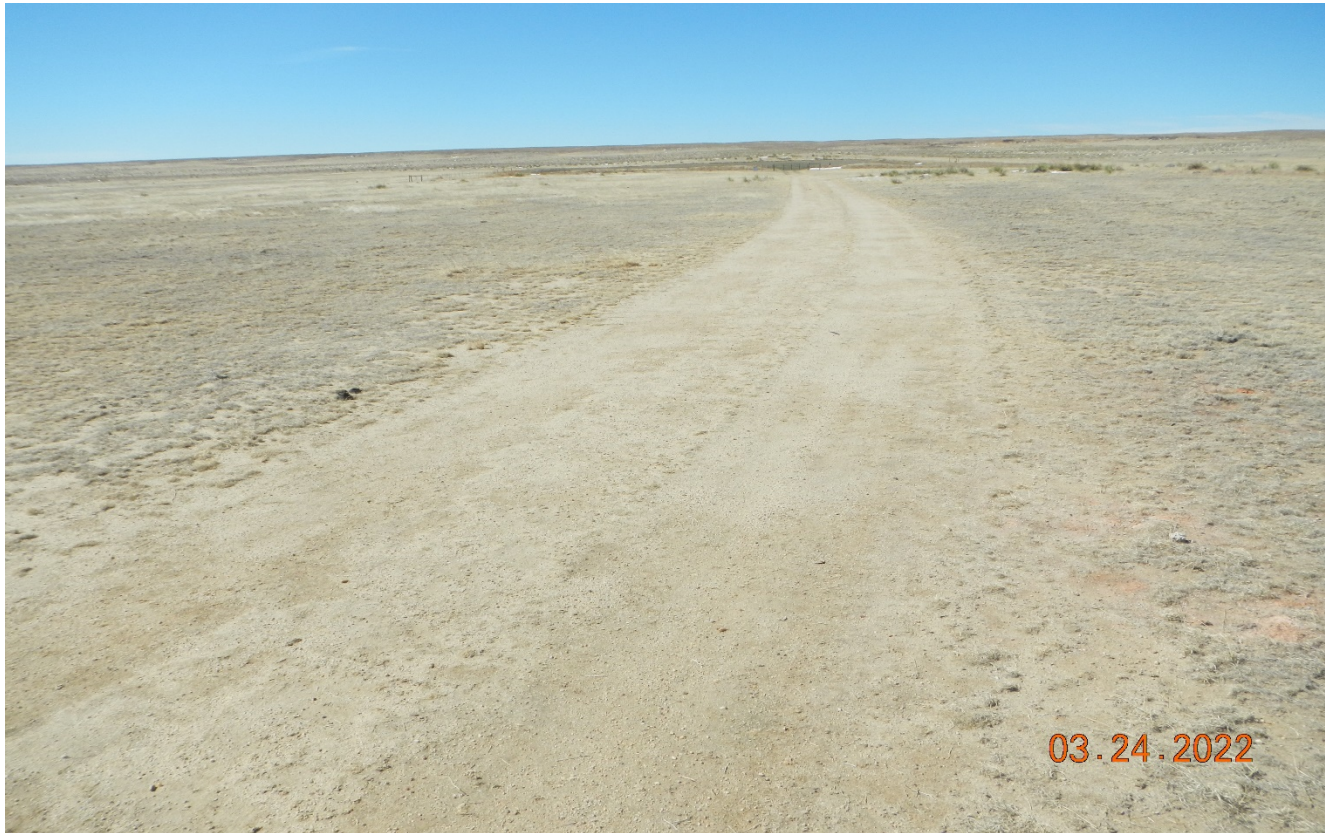
**Photo 2.** Facing southwest along the access road.

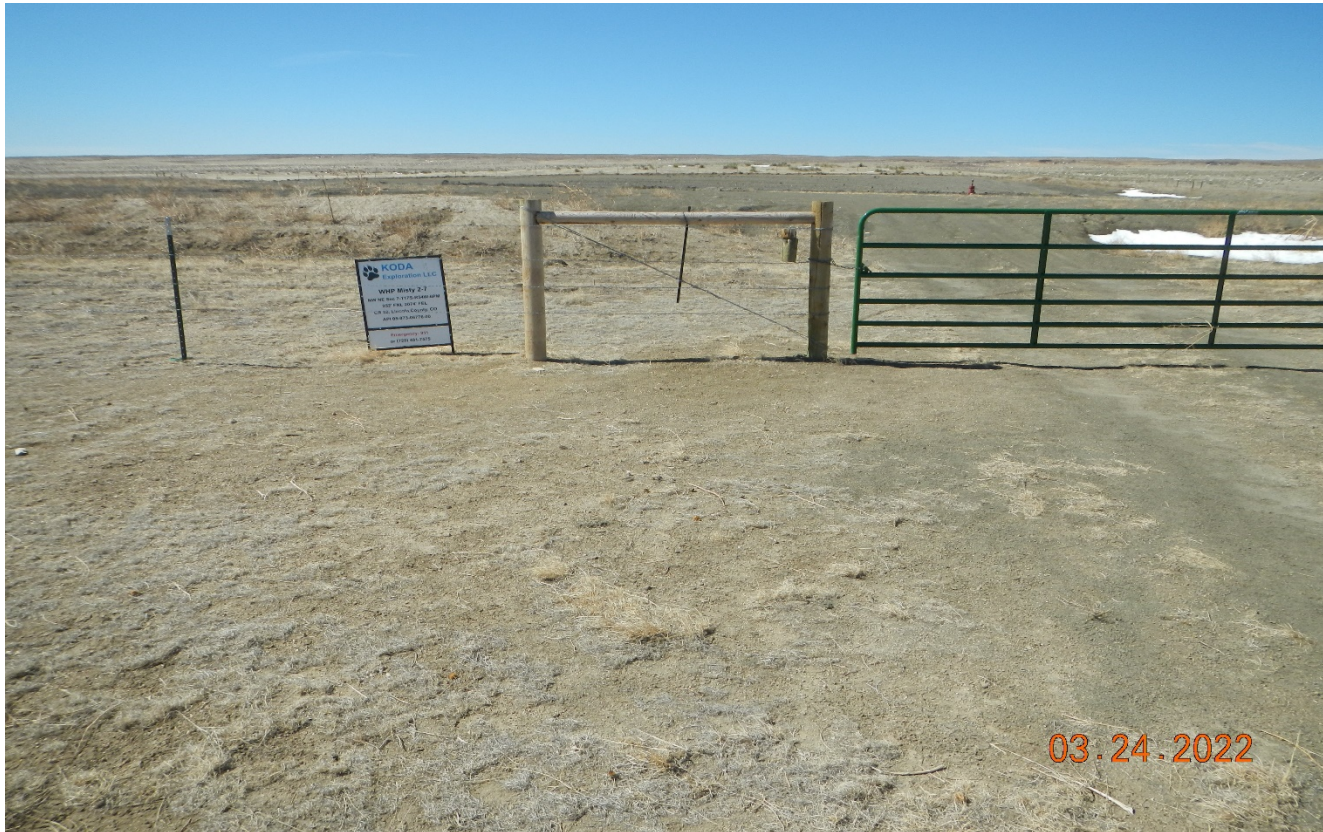
**Photo 3.** Facing southwest toward the fenced location.

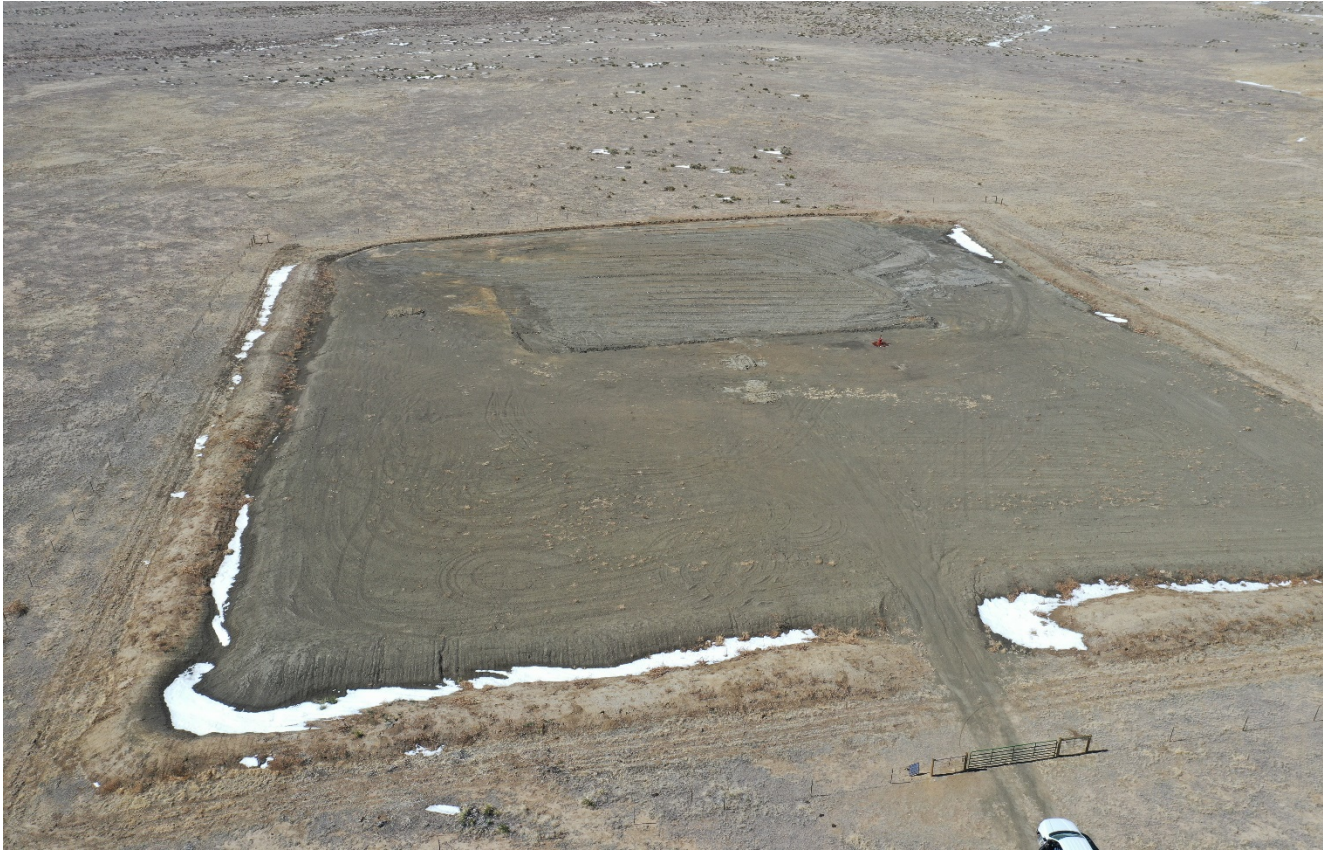
**Photo 4.** Drone aerial photo facing west toward the location. The location has not been reclaimed per the 1003 Rules. Soils are not protected from erosion and degradation.

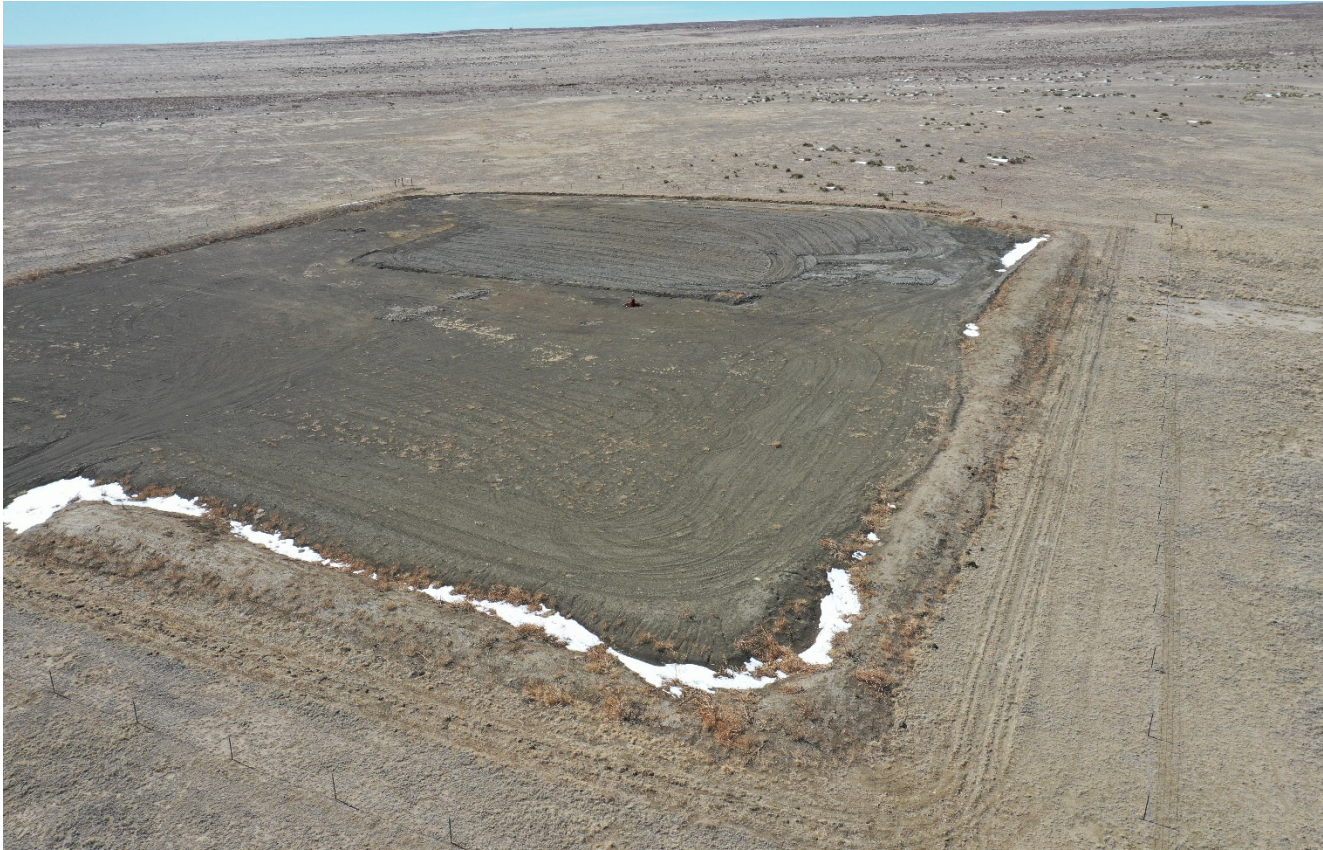
**Photo 5.** Facing southeast toward the location. The pit has been backfilled however reclamation has not been performed. Bare soils are susceptible to erosion.

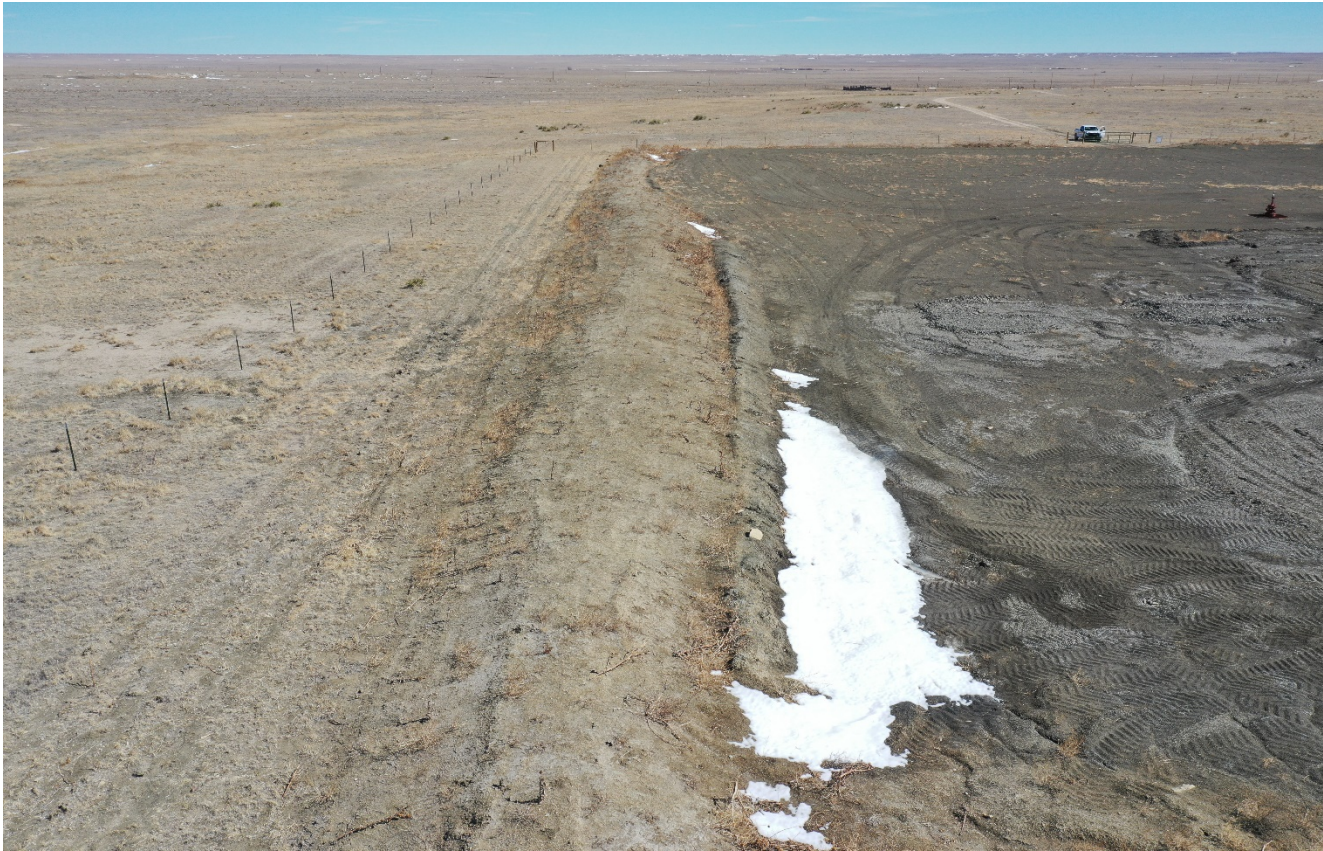
**Photo 6.** The topsoil piles stored along the perimeter are not protected from erosion and weed infestation. There are undesirable weeds throughout the topsoil piles.

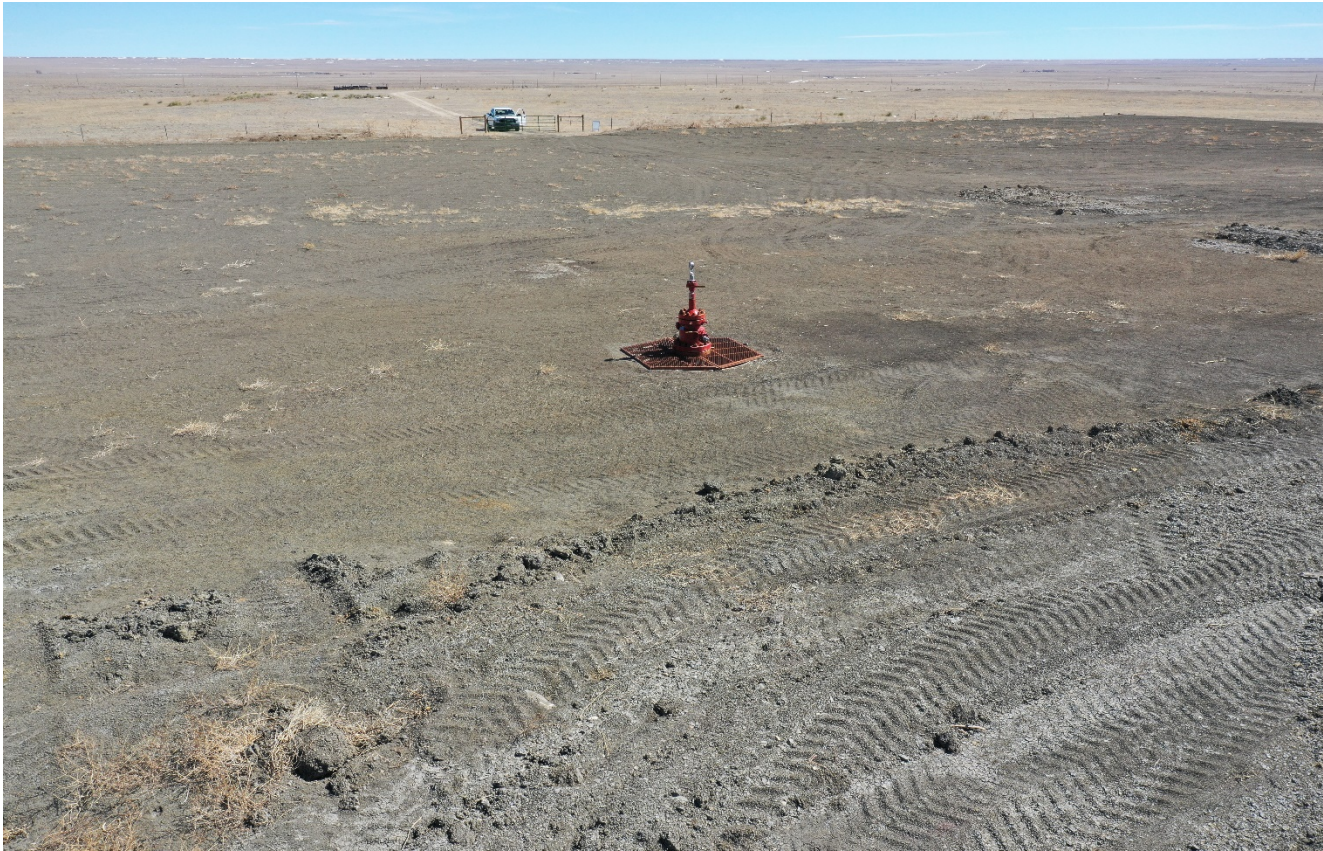
**Photo 7.** The wellhead remains at center of the location.
