# Inspection Photos

Operator: BERRY PETROLEUM COMPANY LLC

Location ID: 335966

Garfield County, CO

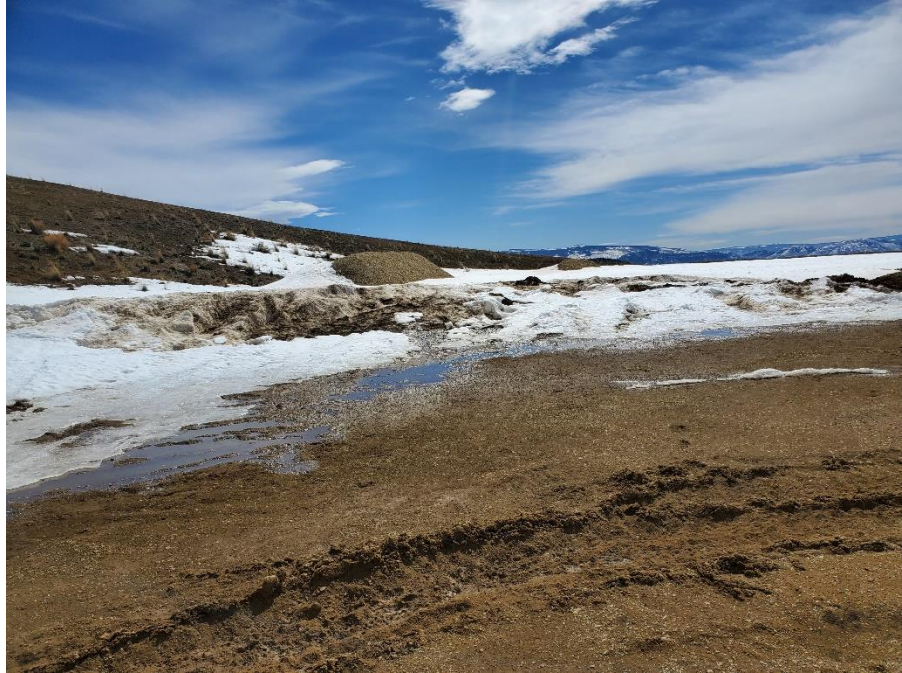
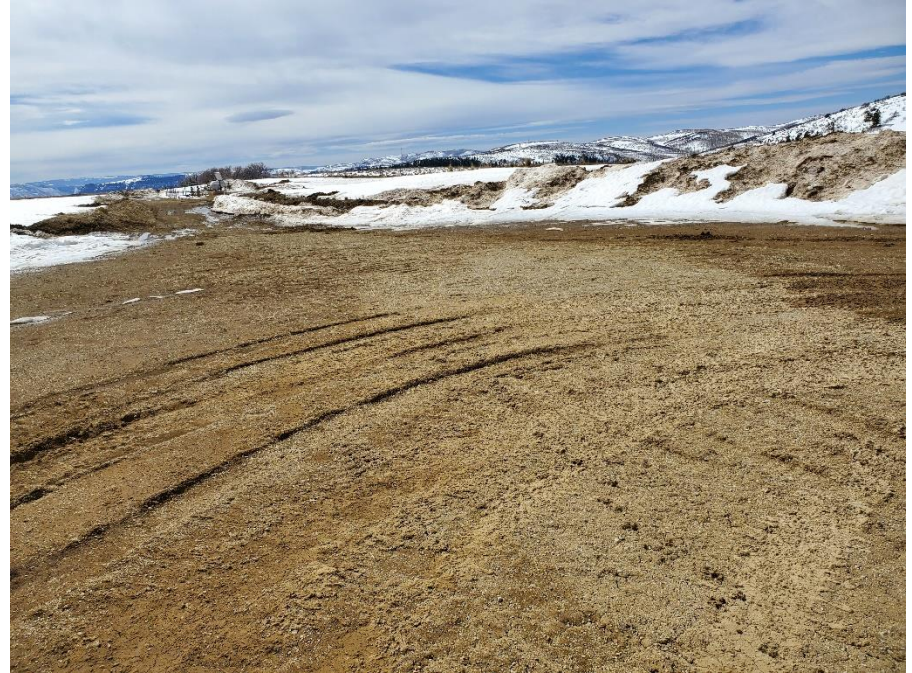
**Photo 1:** Photos provide overview of the areas on Location in use for soil remediation. See Remediation Proj. #10050 for additional details.

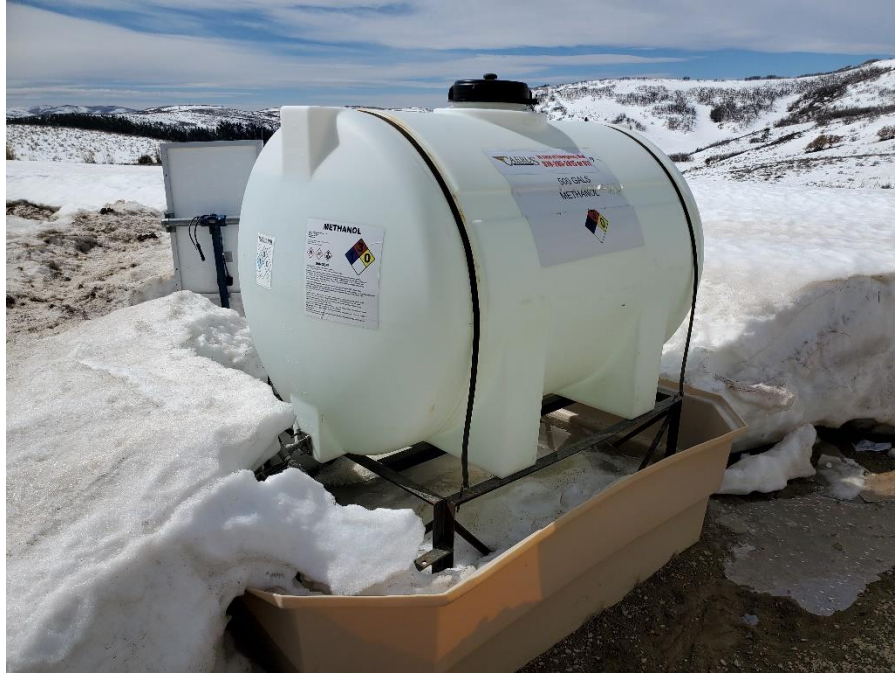
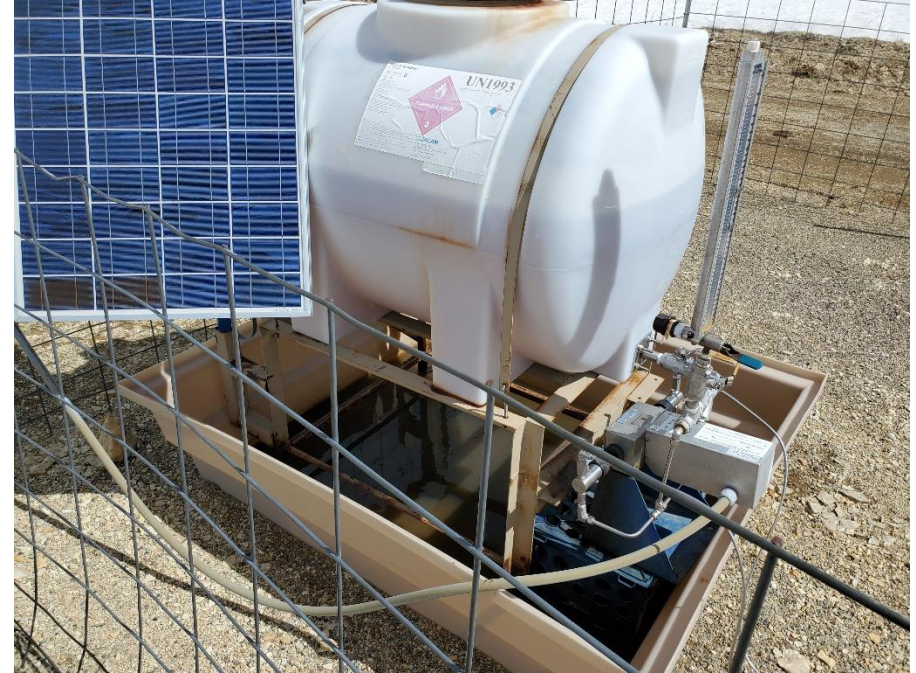
**Photo 2:** Photos show methanol tanks on the Location. BMPs to prevent wildlife access is missing from the secondary containment. Photo left also shows secondary containment has filled largely with snowmelt and/or stormwater, and no longer appears to be adequate to contain a spill from the tank. Unclear if tank contains contents and if equipment is in use. If unused tank requires removal per Rule 606.

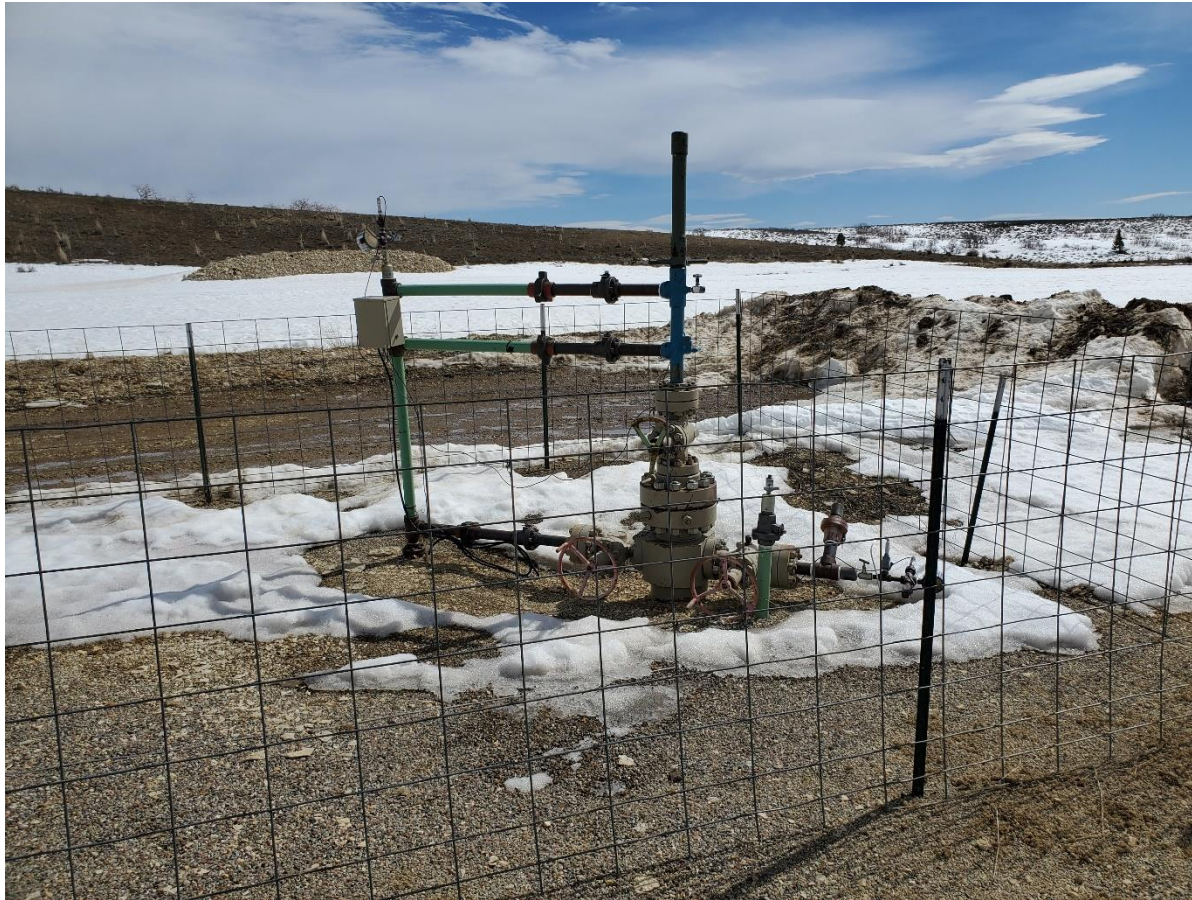
**Photo 3:** Photo shows signage missing or not visible at the Chevron #6-7D well.
