Horseshoe #1  
 St. Croix Operating, Inc.  
 NENE S27 T3S R49W  
 Geologic Hazards Map

St. Croix Operating, Inc.  
Horseshoe #1  
NENE Section 27, T3S R49W  
Washington County, Colorado

GEOLOGIC HAZARDS EVALUATION

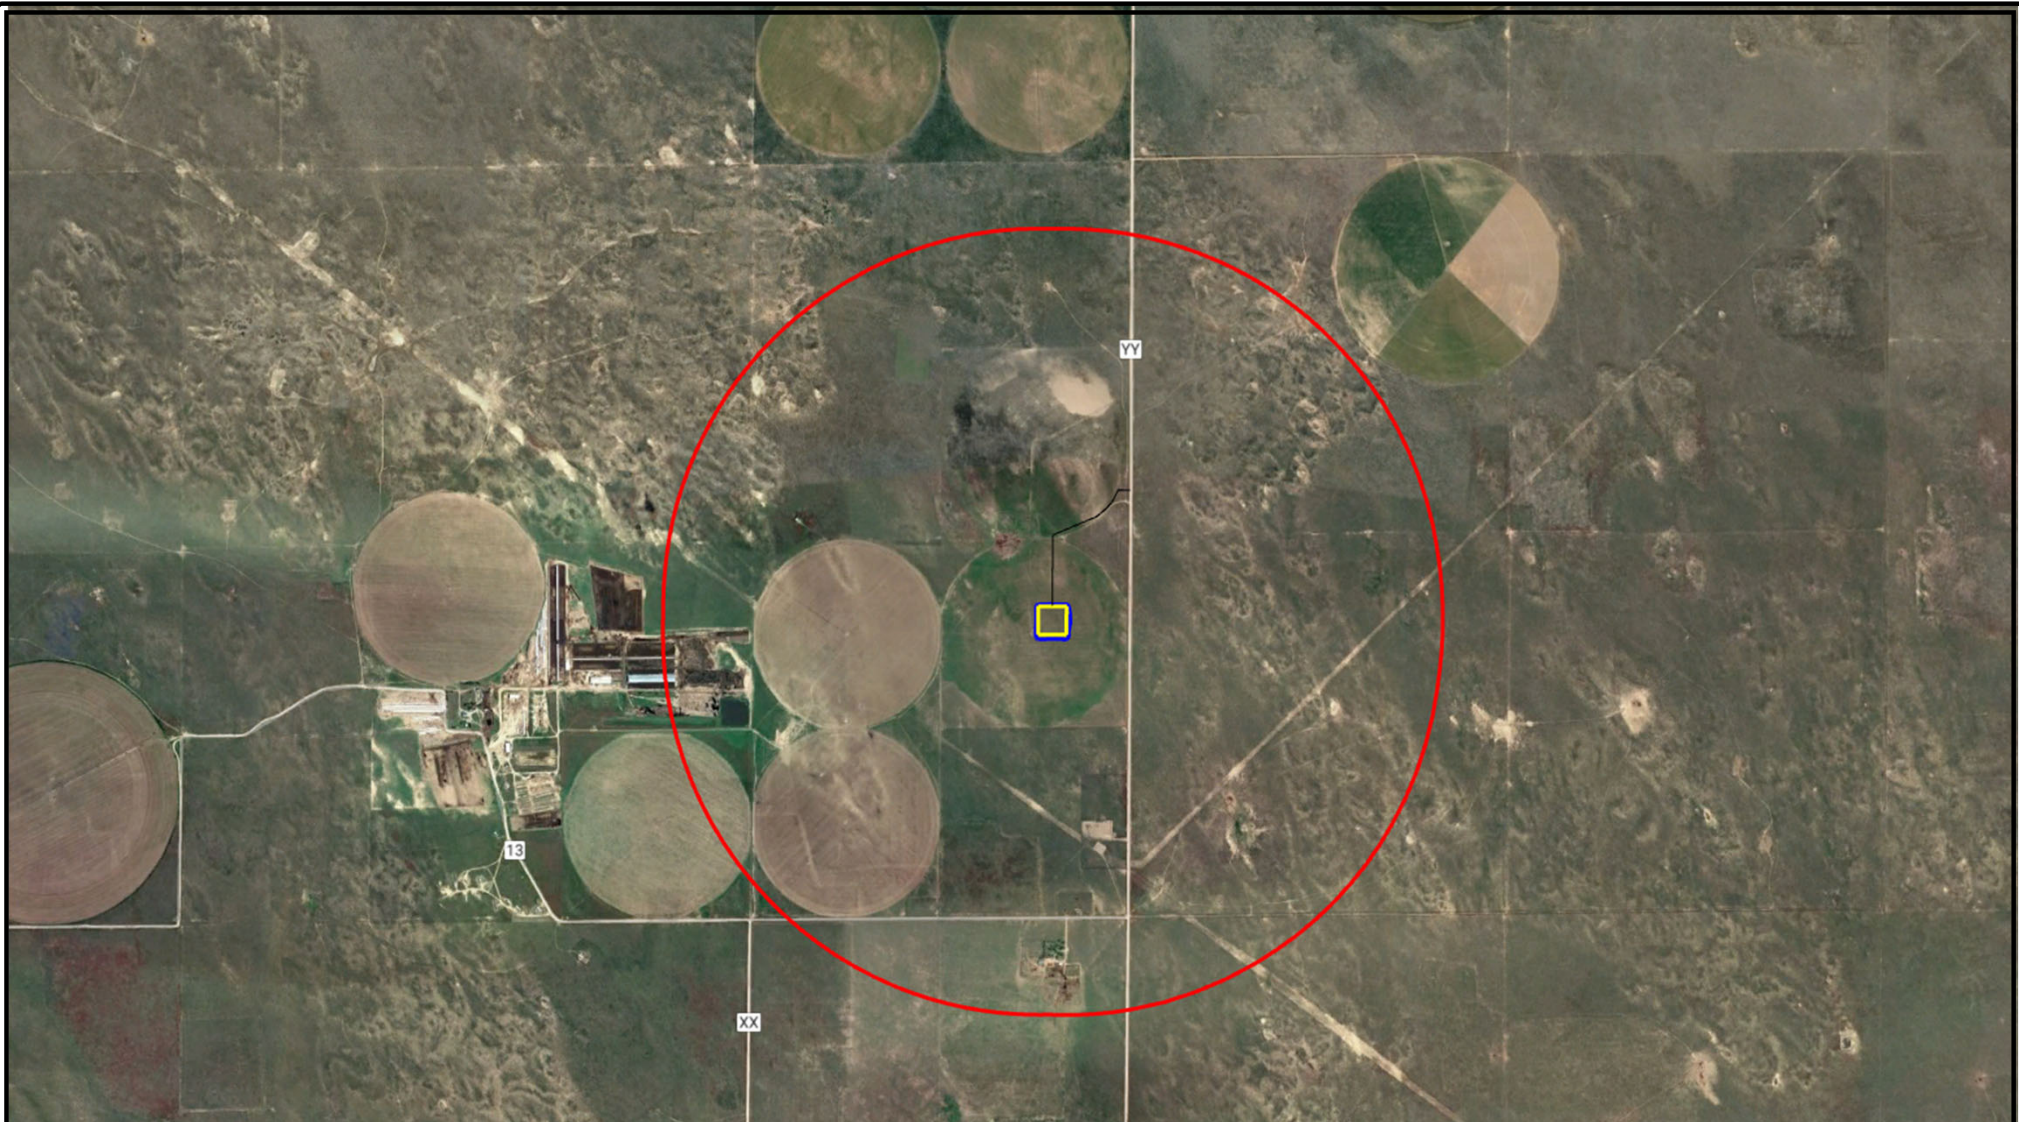
- St. Croix has prepared one map showing the Oil and Gas Location in relation to any Geologic Hazards within a 1-mile radius.
