Location Name: Lowe #3-12, #8-12 Location ID/API #: 461219

COLORADO
Oil & Gas Conservation
Commission
Department of Natural Resources

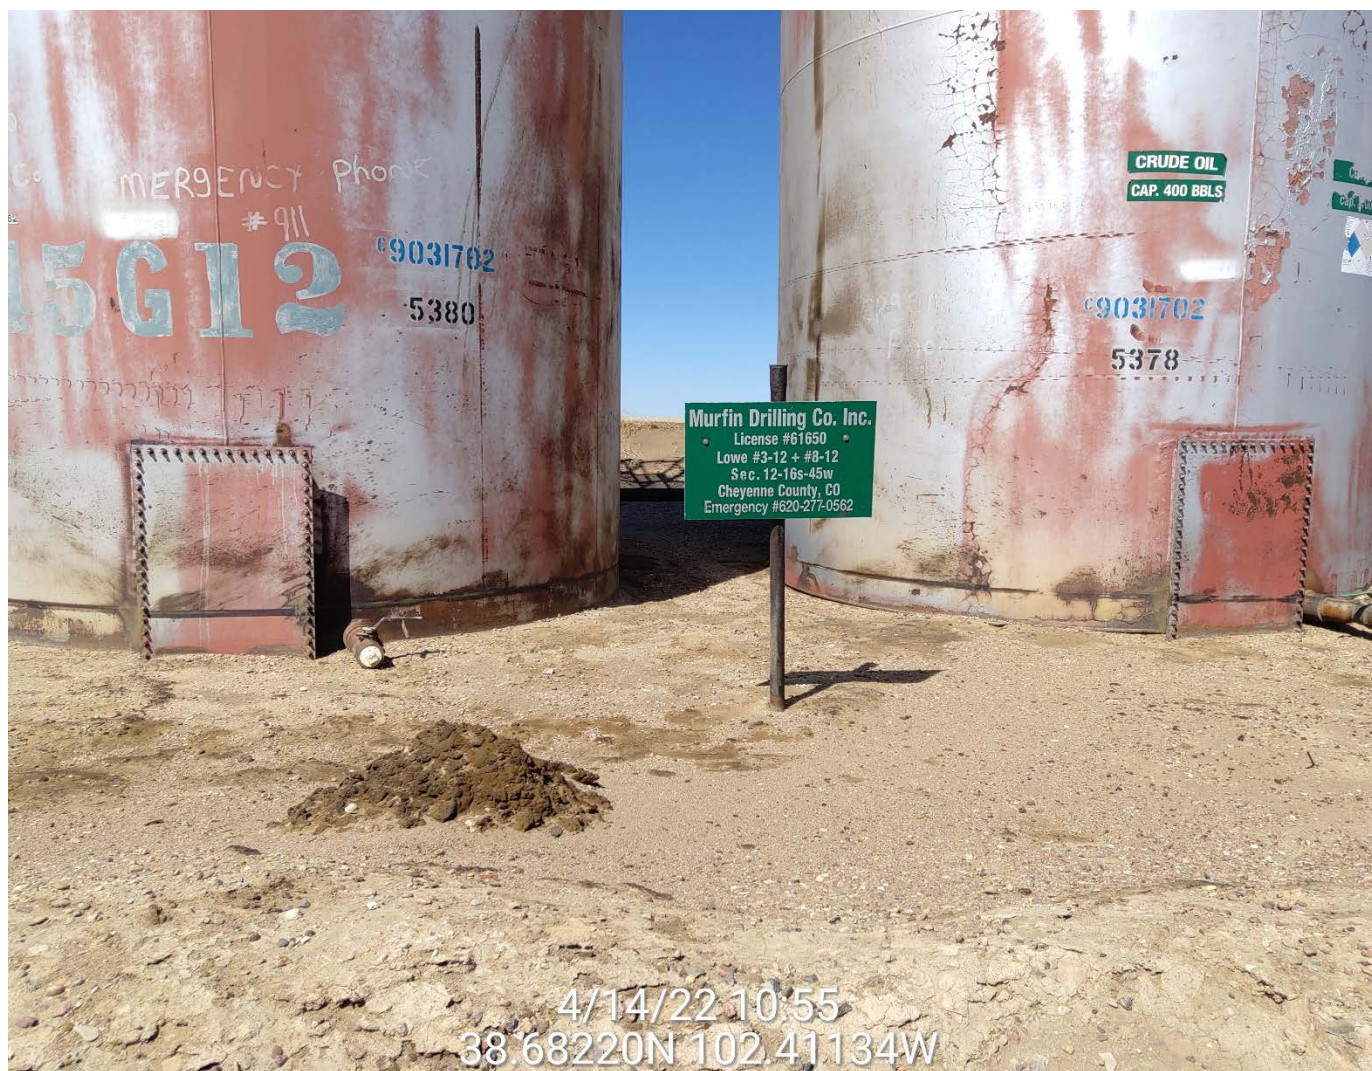
Stained soil inside containment.

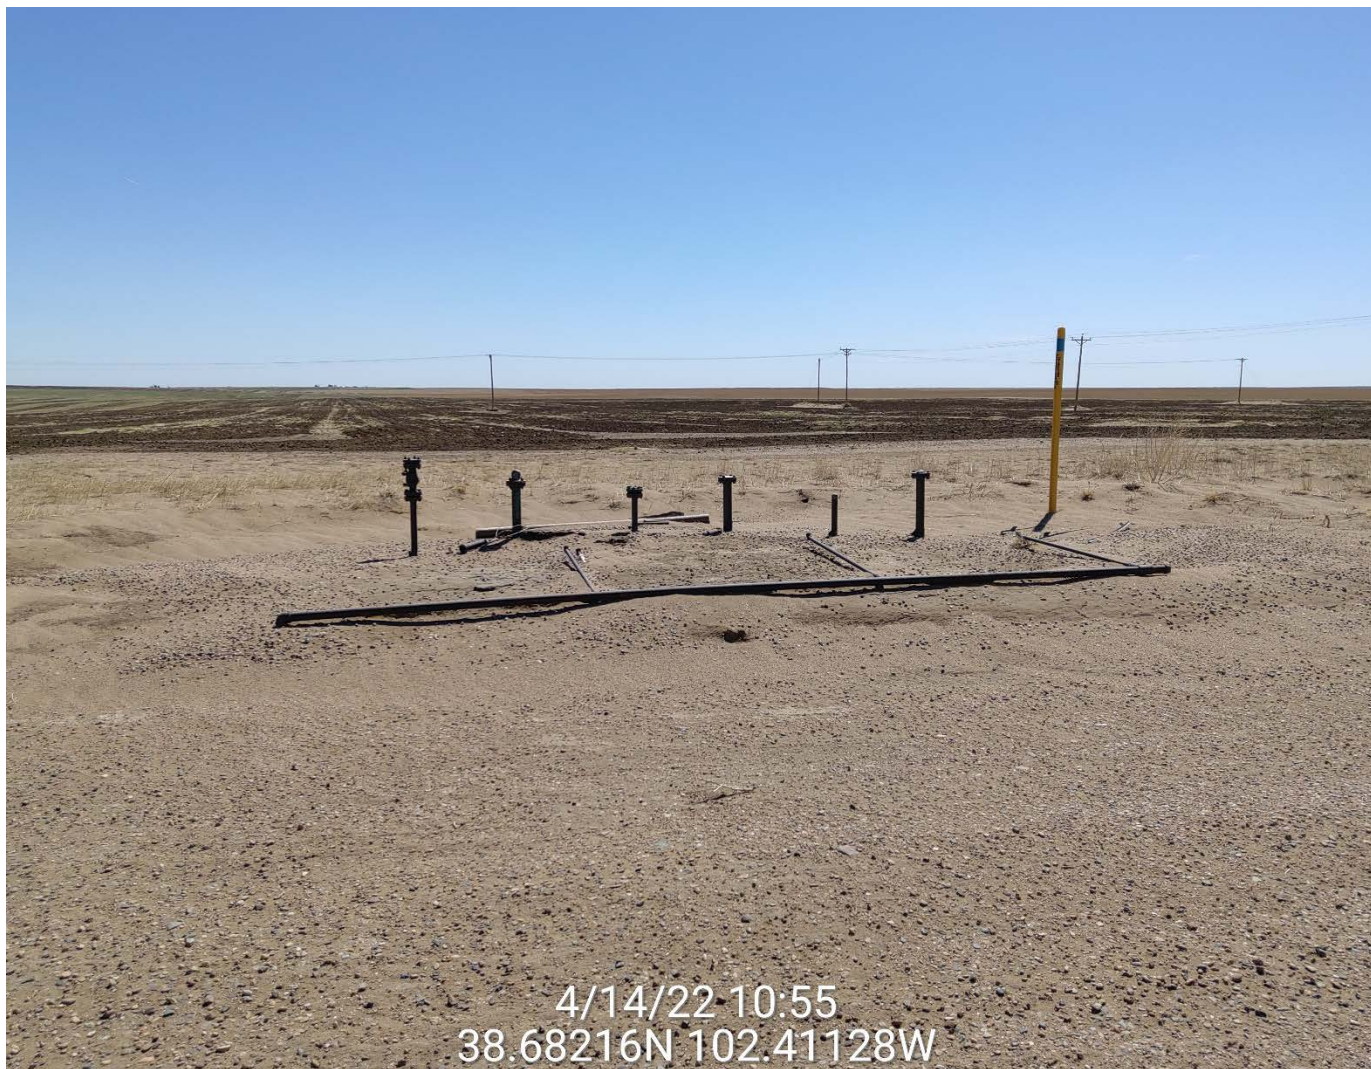
4/14/22 10:55
38.68216N 102.41128W

Improper abandonment of flowline or crude oil transfer line (not purged, depressurized, risers cut 3' below grade, ends sealed, equipment removed) per 1105. Disconnected flowline risers not OOSLAT (out of service locks and tags).

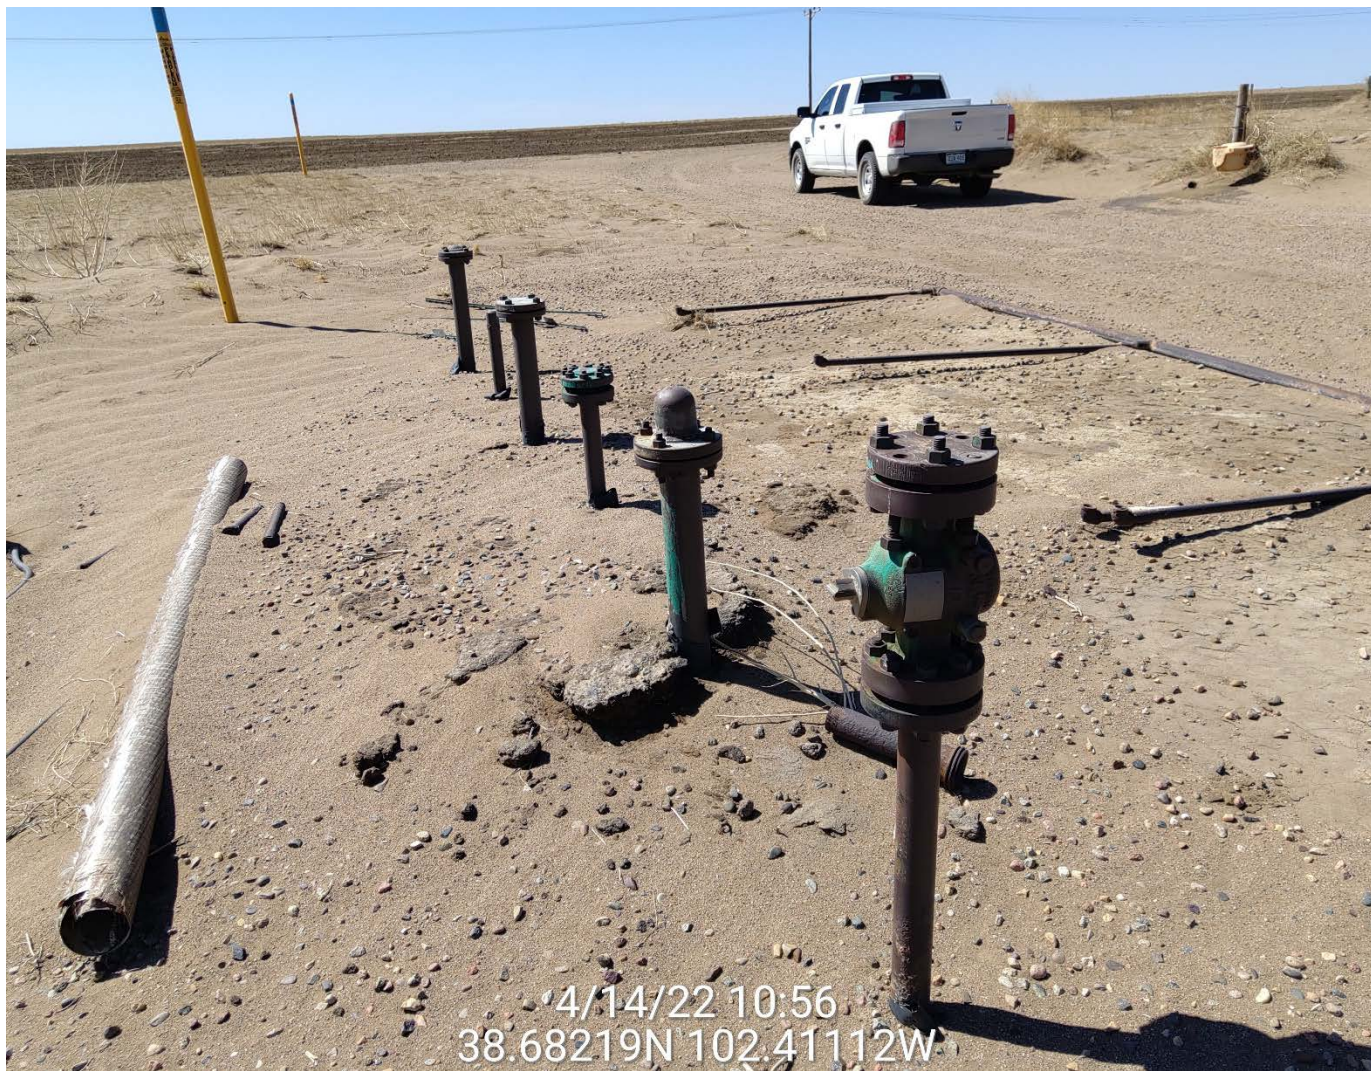
Improper abandonment of flowline or crude oil transfer line (not purged, depressurized, risers cut 3' below grade, ends sealed, equipment removed) per 1105. Disconnected flowline risers not OOSLAT (out of service locks and tags).

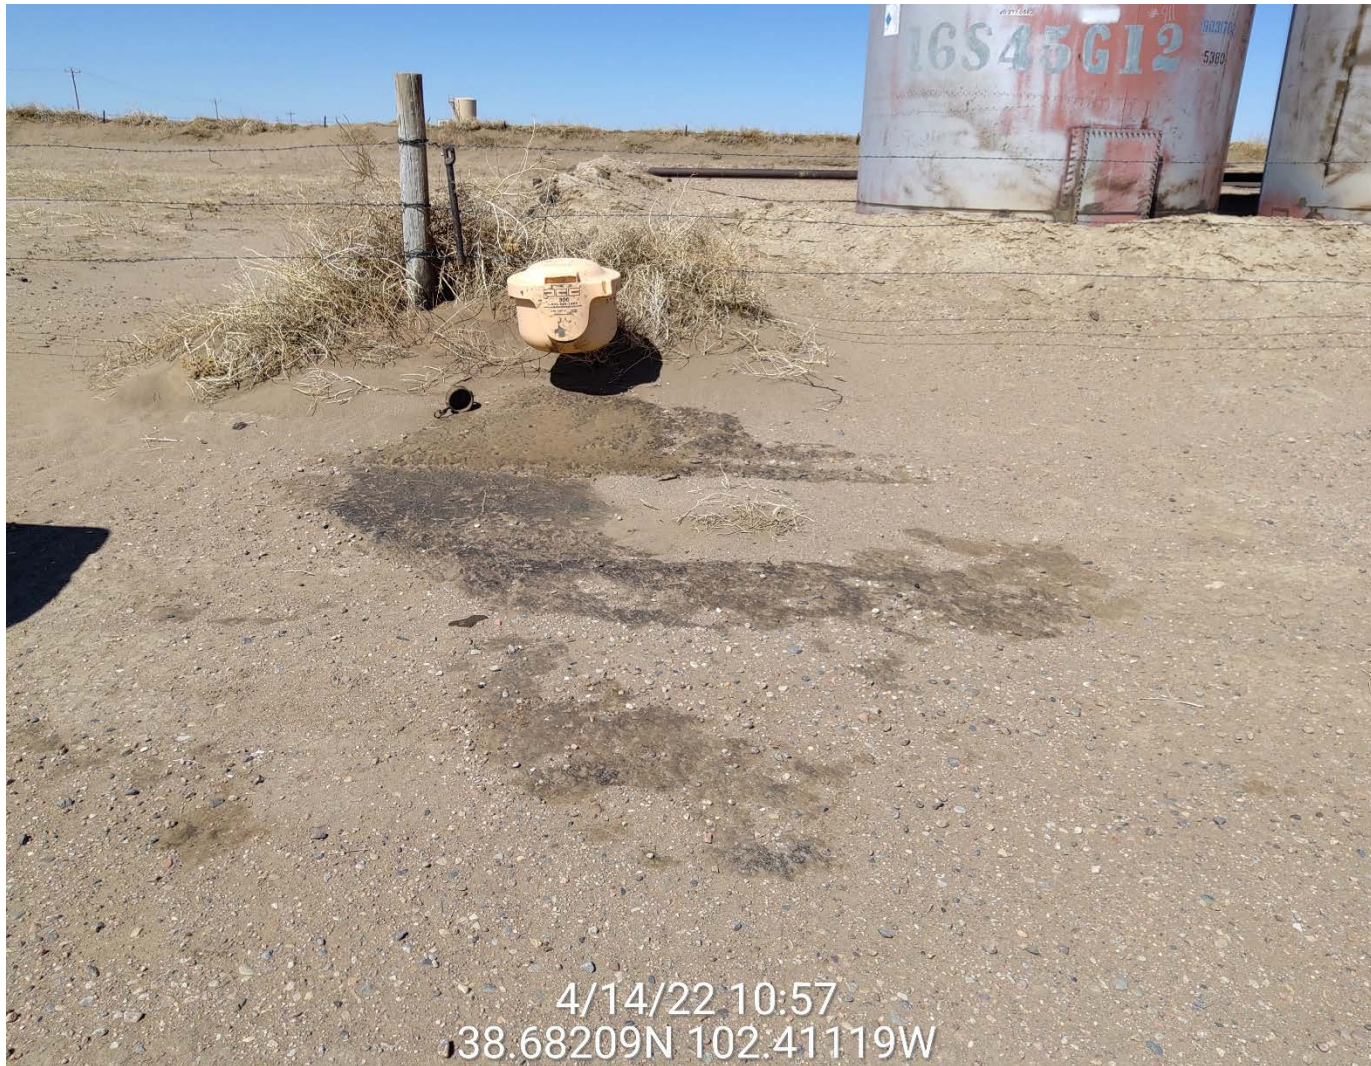
4/14/22 10:57
38.68209N 102.41119W

Stained soil around loadout
