Inspection Photos

Operator: Chevron USA Inc - #16700

Location Name: Wilson Creek Unit-63N94W /34NESW

Inspection Document #: 702800190

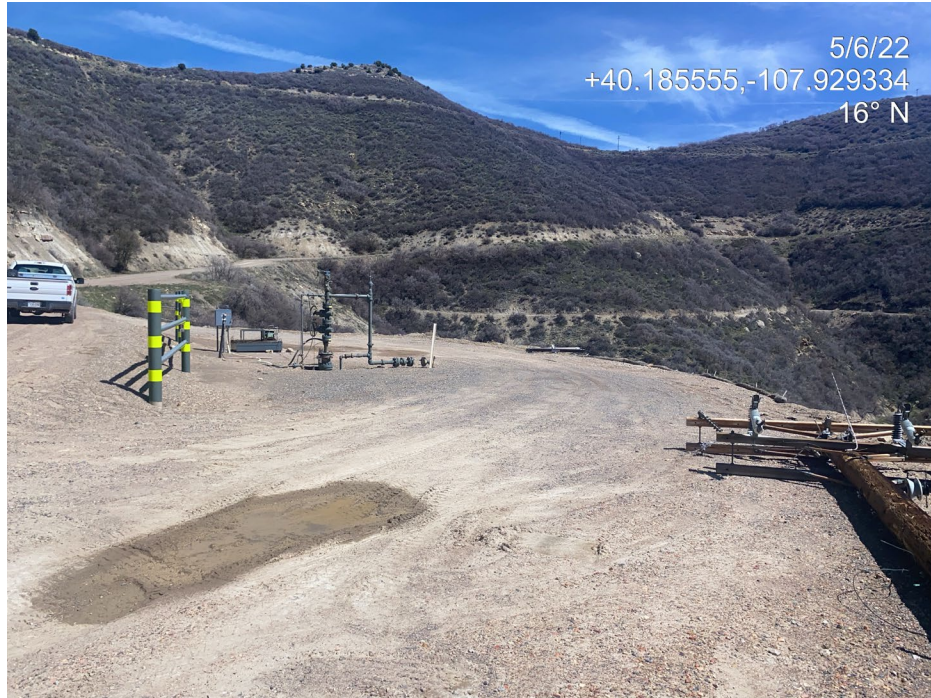
Photo 1. Photo taken from the south of the Location shows an overview of the Location. Photo also shows power lines on the Location are being decommissioned.

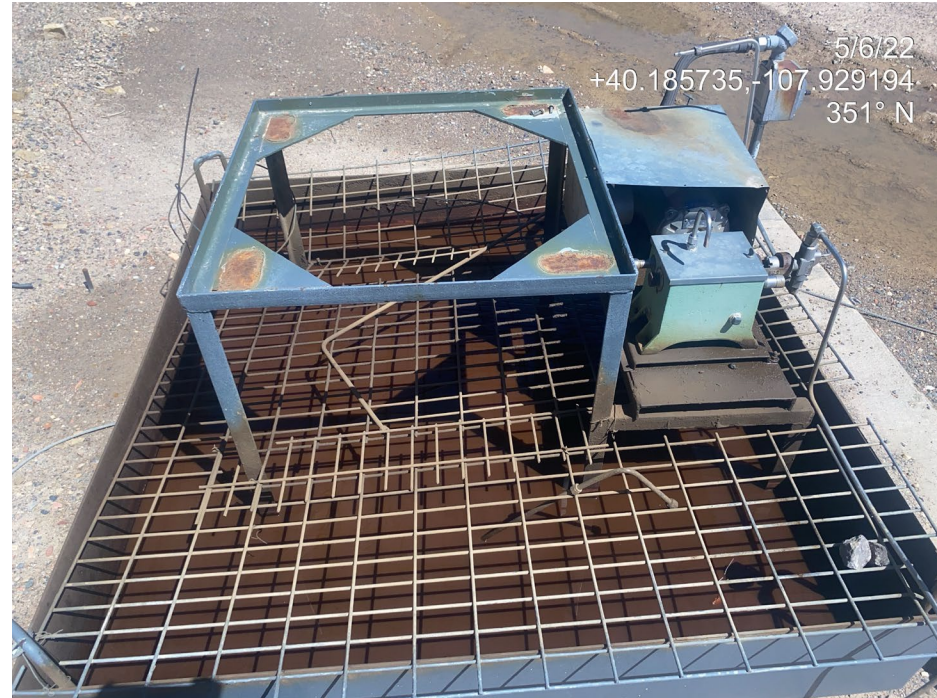
Photo 2. Photo shows a secondary containment BMP filled with fluid. Wildlife protection BMPs to enable wildlife egress are missing or insufficient.

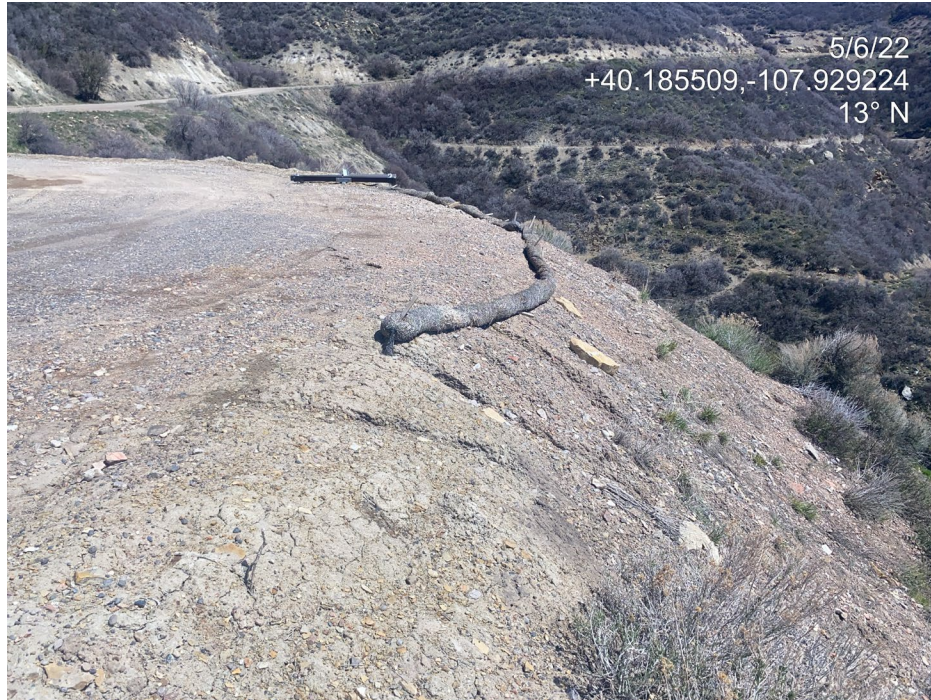
Photo 3. Photo taken from the east of the Location shows stormwater and sediment control BMPs are missing or insufficient. Erosion is evident on the eastern perimeter of the Location.

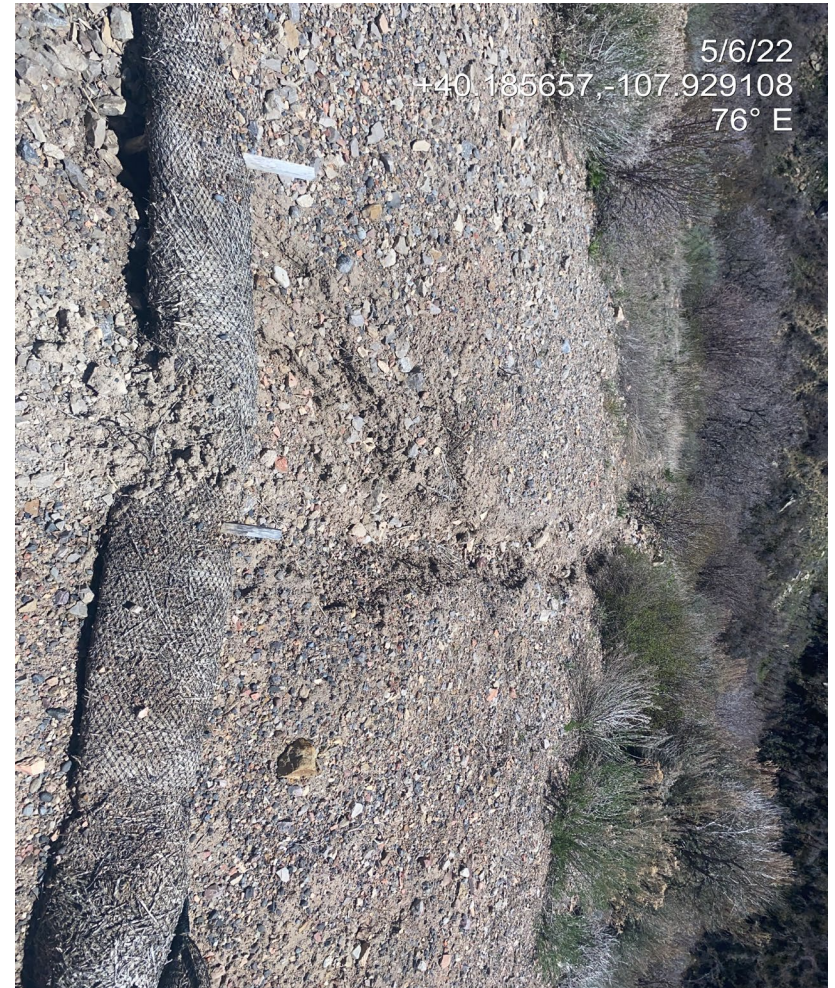
Photo 4. Refer to Photo 3 comments.
