COGCC Inspection Doc # 693904295

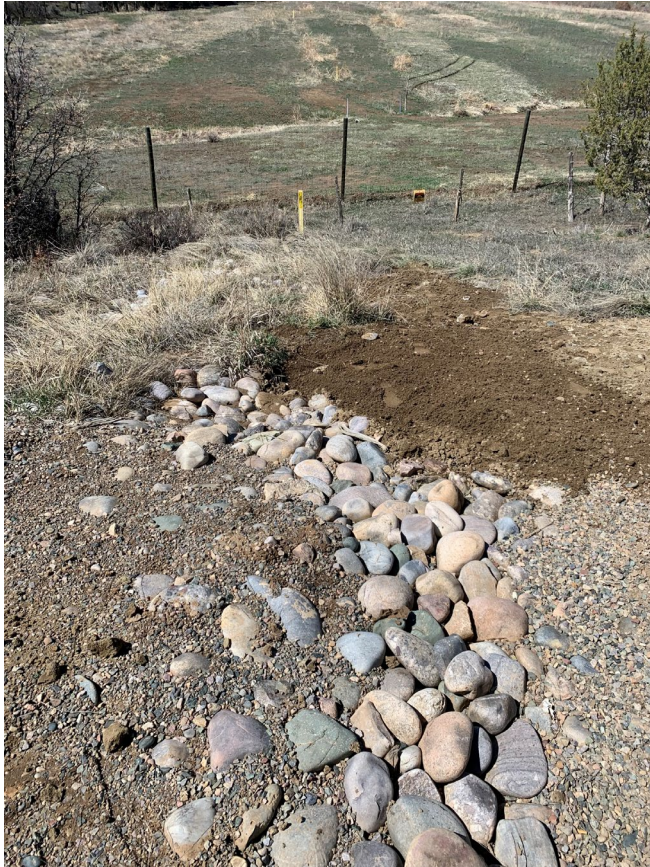
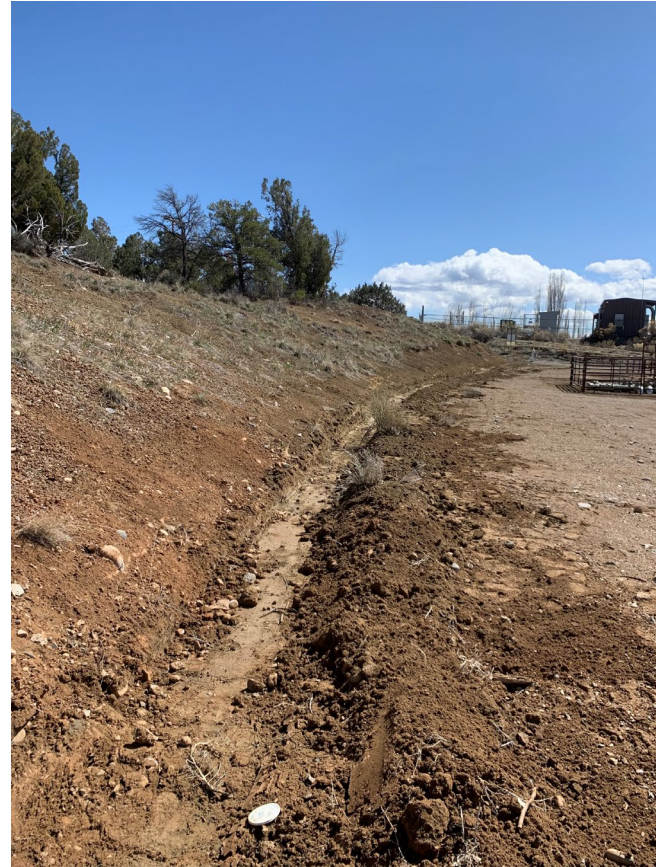
Repaired erosion channel on north side of location and re-established drainage ditch on east side of location along the cut bank.

CA Complete 03/30/2022
