Colorado Oil and Gas Conservation Commission

Mustang V41-27-28XRLNB Issue Report

Created on July 22, 2022

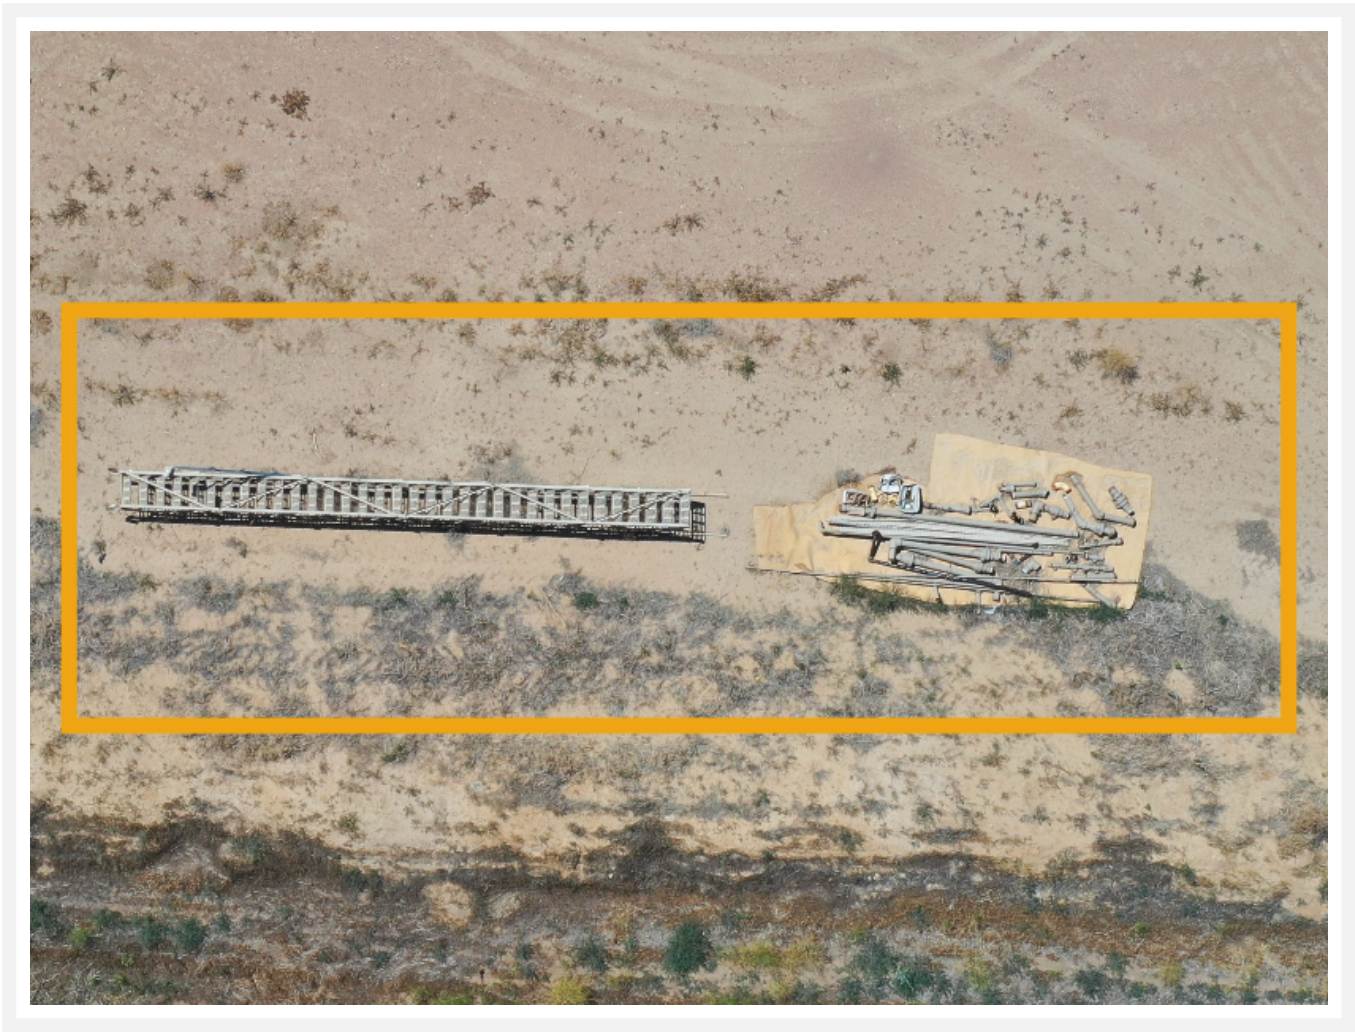
5 - Observation

Summary: Unused equipment in multiple spots needs to be removed for good housekeeping. Comply with Rule 606. With a corrective action date of 5/6/22

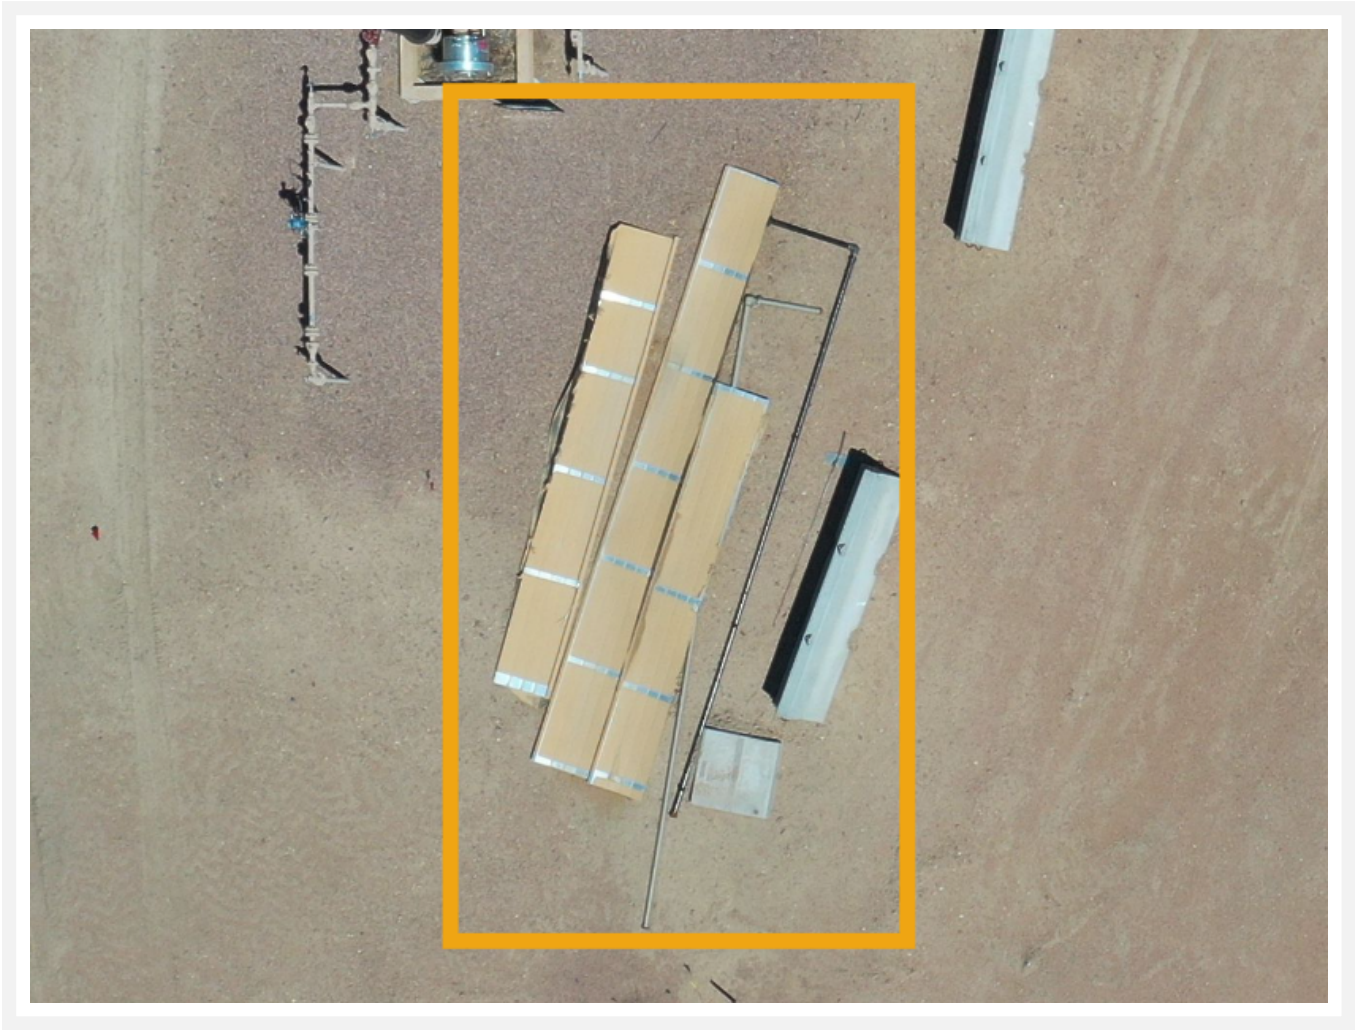
6 - Observation

Summary: Trash in multiple spots needs to be removed for good housekeeping. Comply with Rule 606. With a corrective action date of 5/6/22

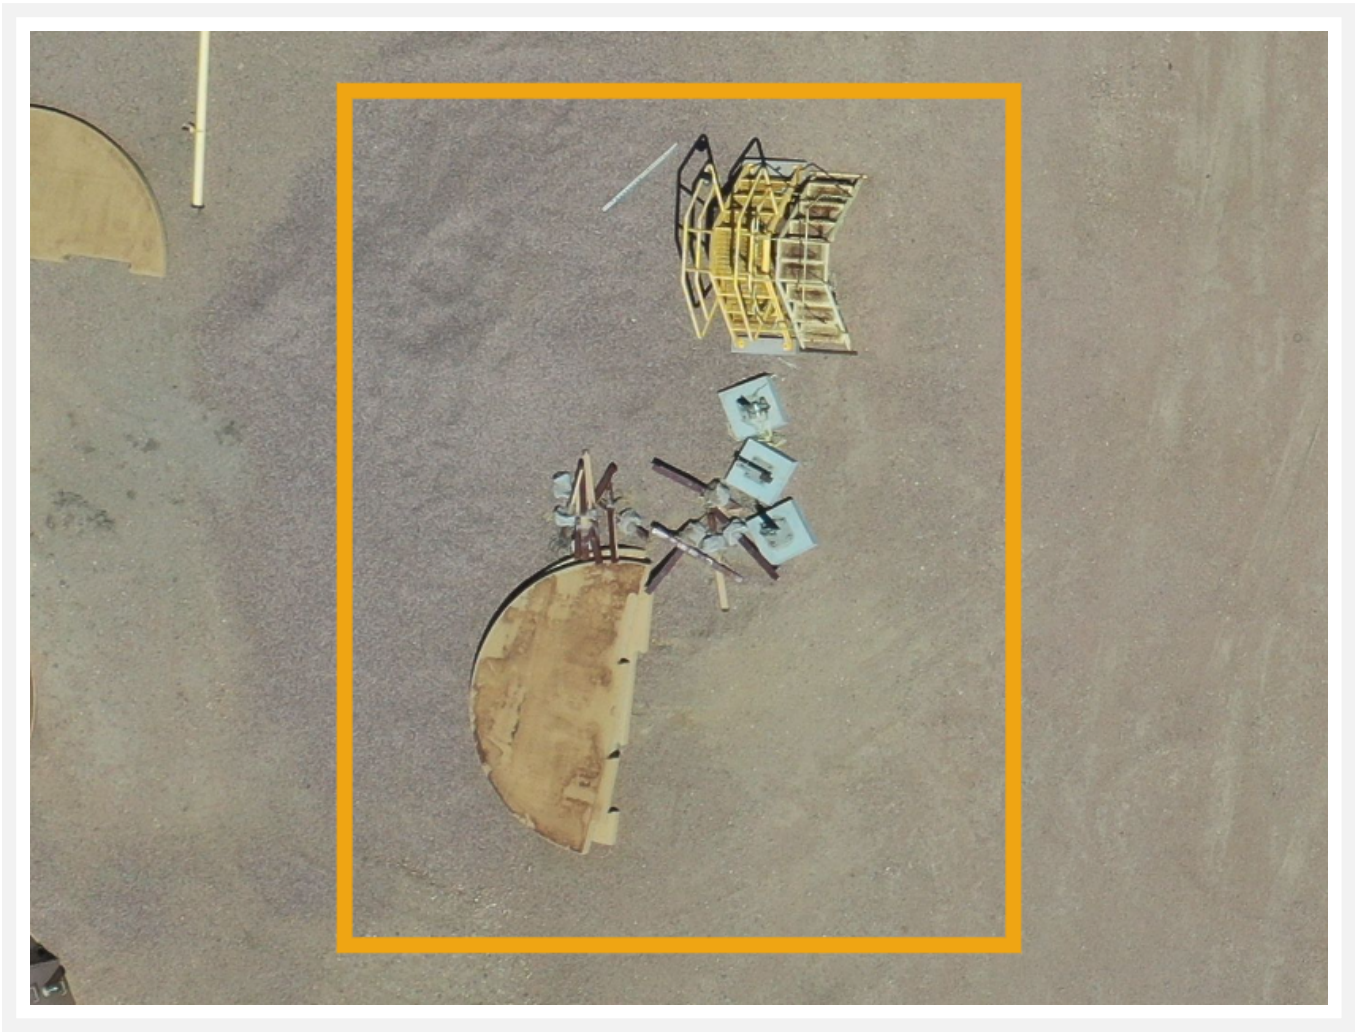
8 - Observation

Summary: Unused equipment in multiple spots needs to be removed for good housekeeping. Comply with Rule 606. With a corrective action date of 5/6/22

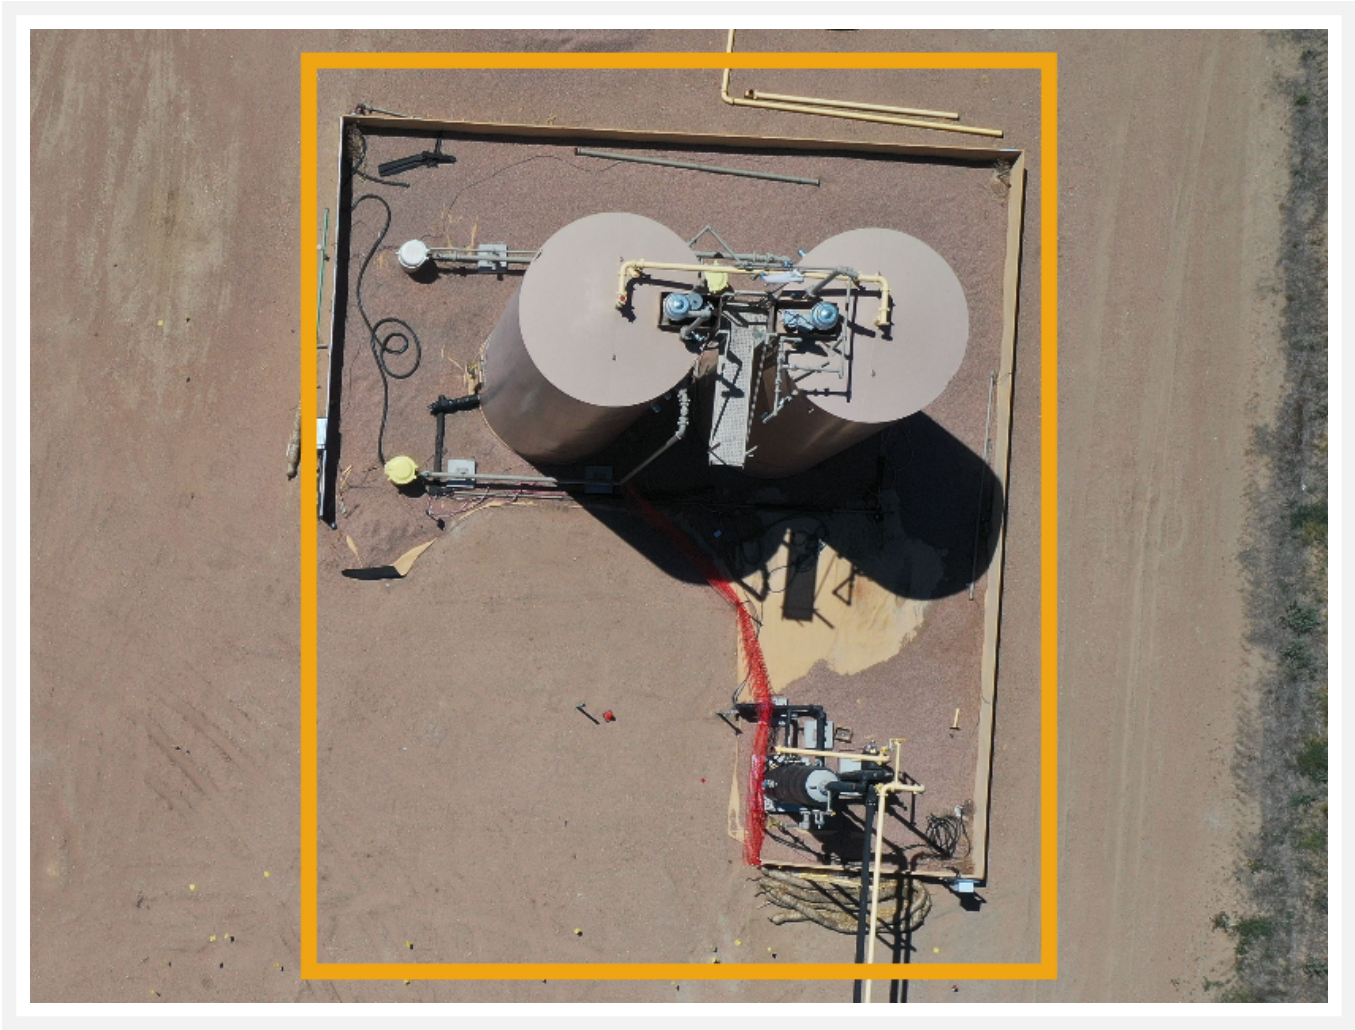
9 - Observation

Summary: Repair/ Install metal berms around production tanks. Repair or install berms or other secondary containment devices per Rule 912.d.(1). With a corrective action date of 5/13/22

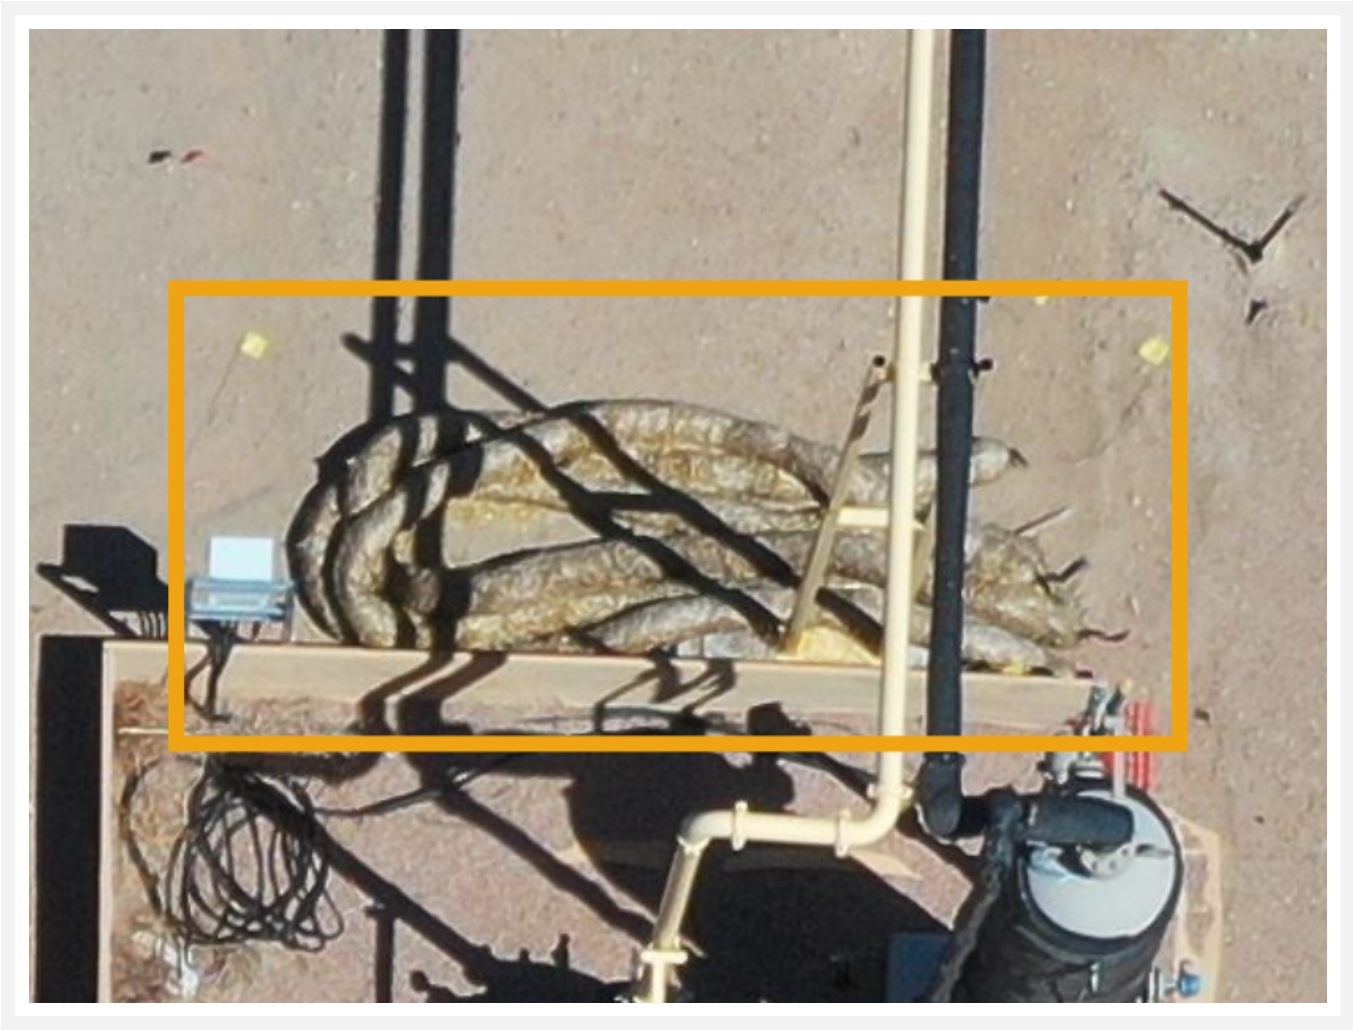
10 - Observation

Summary: Trash in multiple spots needs to be removed for good housekeeping. Comply with Rule 606. With a corrective action date of 5/6/22

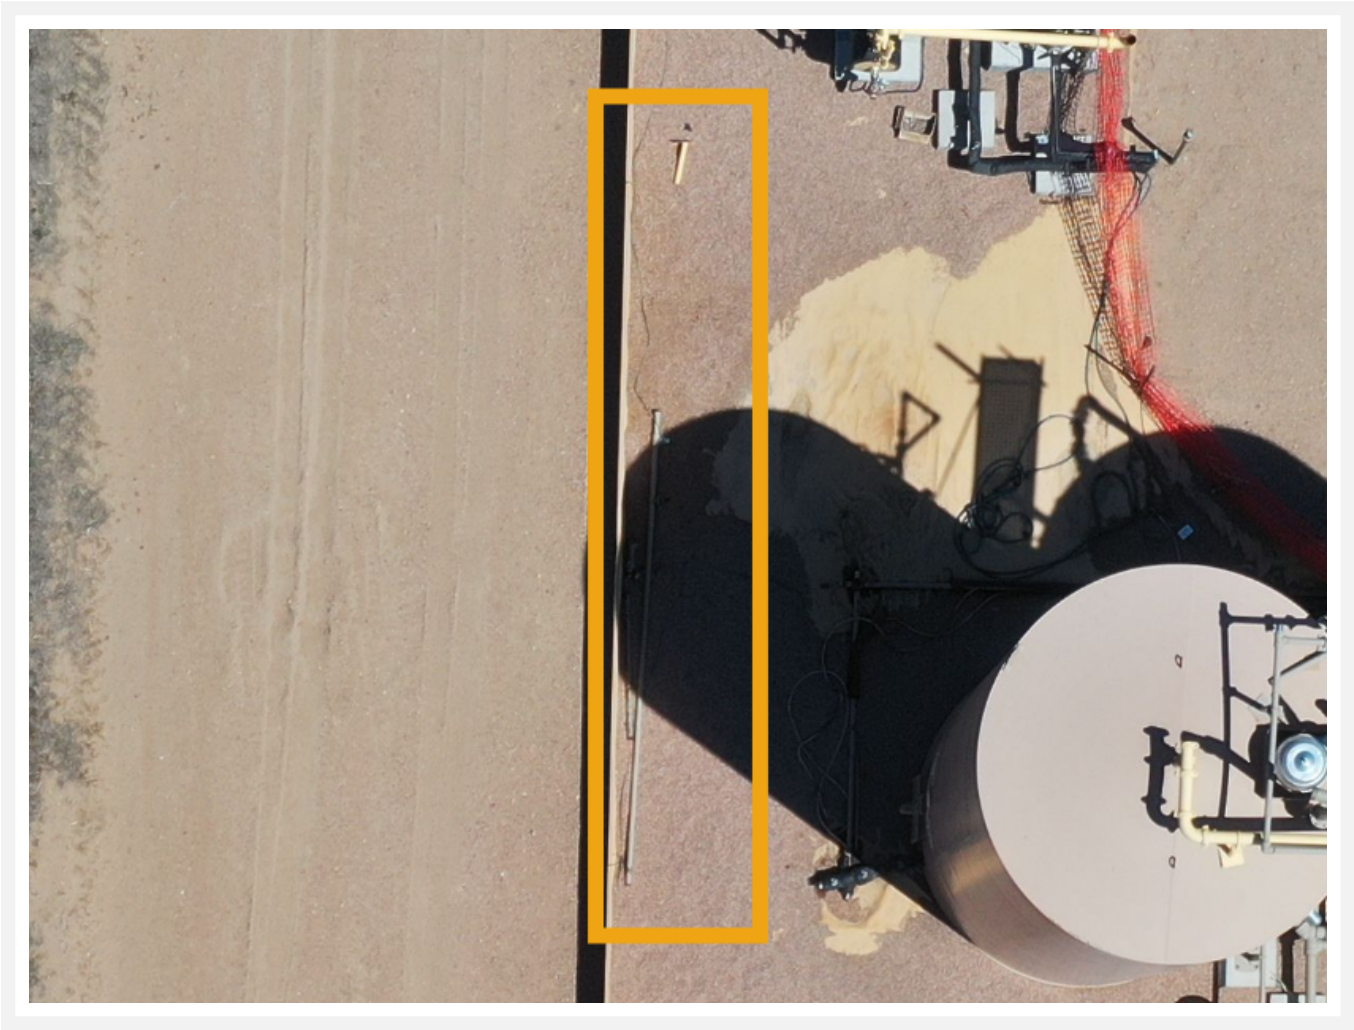
11 - Observation

Summary: Unused equipment in multiple spots needs to be removed for good housekeeping. Comply with Rule 606. With a corrective action date of 5/6/22

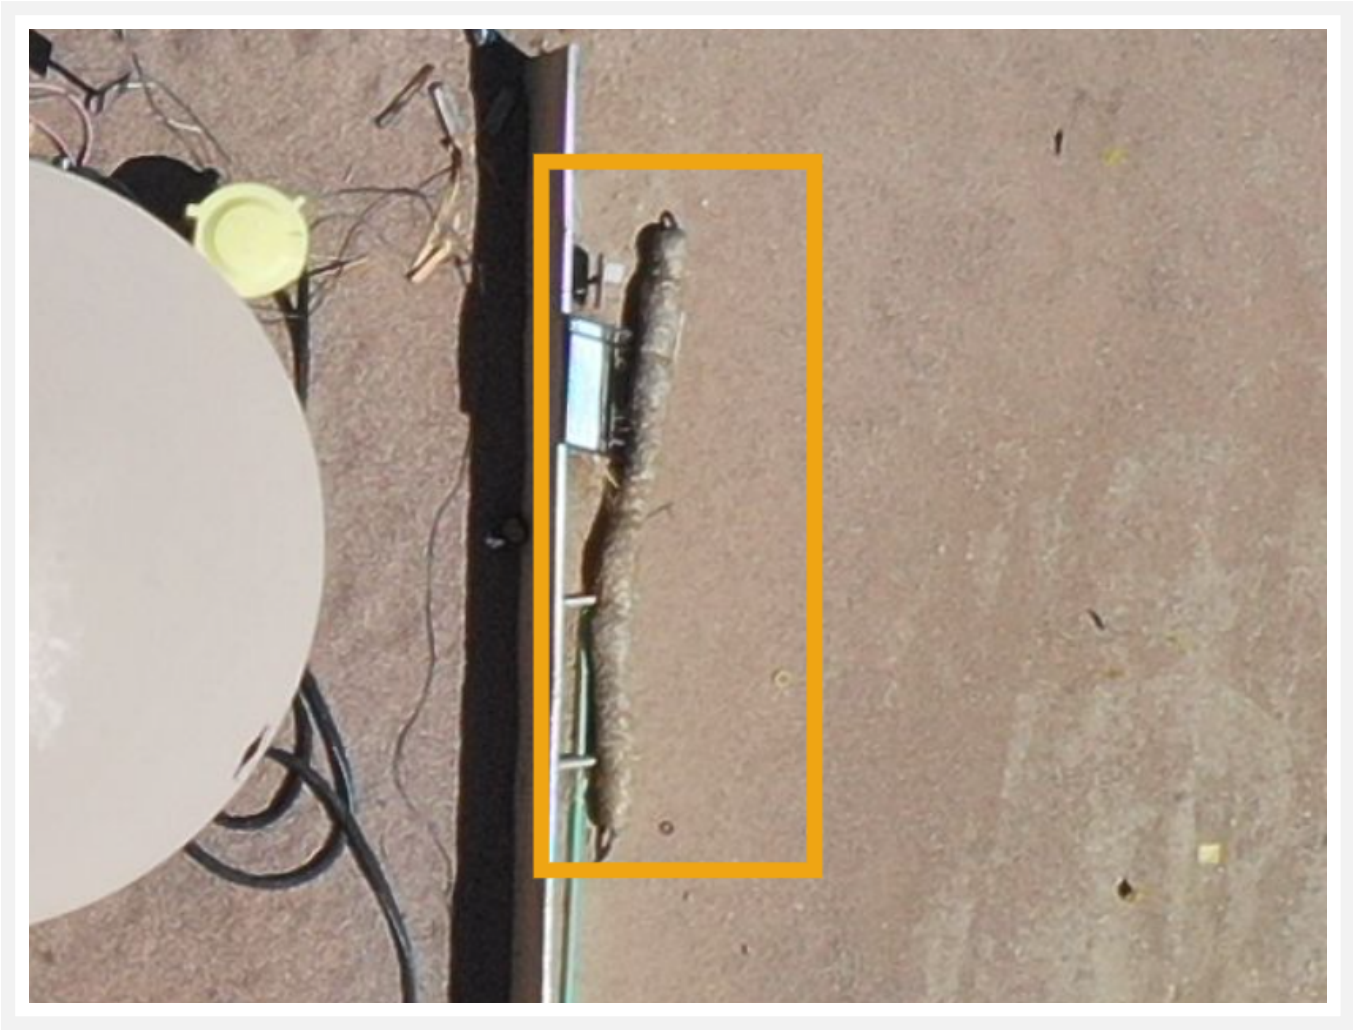
12 - Observation

Summary: Trash in multiple spots needs to be removed for good housekeeping. Comply with Rule 606. With a corrective action date of 5/6/22

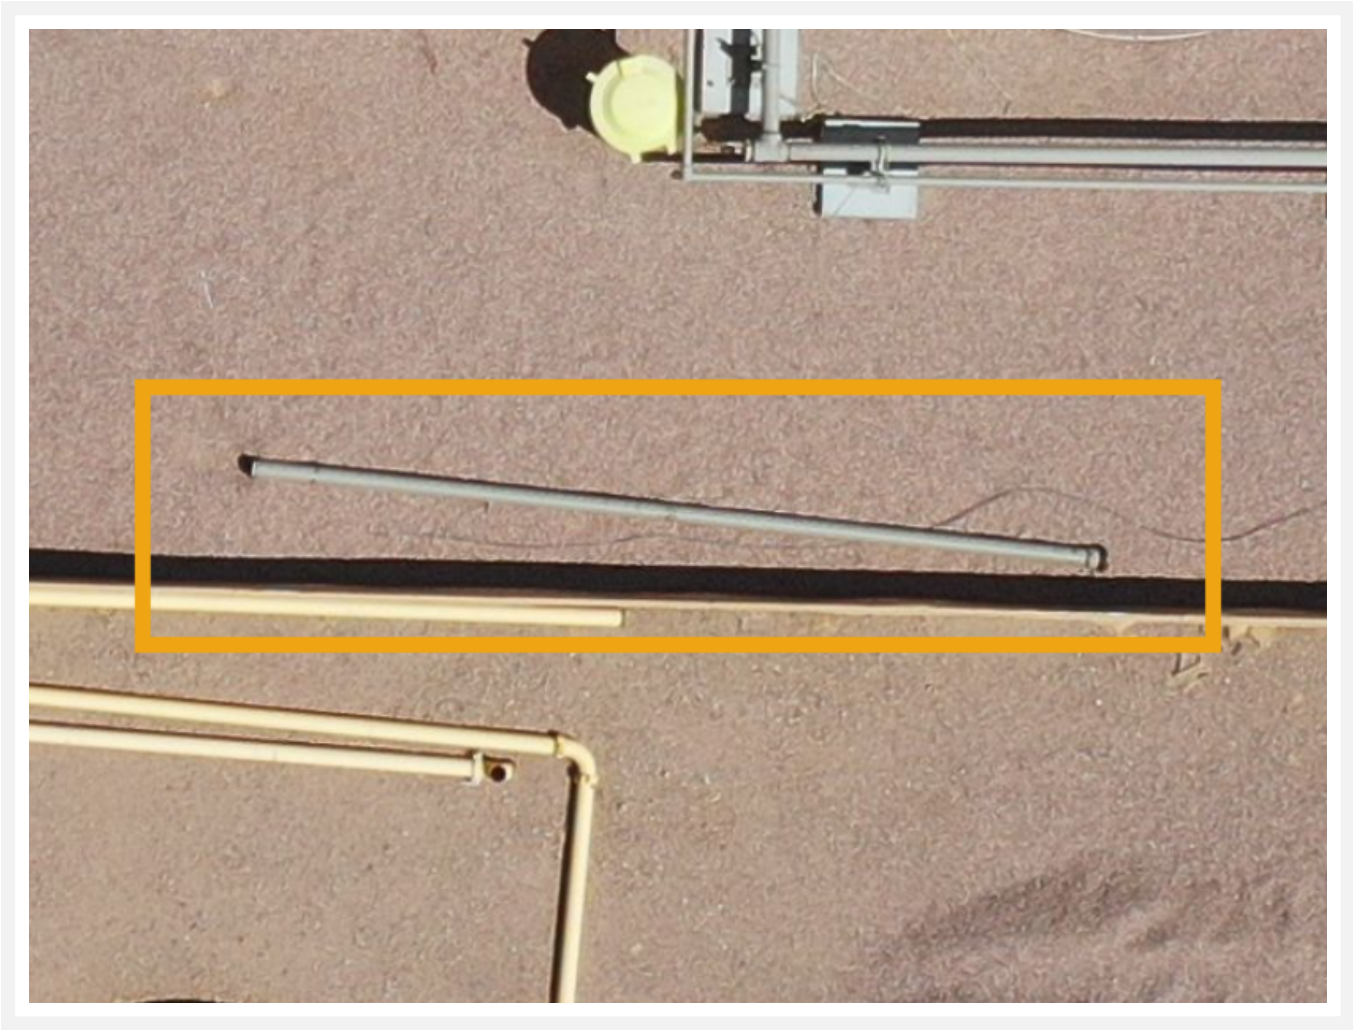
14 - Observation

Summary: **Unused equipment in multiple spots needs to be removed for good housekeeping. Comply with Rule 606. With a corrective action date of 5/6/22**

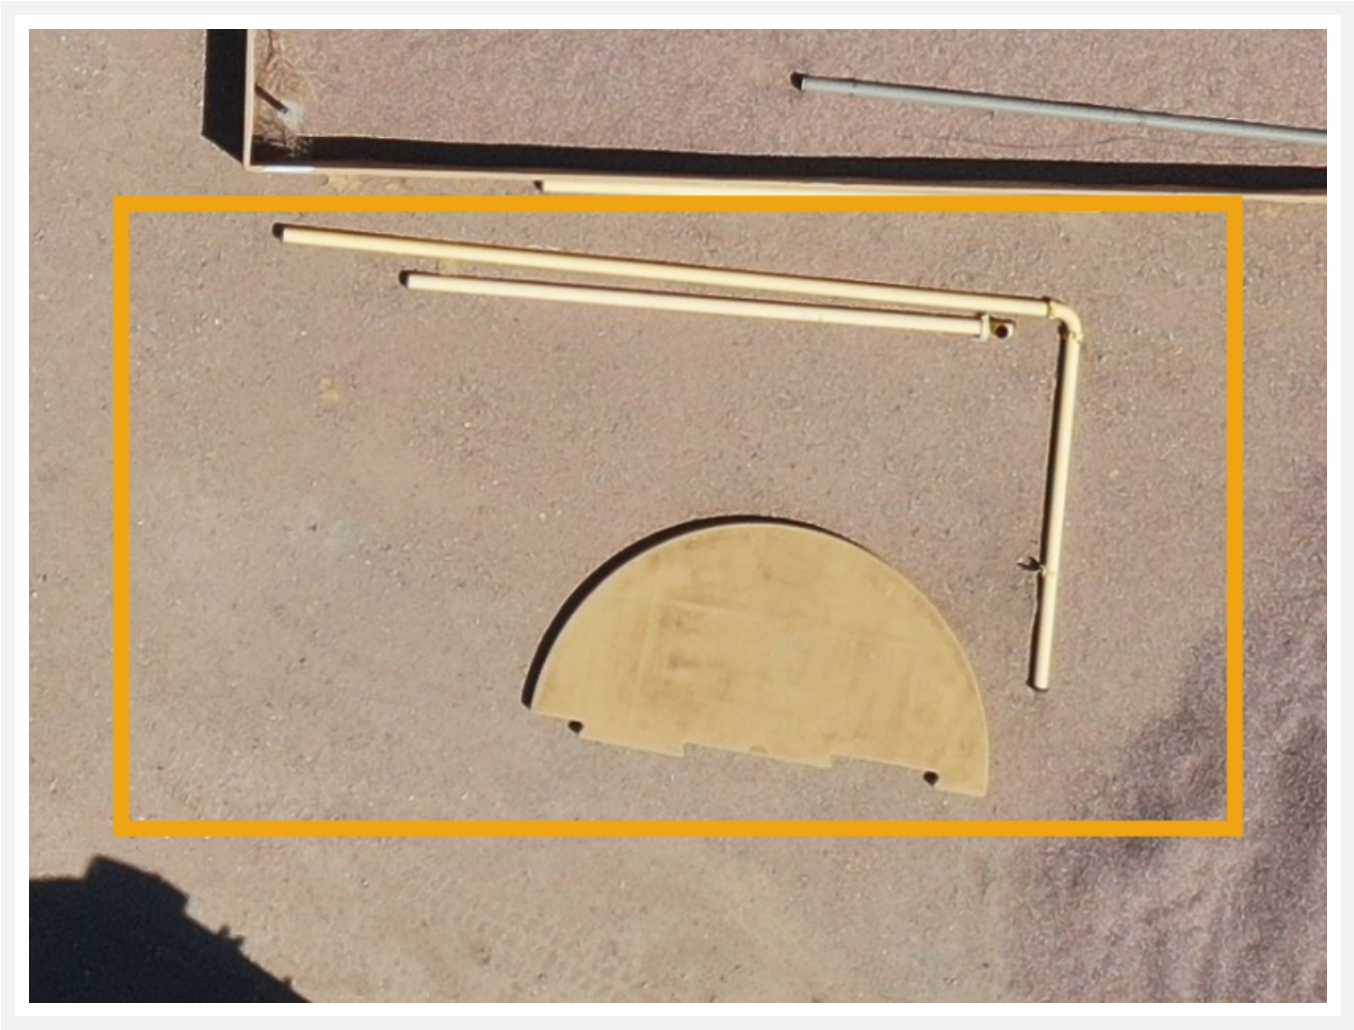
15 - Observation

Summary: Unused equipment in multiple spots needs to be removed for good housekeeping. Comply with Rule 606. With a corrective action date of 5/6/22

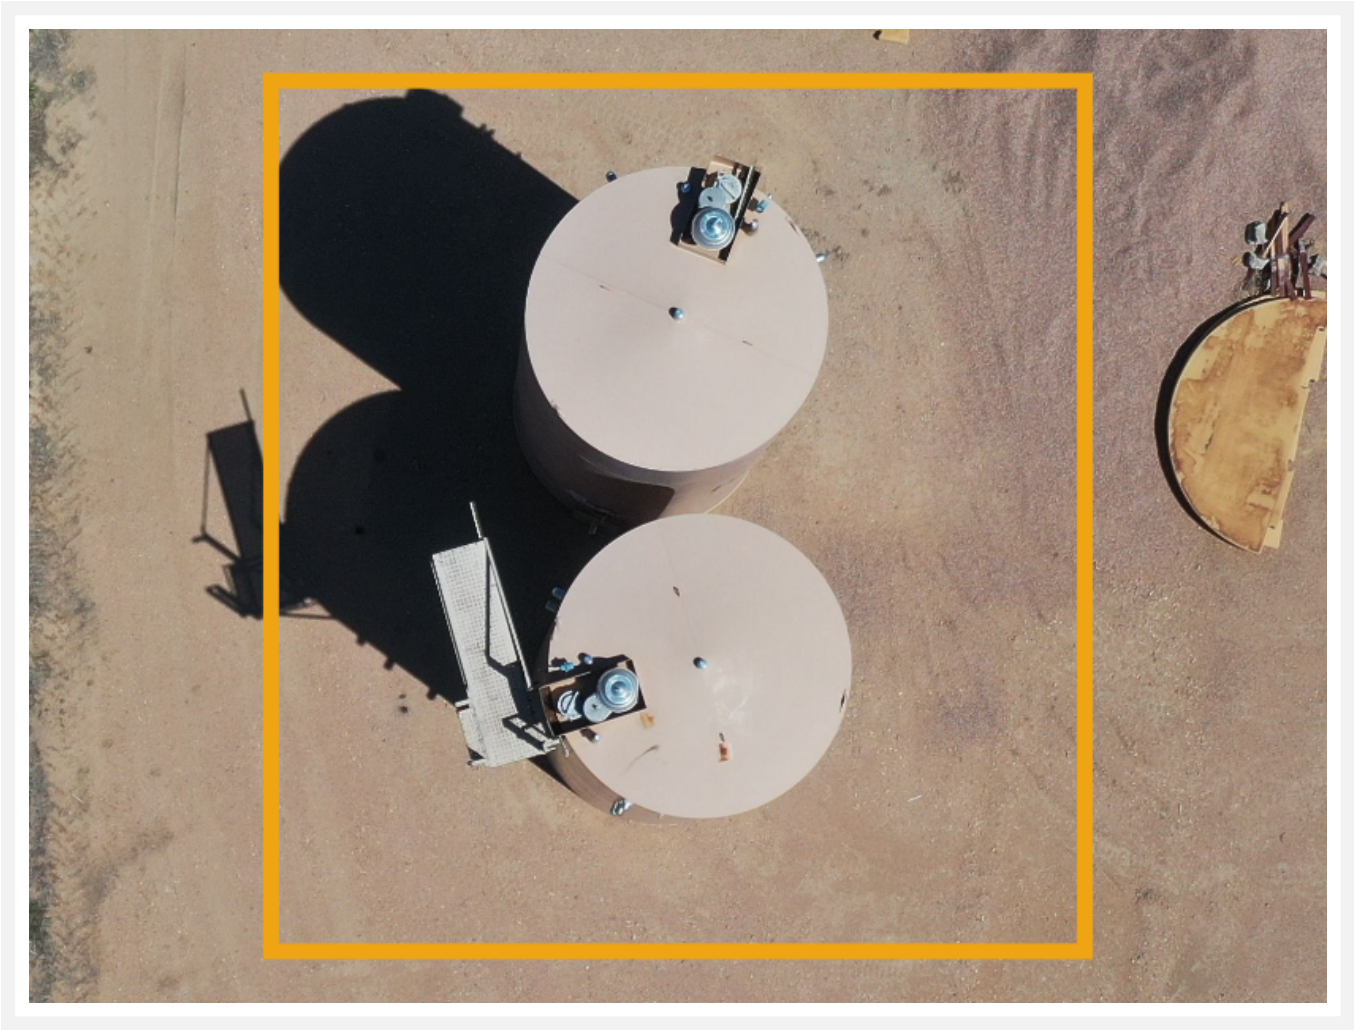
16 - Observation

Summary: **Unused production tanks need to be removed for good housekeeping. Comply with Rule 606. With a corrective action date of 5/27/22**

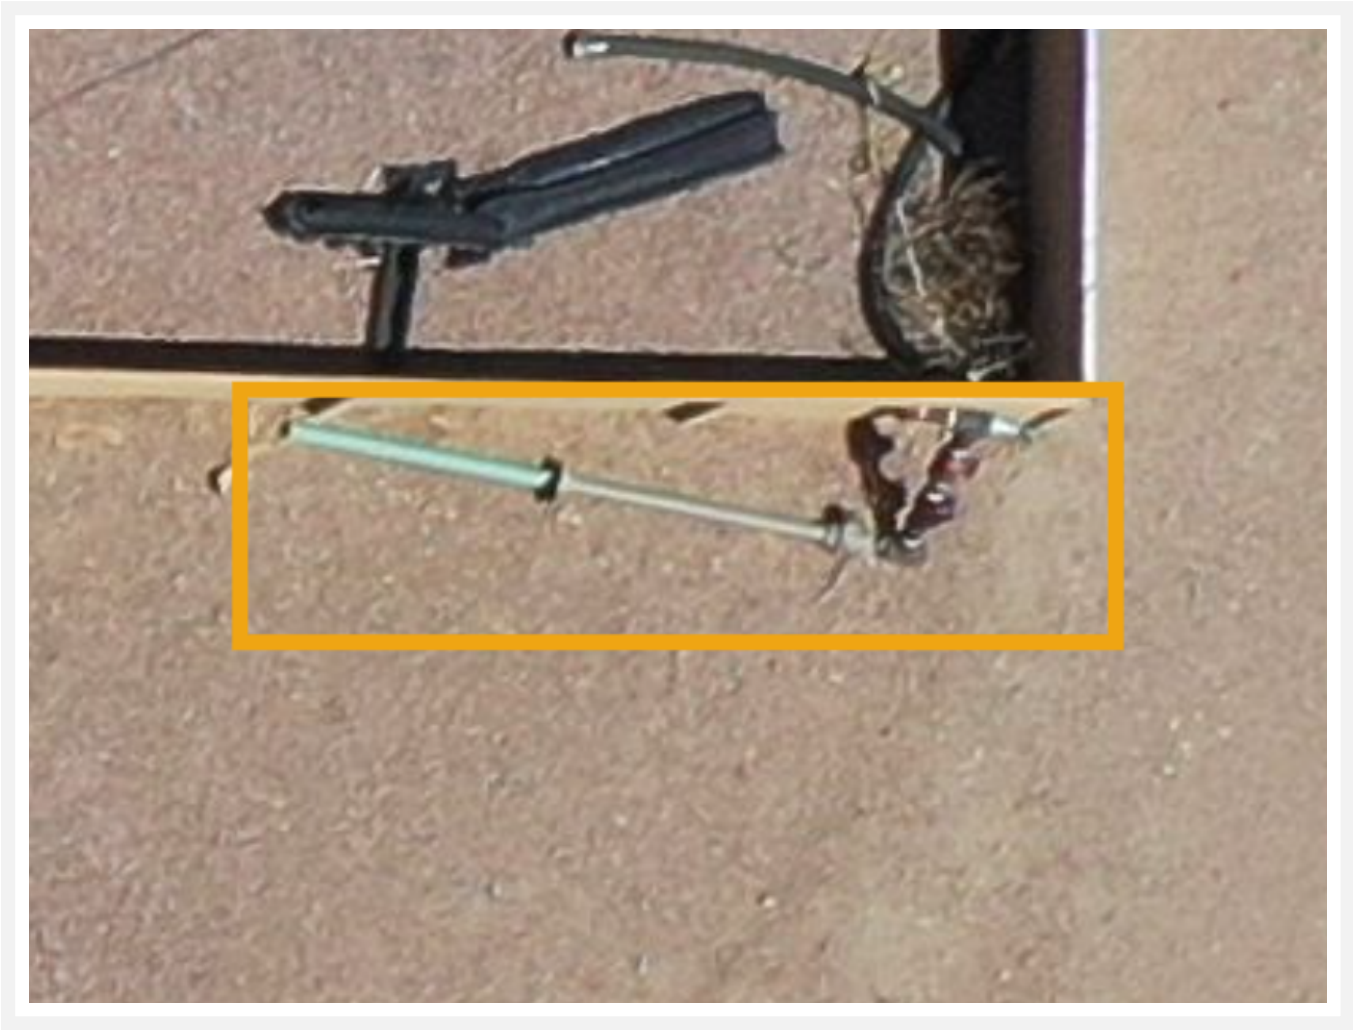
17 - Observation

Summary: Unused equipment in multiple spots needs to be removed for good housekeeping. Comply with Rule 606. With a corrective action date of 5/6/22
