HYDROLOGY MAP  
RAINBOW 24-9HZ  
HORIZONTAL MULTI-WELL PAD

E1/2 SECTION 9, TOWNSHIP 5 NORTH, RANGE 67 WEST, 6TH P.M., GREELEY, COLORADO

PREPARED FOR:  
Kerr-McGee Oil & Gas Onshore LP

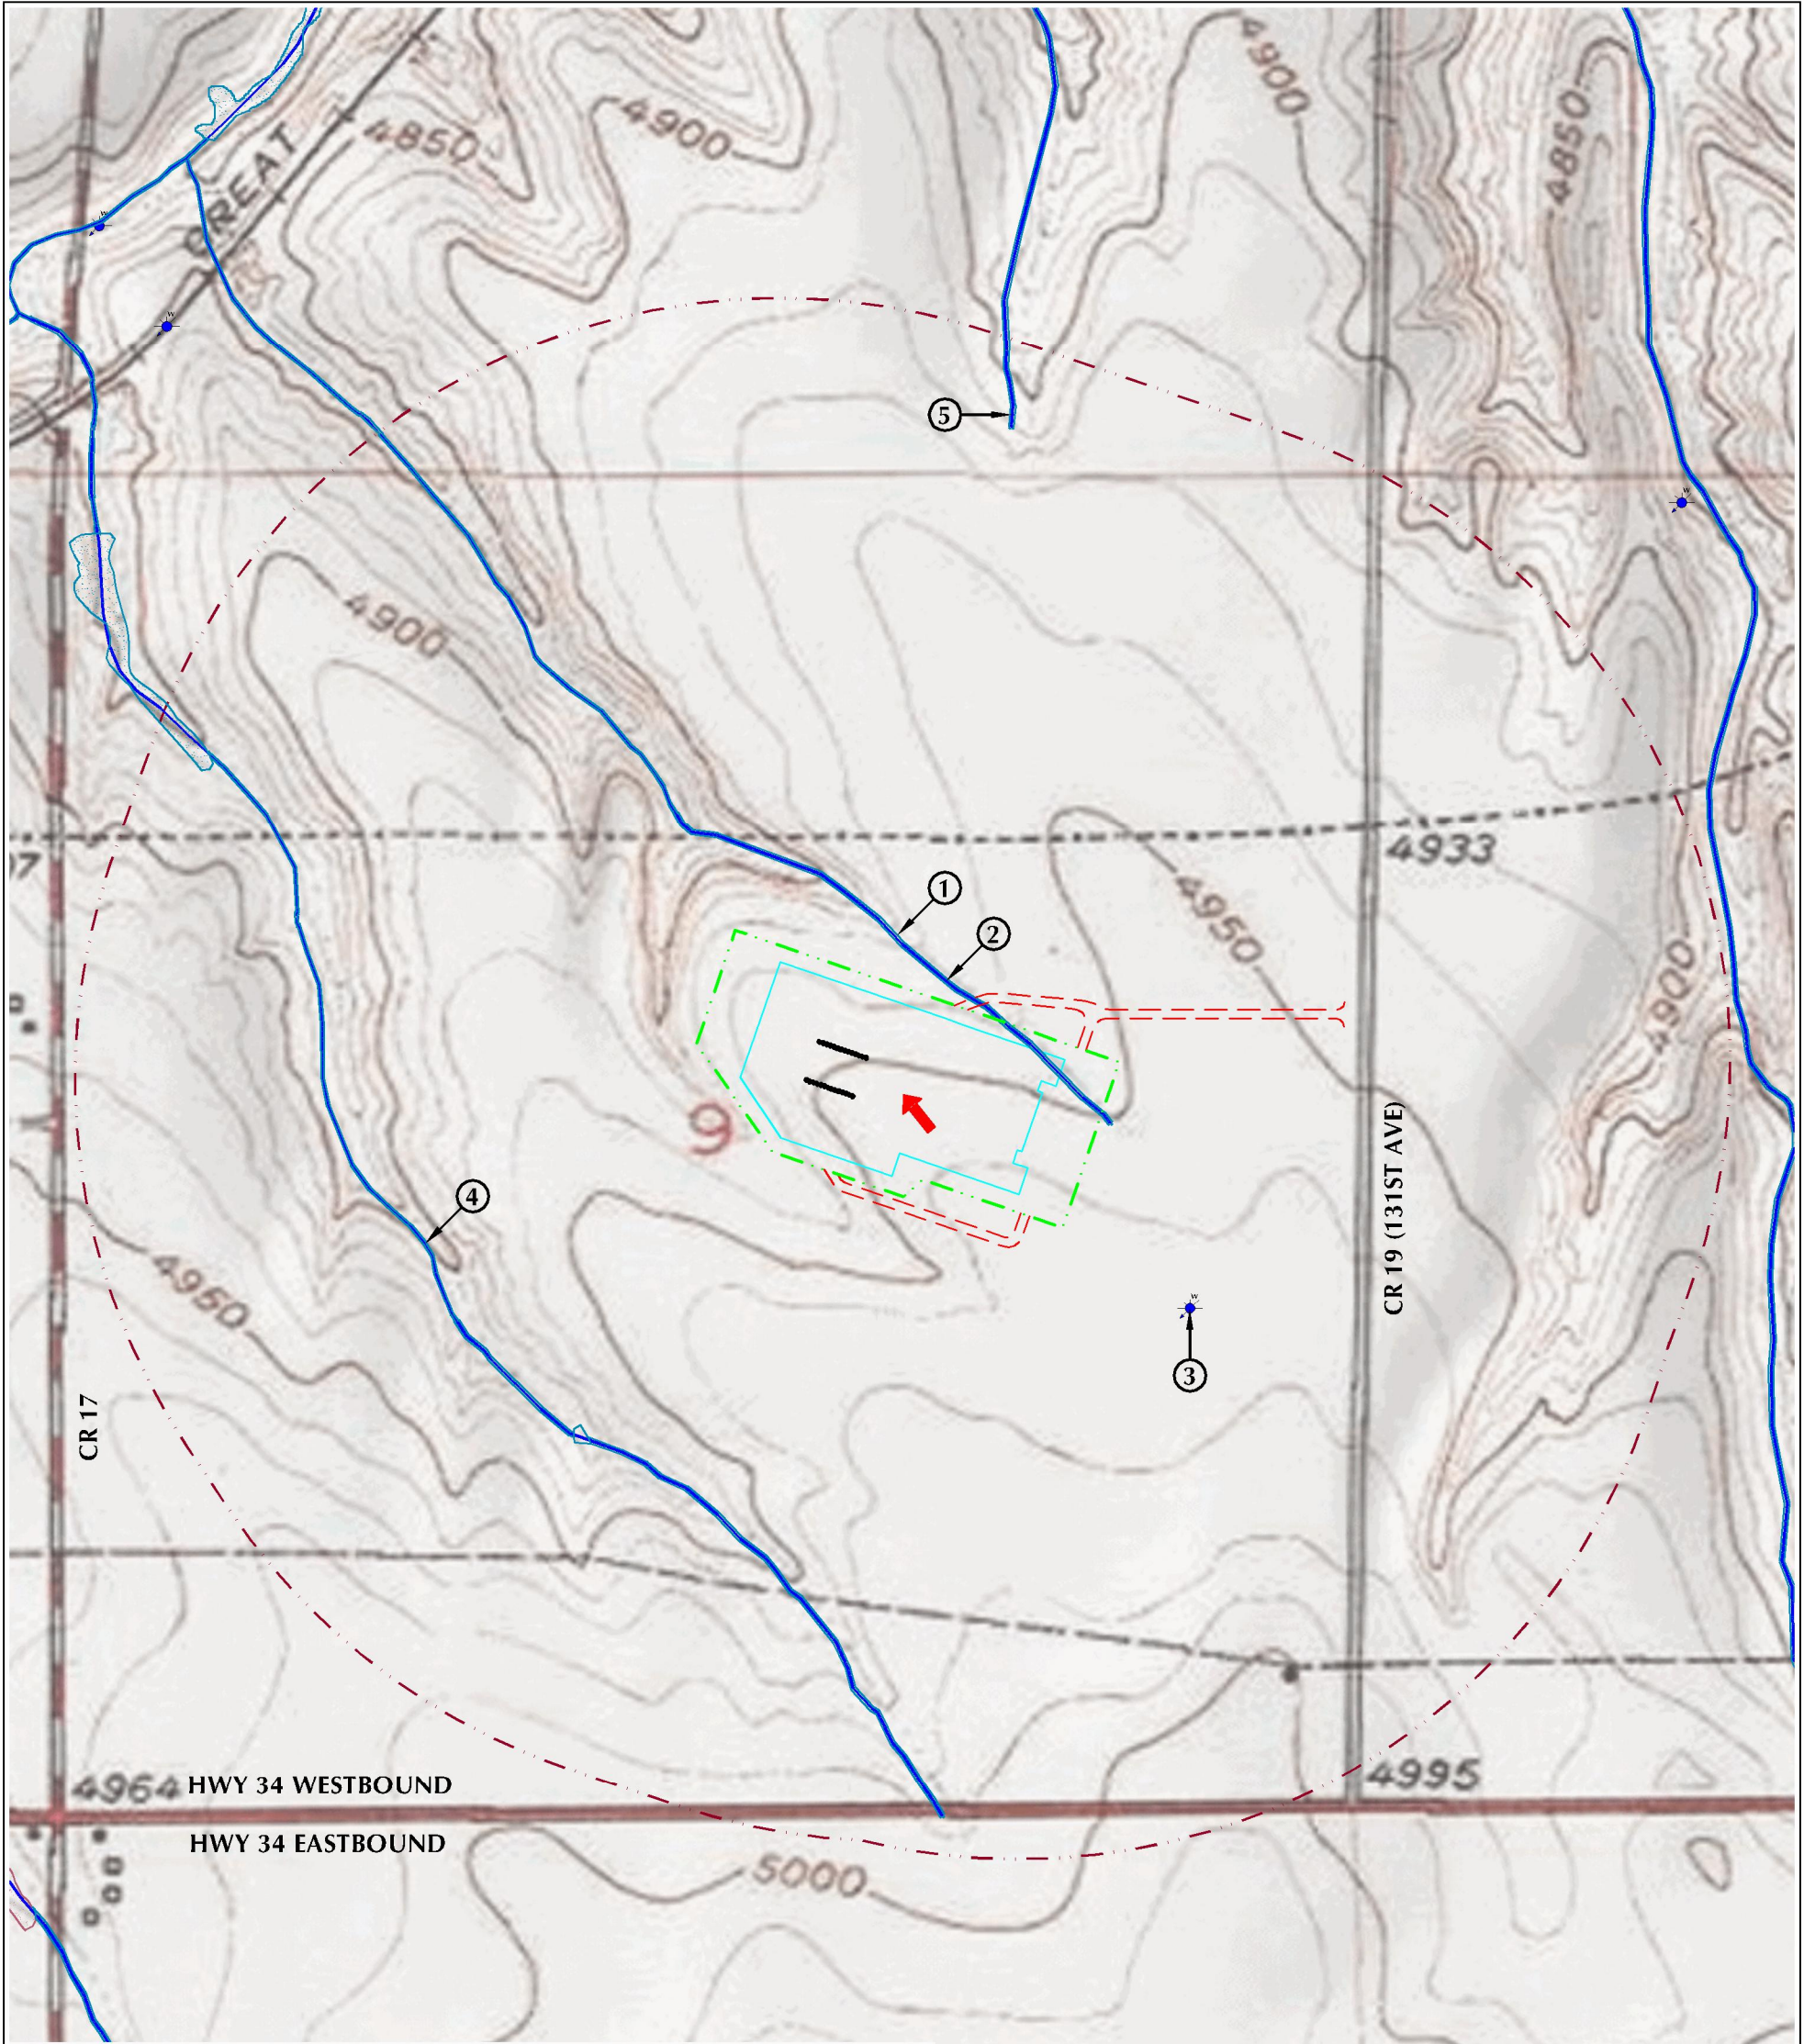
- NOTES:
- WORKING PAD SURFACE IS NOT WITHIN 2640' OF A GUDI OR TYPE III AQUIFER PUBLIC WATER SYSTEM WELL.
  - WORKING PAD SURFACE DOES NOT HAVE ANY SURFACE WATERS WITHIN 2640' THAT ARE 15 MILES UPSTREAM OF A PUBLIC WATER SYSTEM INTAKE.

- NWI RIVERINE/POND/WETLAND AREAS ARE  $\pm 0'$ ,  $\pm 1389'$  SW,  $\pm 1392'$  SW,  $\pm 1406'$  SW,  $\pm 2299'$  N AND  $\pm 2385'$  W.
- INTERMITTENT DRAINAGE IS  $\pm 0'$ .
- EXISTING WATER WELL (PERMIT #32200-MH, PERMIT ISSUED) IS  $\pm 817'$  SE.
- INTERMITTENT DRAINAGE IS  $\pm 1398'$  SW.
- INTERMITTENT DRAINAGE IS  $\pm 2309'$  N.

ALL MEASUREMENTS ARE MADE  
FROM NEAREST EDGE OF  
WORKING PAD SURFACE
