# Final Reclamation Inspection

Operator: Merit Energy Company- #56565

Location ID: 319665

Inspection Photos  
Location Name: BERGMAN #1  
Location ID: 319665

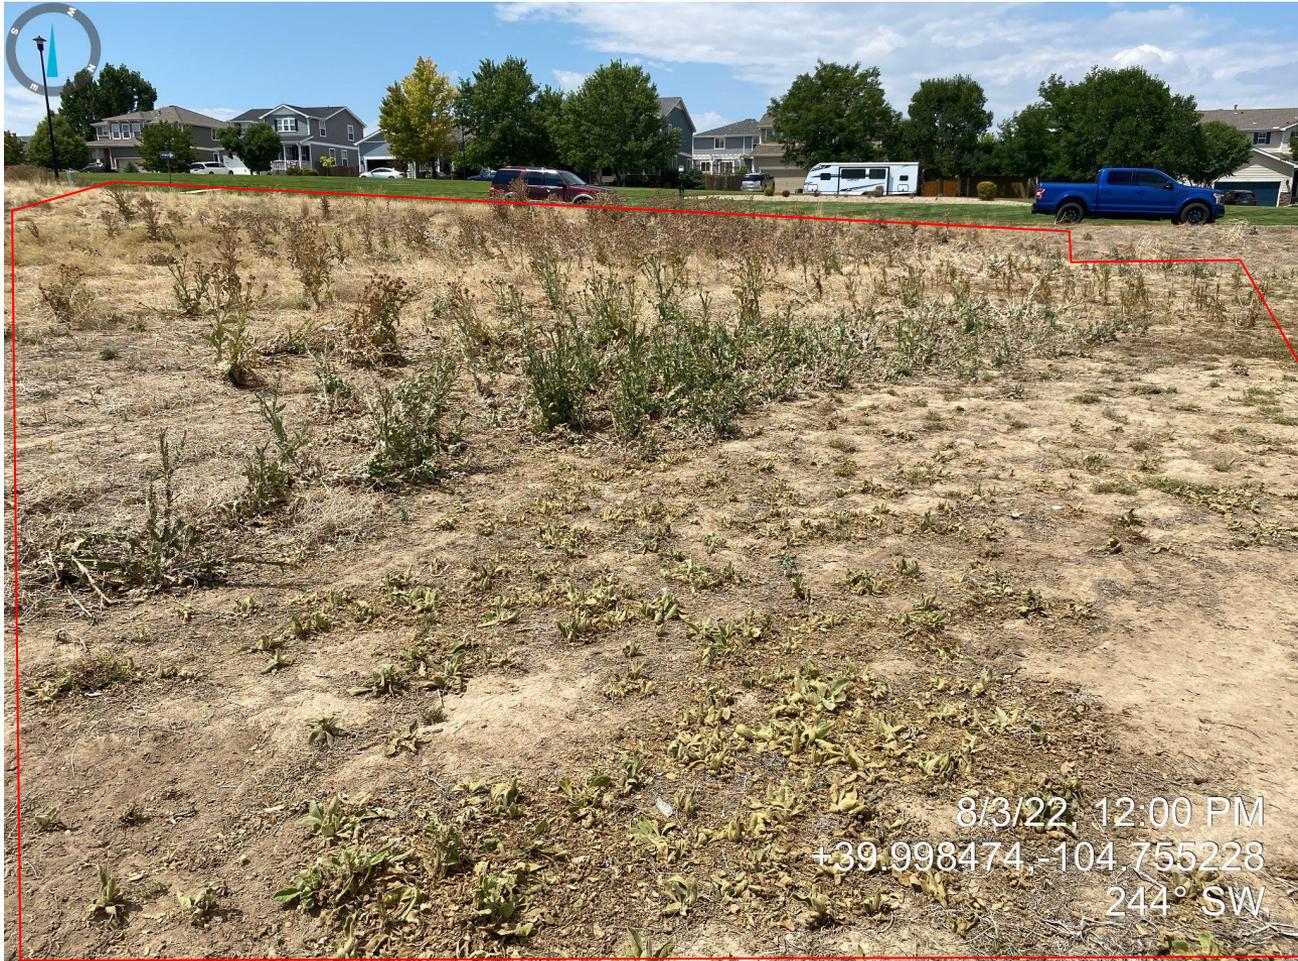
**Photo 1.** Location photo taken from center portion, facing southwest. Photo illustrates unmanaged Colorado List B and C noxious weeds, scotch thistle (B) and common mullein (C) (both highlighted in red).

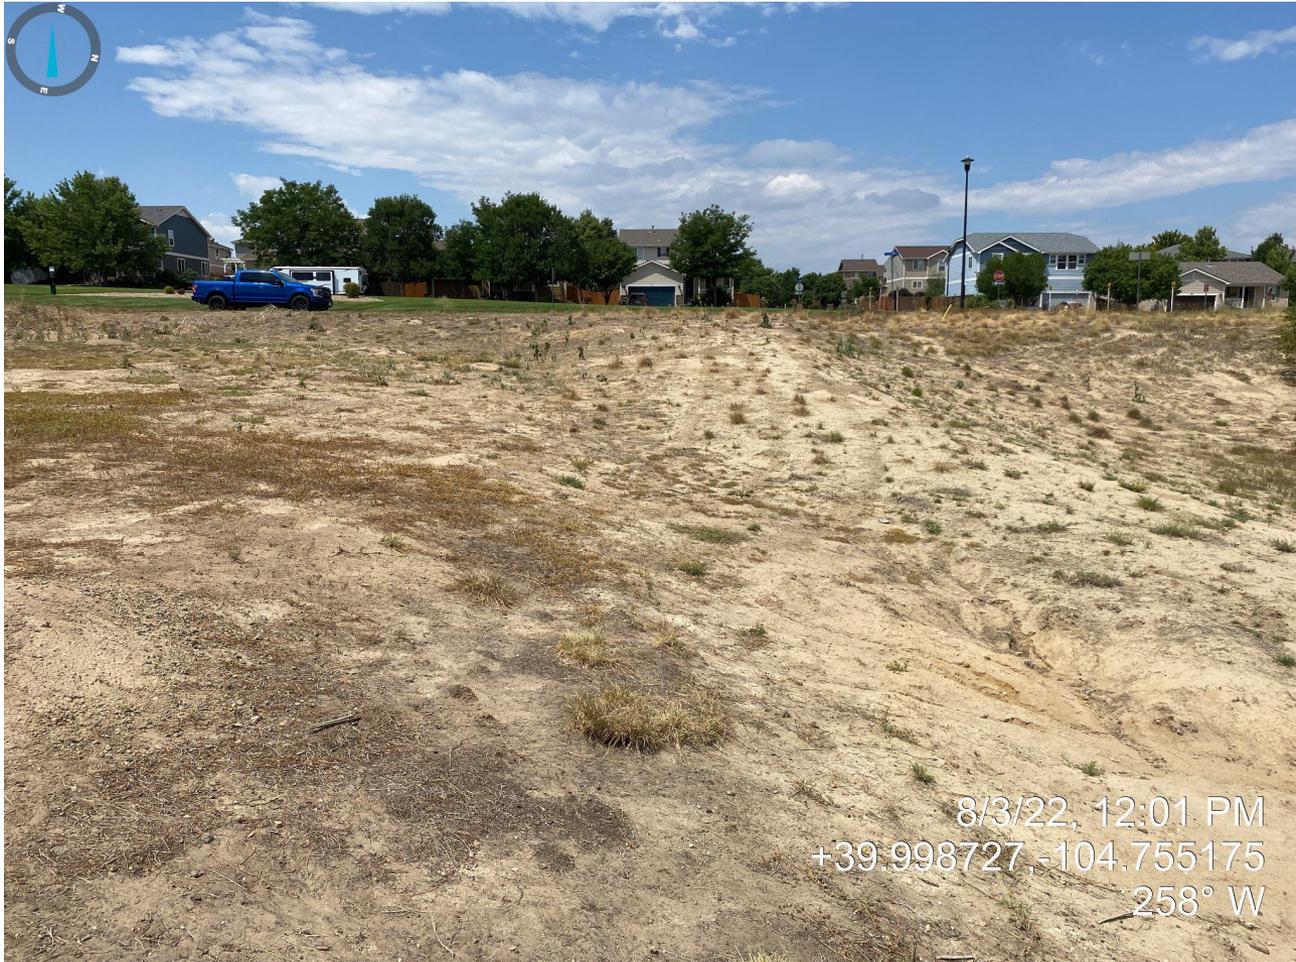
**Photo 2.** Location photo taken from northern portion, facing west. Photo illustrates lack of uniform vegetation cover resulting in bare soil.

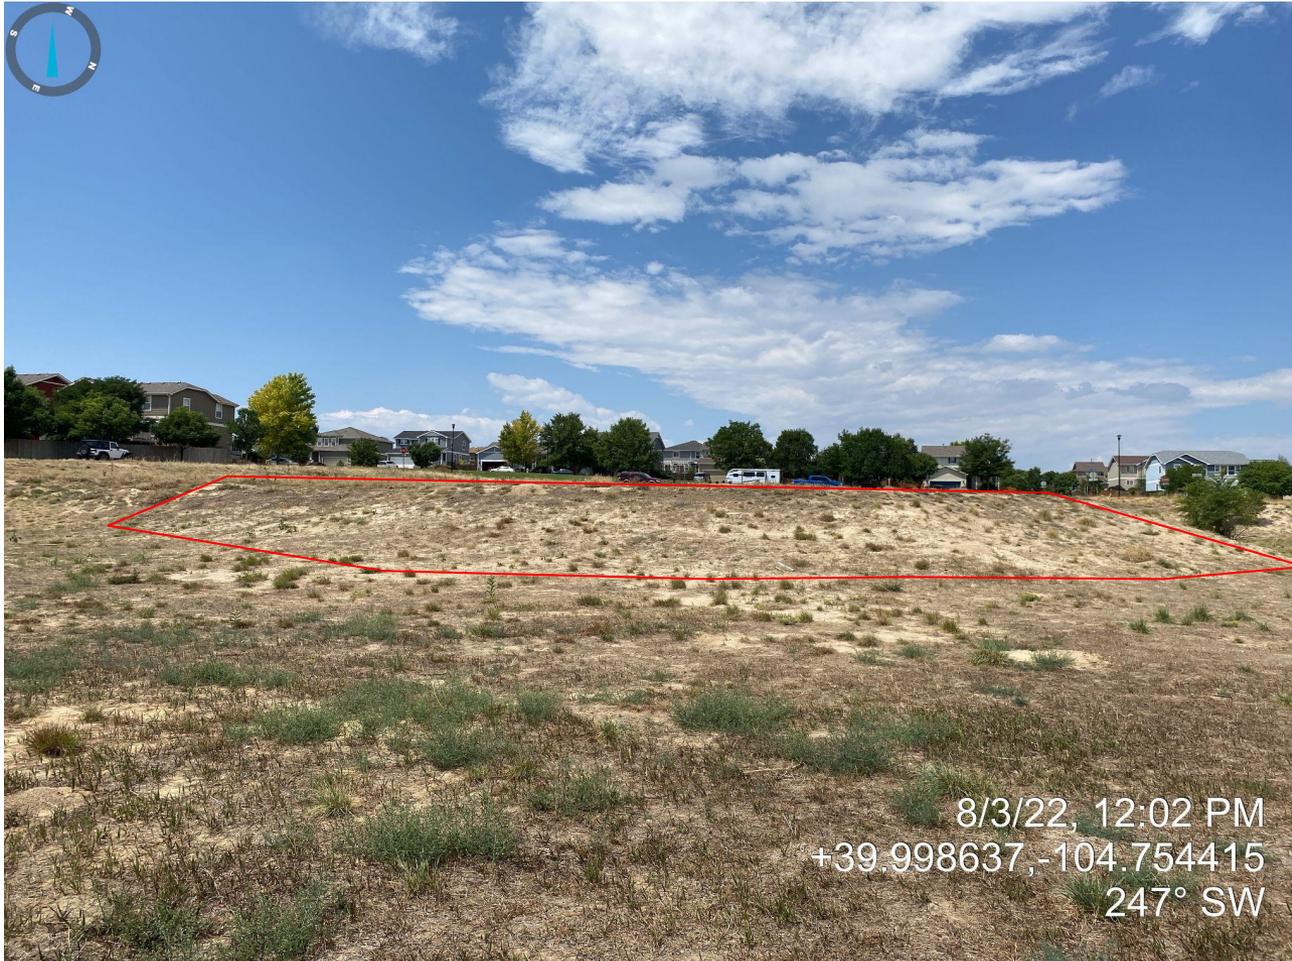
**Photo 3.** Photo taken east of location, facing southwest. Photo illustrates that location (highlighted in red) and access road have not been reclaimed (e.g. not regraded or recontoured).

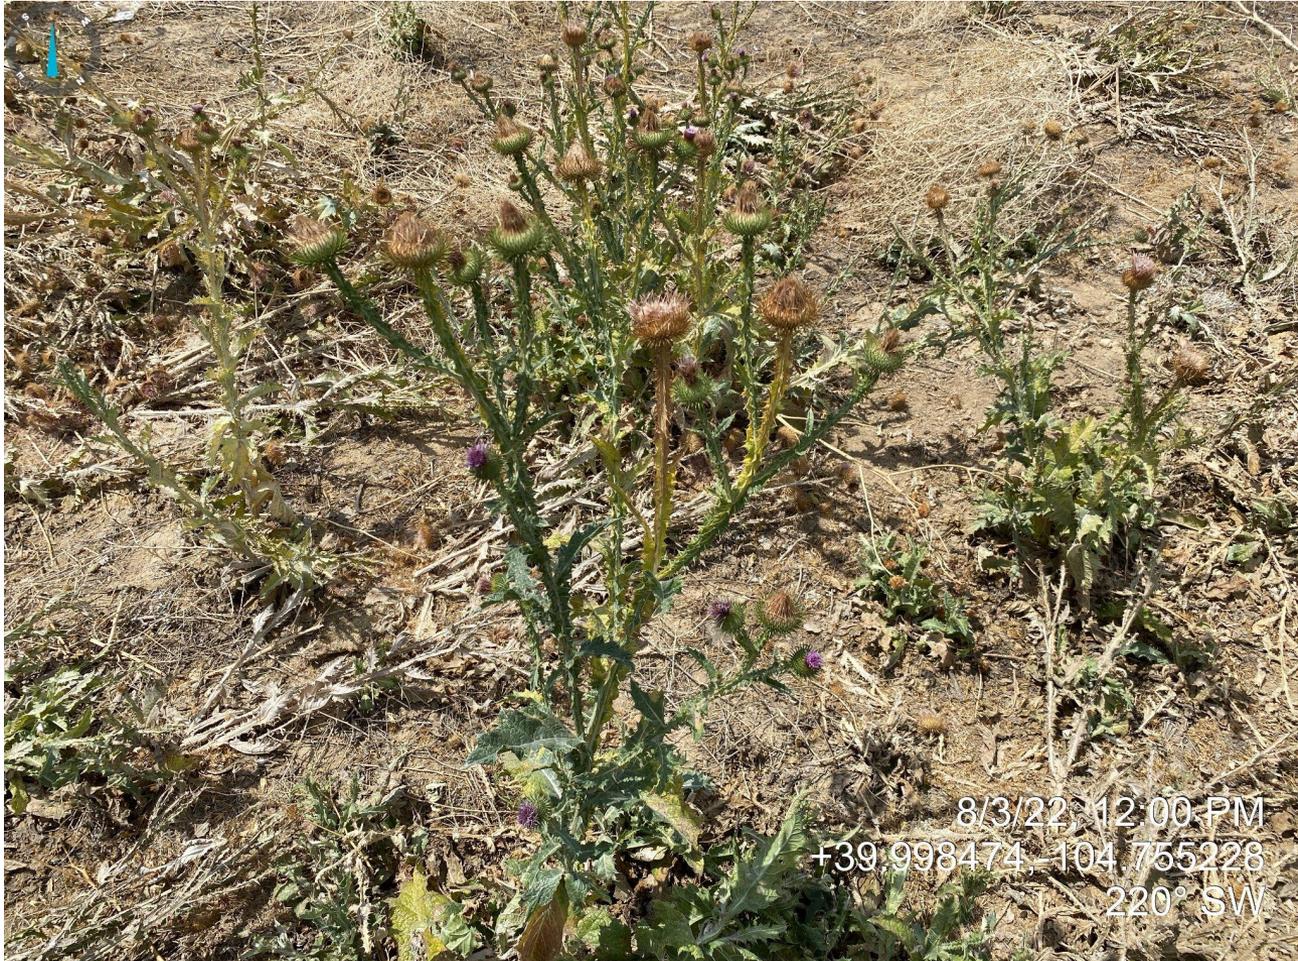
**Photo 4.** Photo illustrates scotch thistle (CO List B noxious weed) found throughout location.
