Inspection Photos

API: 071-07517

Operator: EVERGREEN NATURAL RESOURCES

Inspection Date: 8/23/2022

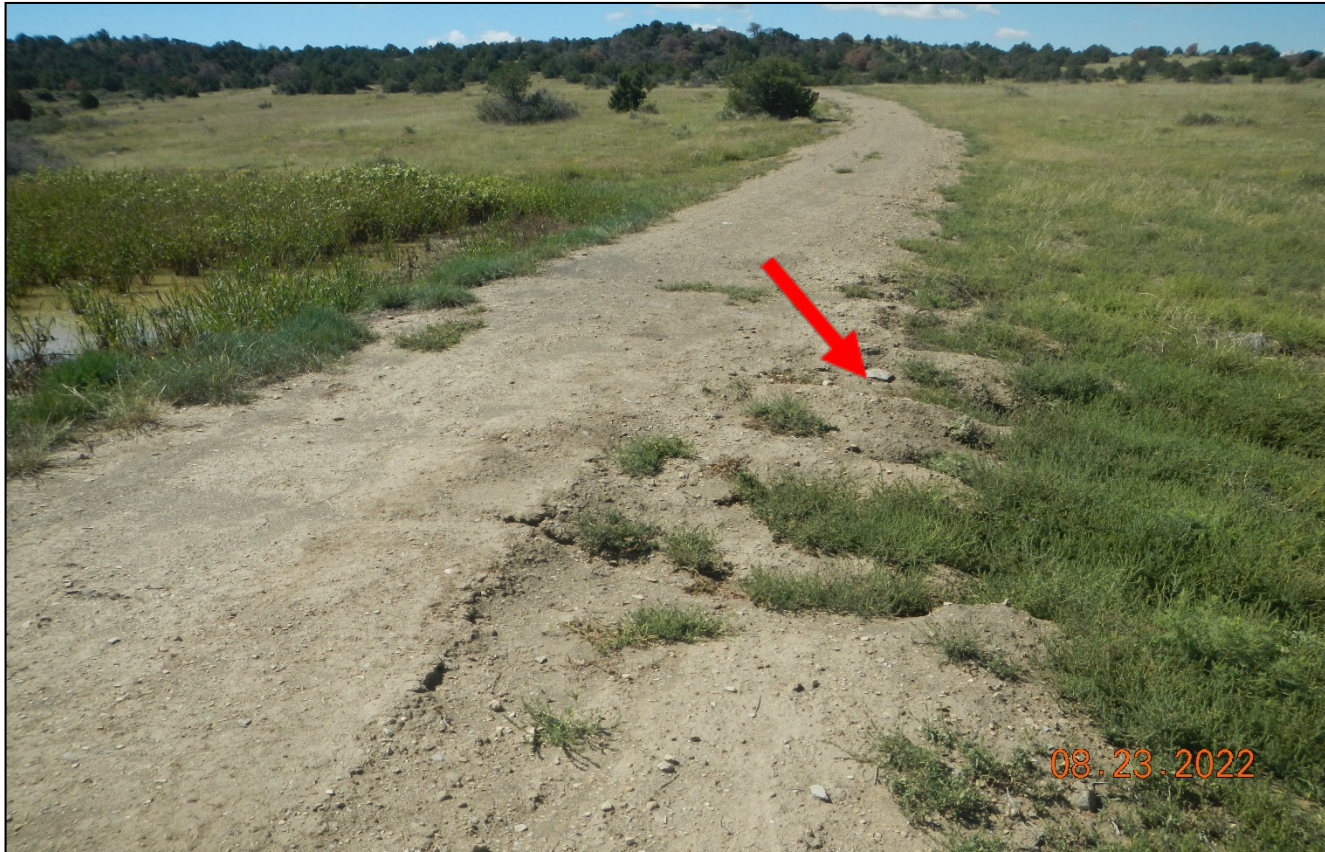
Photo 1. Facing southwest along the access road. There is erosion occurring along the road in this area at the drainage crossing. This area needs to be stabilized.
Lat/Long: 37.35863, -104.53832.

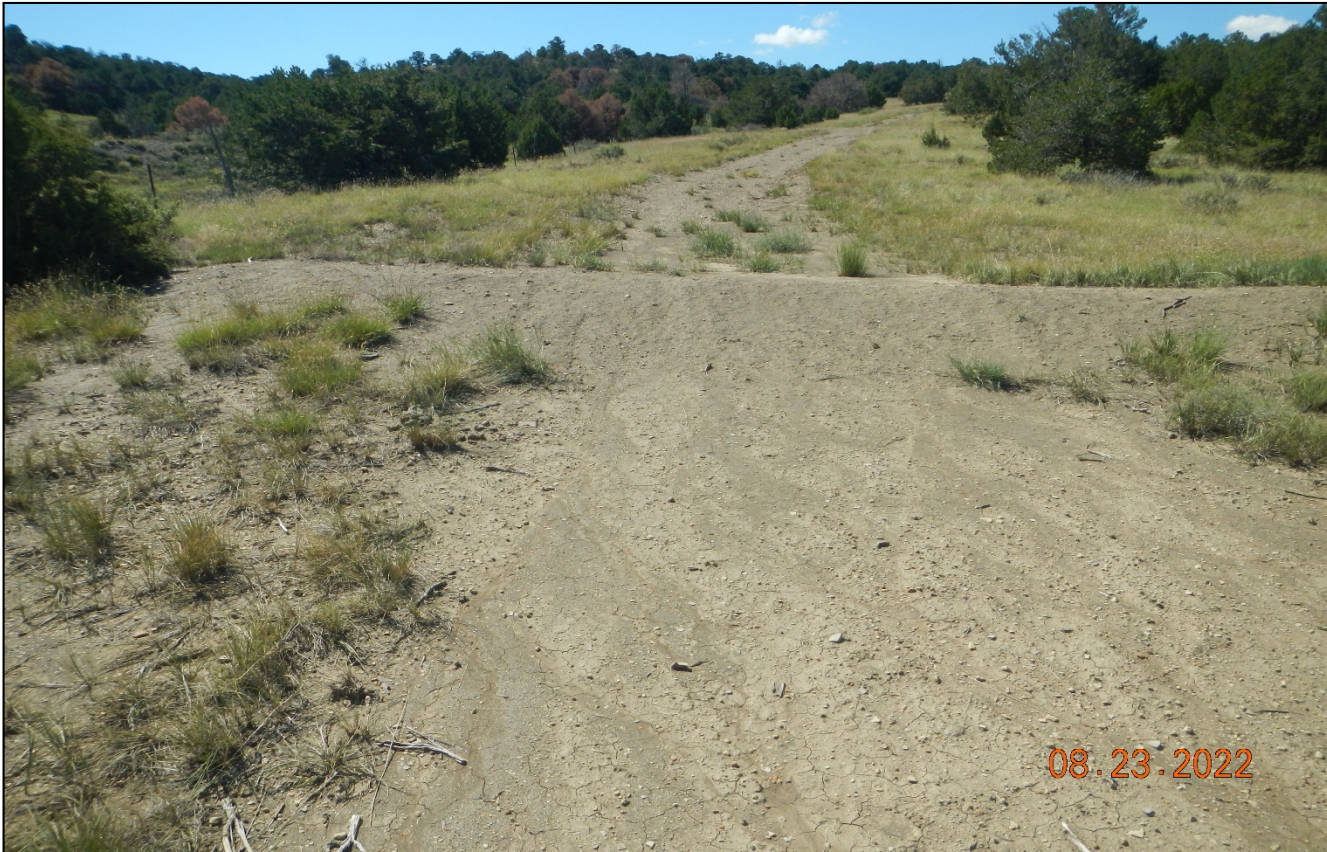
Photo 2. Facing south along the access road. There are multiple berms installed along the road.

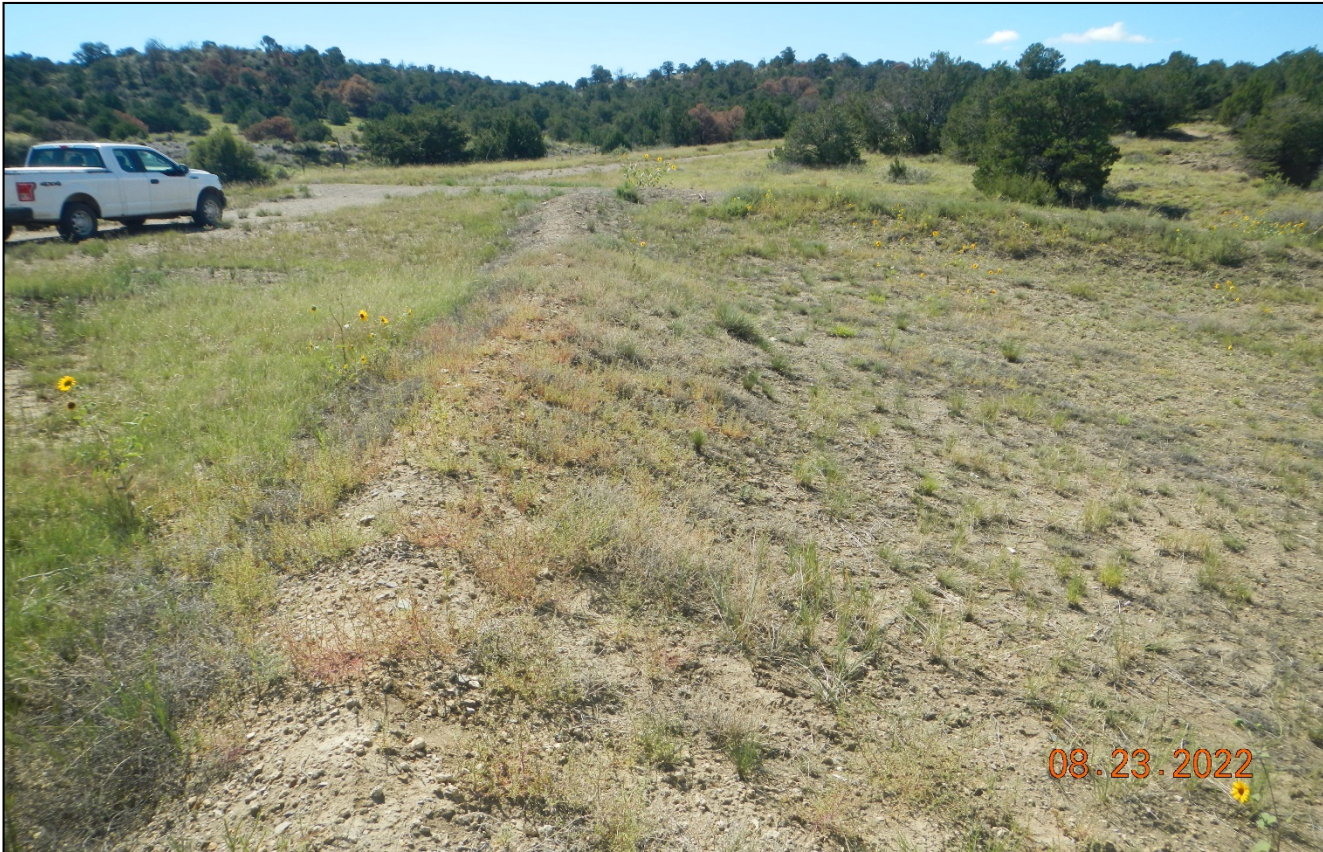
Photo 3. Facing southeast toward the reclaimed area and berm which extends out from the road. Vegetation is progressing in this area.

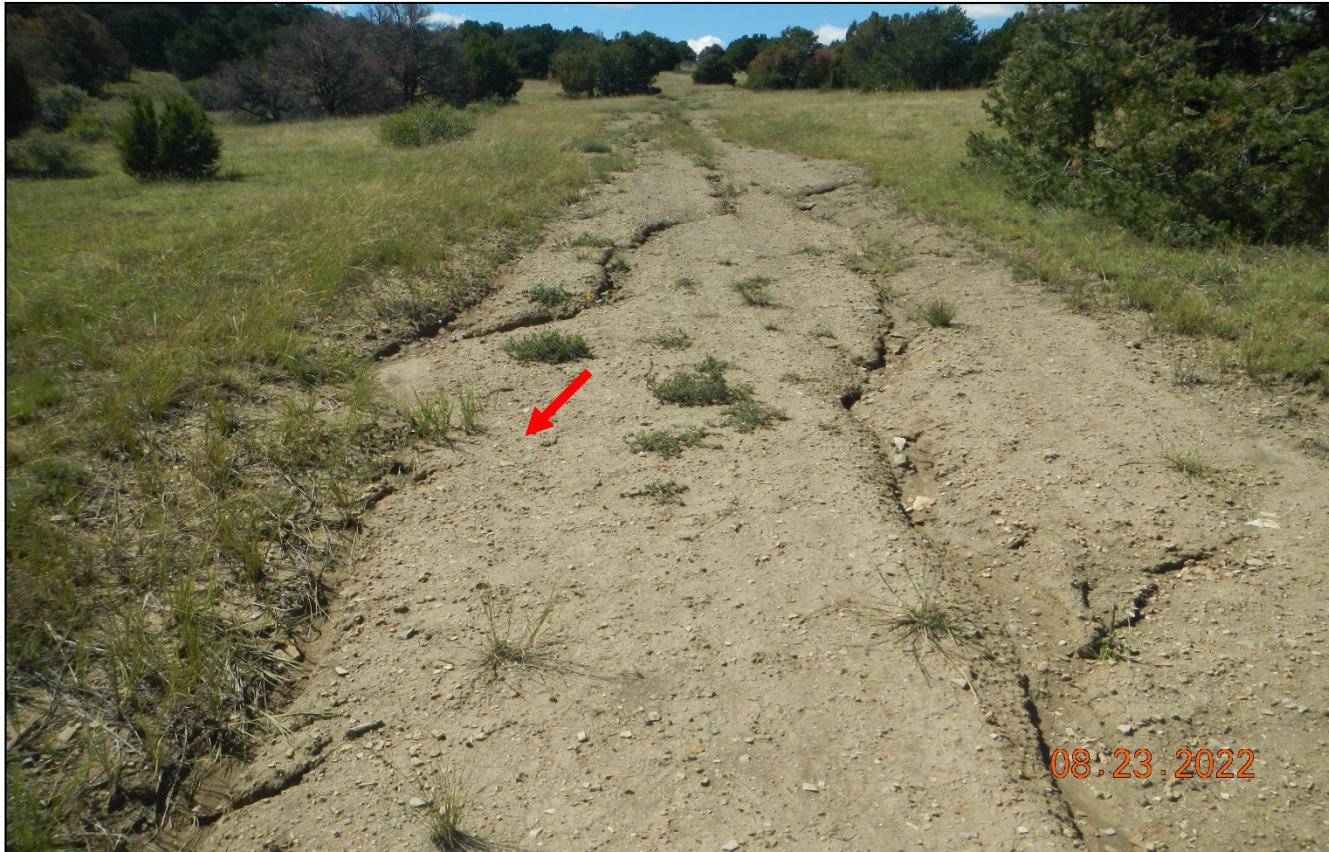
Photo 4. Facing southwest further along the access road. There is erosion occurring along the road in this area.

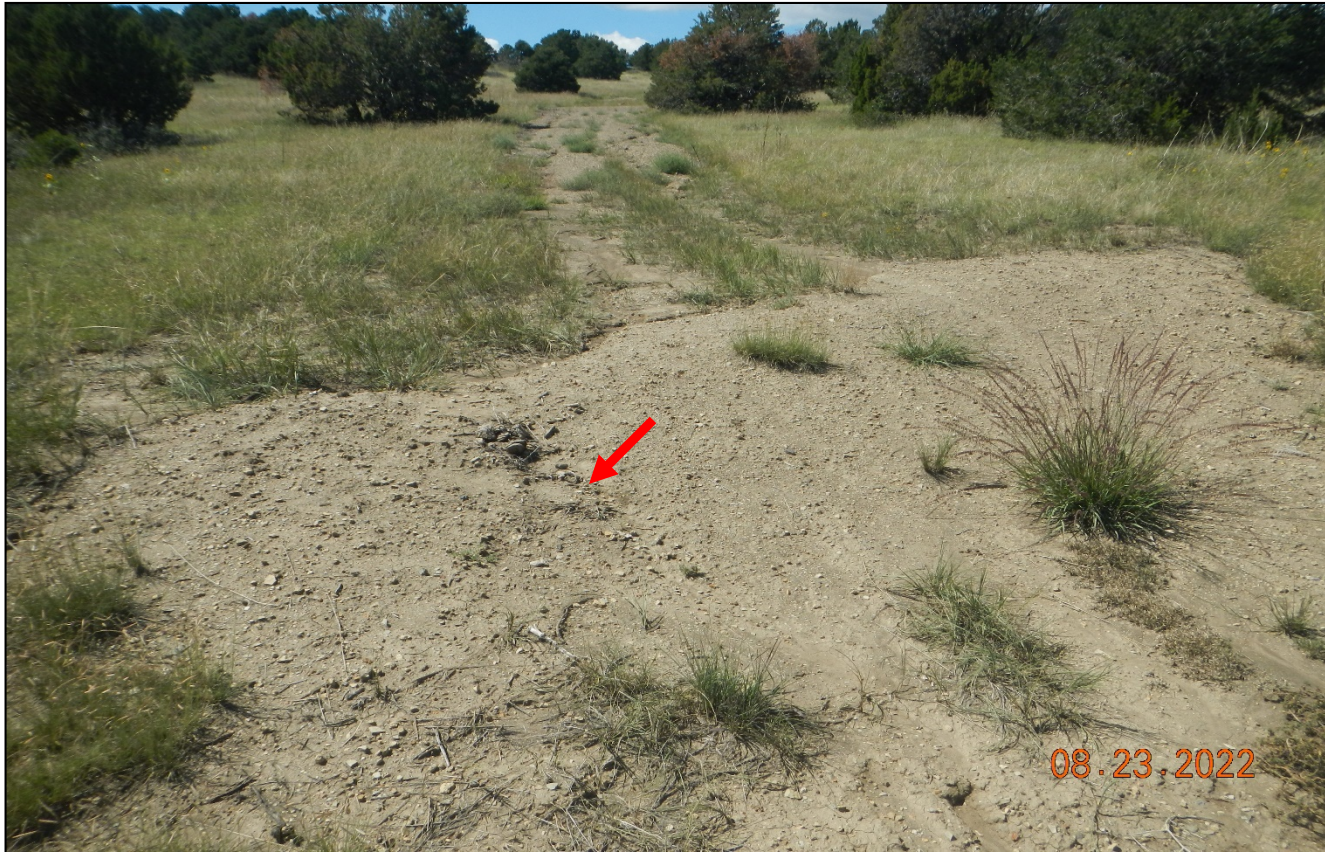
Photo 6. The water bar berm in this area needs maintenance. Stormwater is overtopping the berm causing the erosion shown in the previous photos.

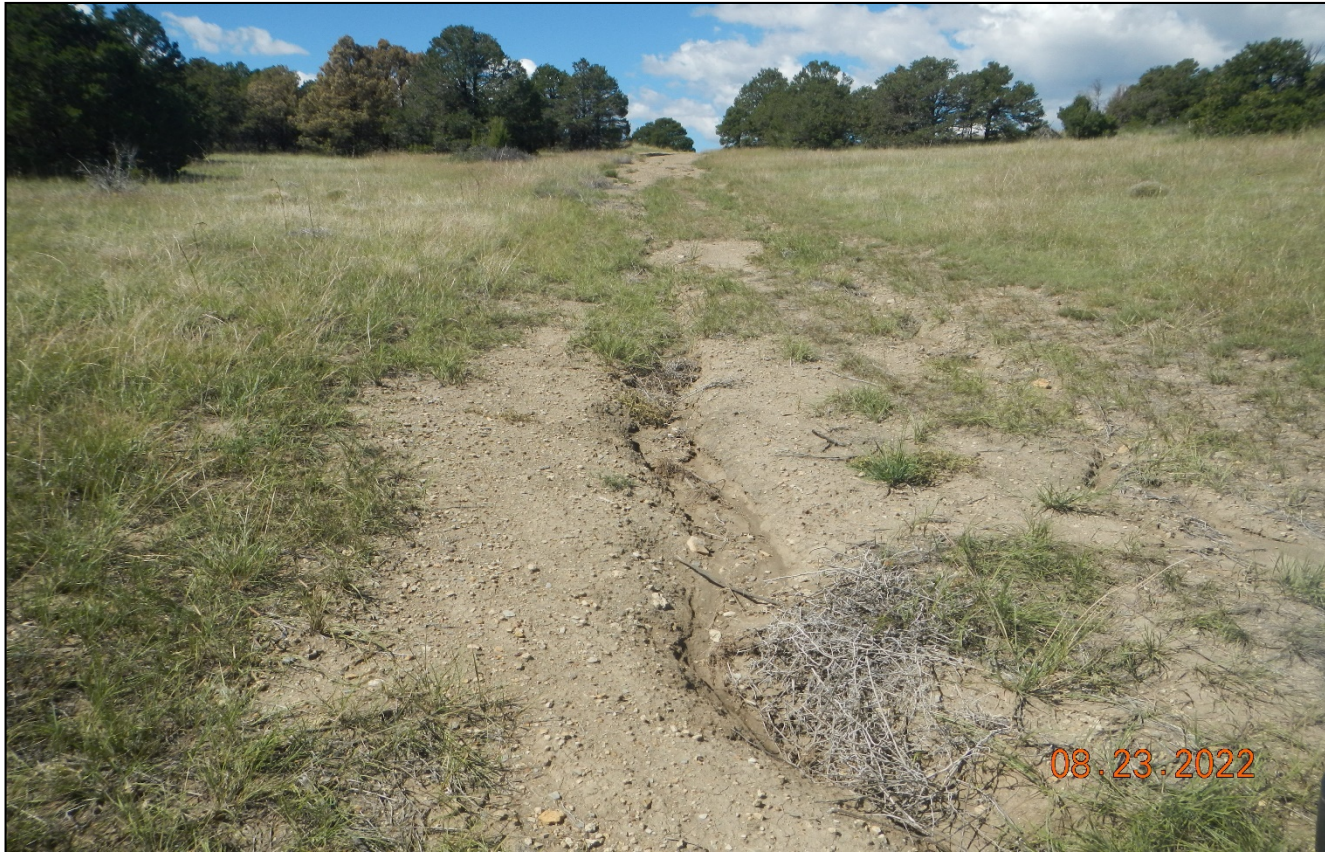
Photo 6. Facing southwest along the access road ascending toward the location. There is erosion in this area that needs to be repaired preferably without disturbing existing vegetation. The water bar further up needs maintenance.

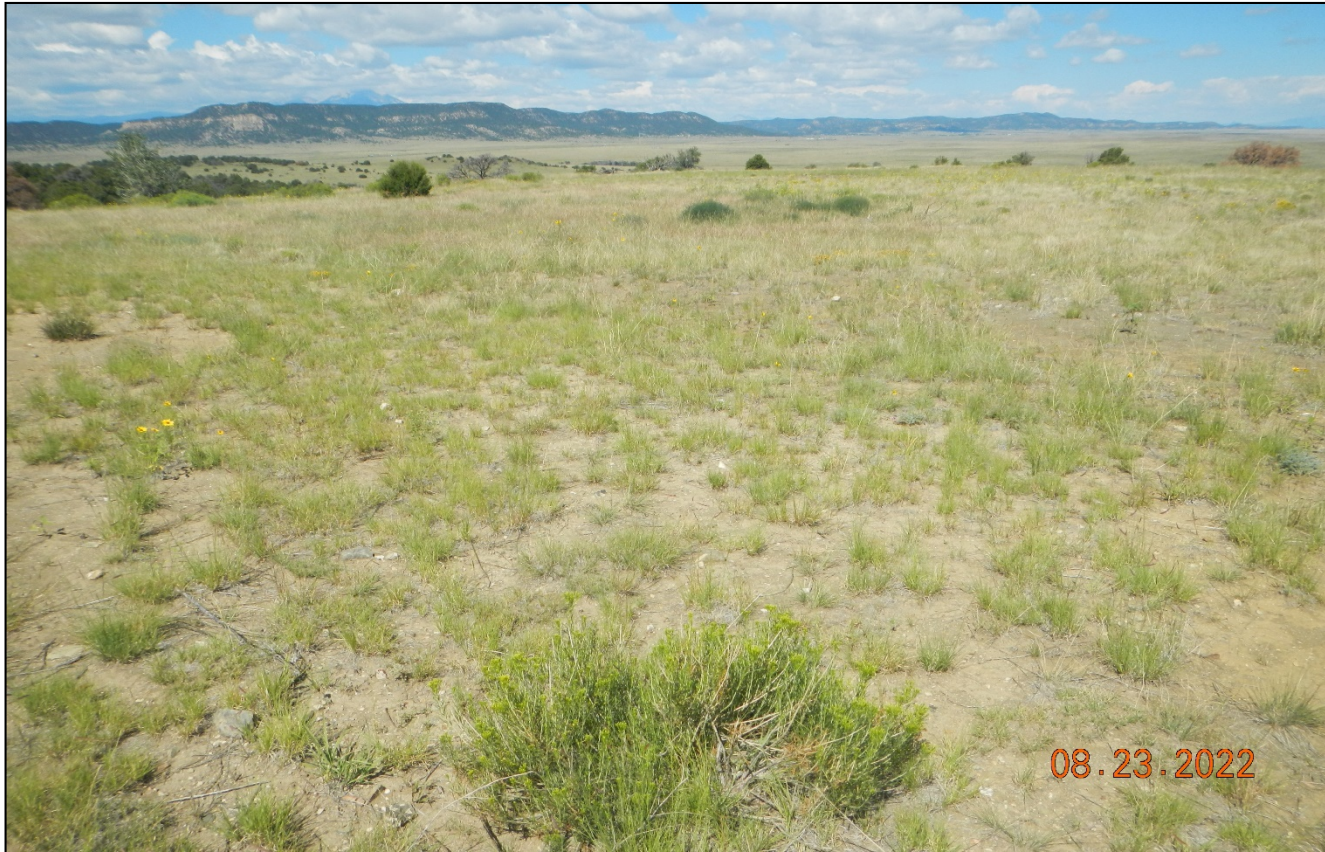
Photo 7. Facing northwest toward the location. The perennial vegetation is progressing throughout the location.
