# Final Reclamation and Stormwater Inspection

Operator: KERR MCGEE OIL & GAS ONSHORE LP - 47120

Location ID: 319675

Inspection Photos  
Location Name: STATE OF COLORADO Y #1  
Location ID: 319675

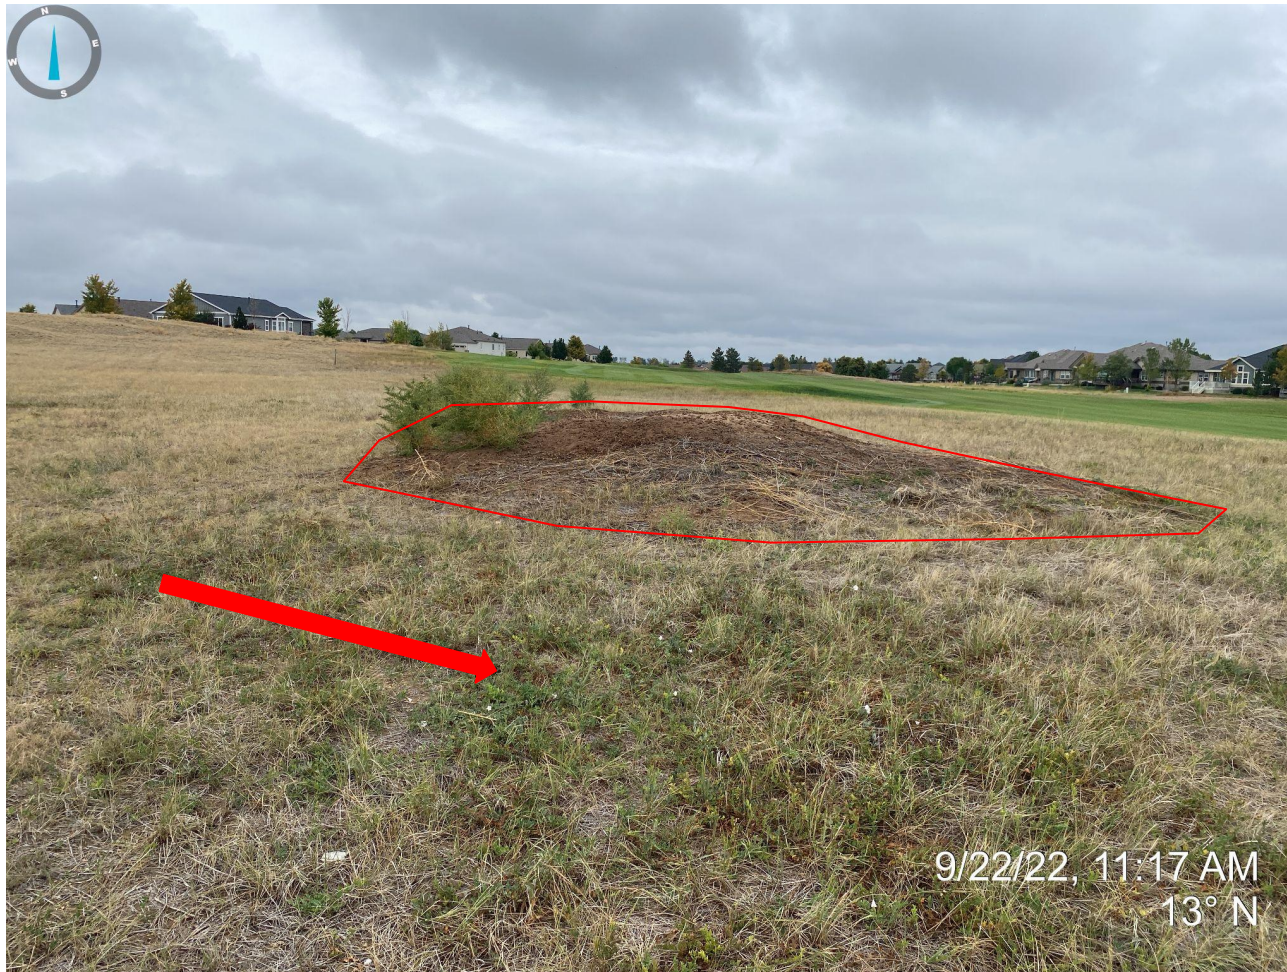
**Photo 1.** Taken south of location, facing north. Photo illustrates soil stockpile placed on top of former location (outlined in red); the soil is slowing the progression towards final reclamation passing. Red arrow indicates Colorado List C Noxious Weed, field bindweed.

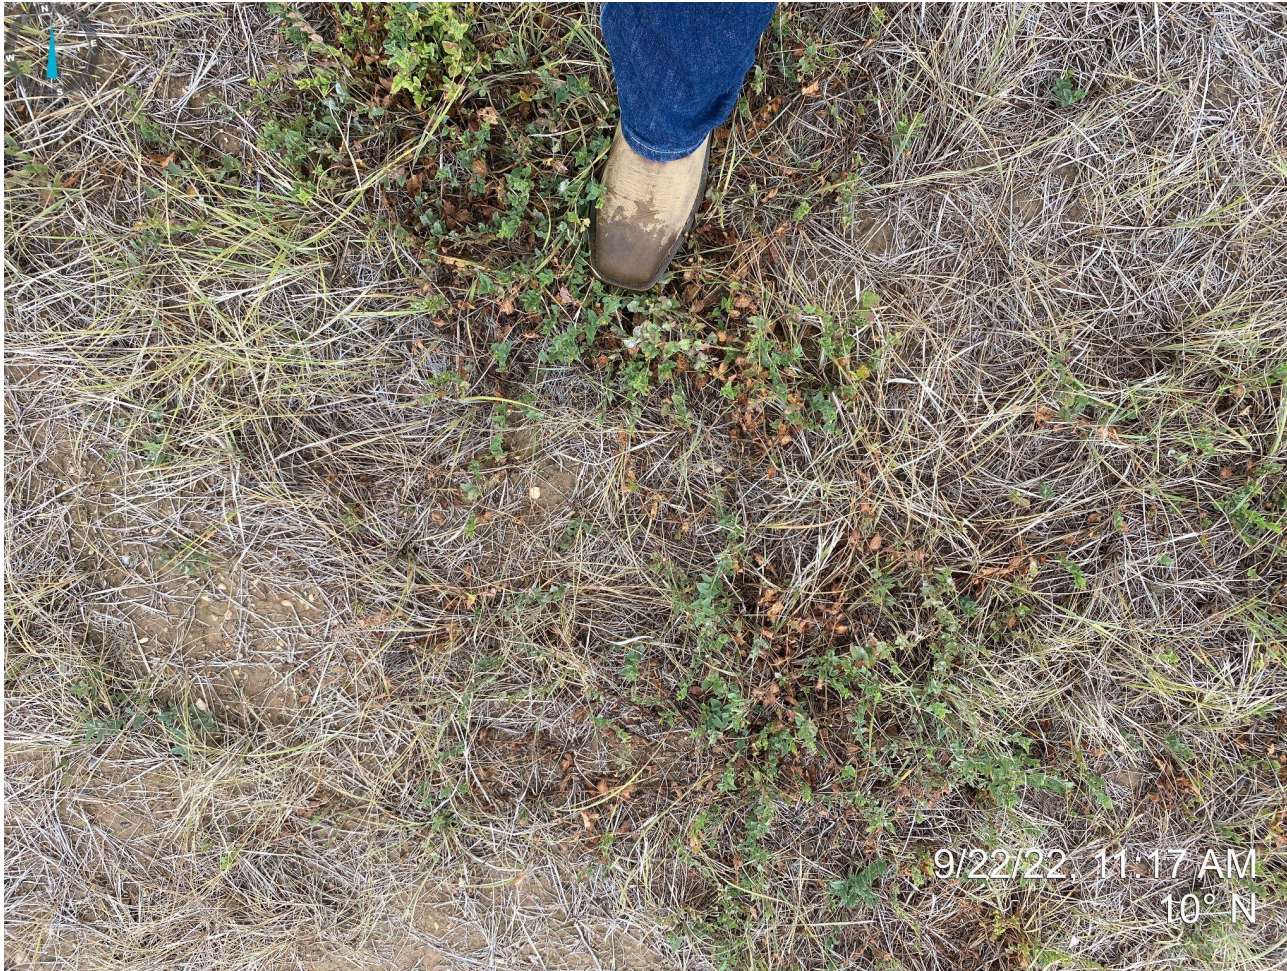
**Photo 2.** Close up photo of Field Bindweed.

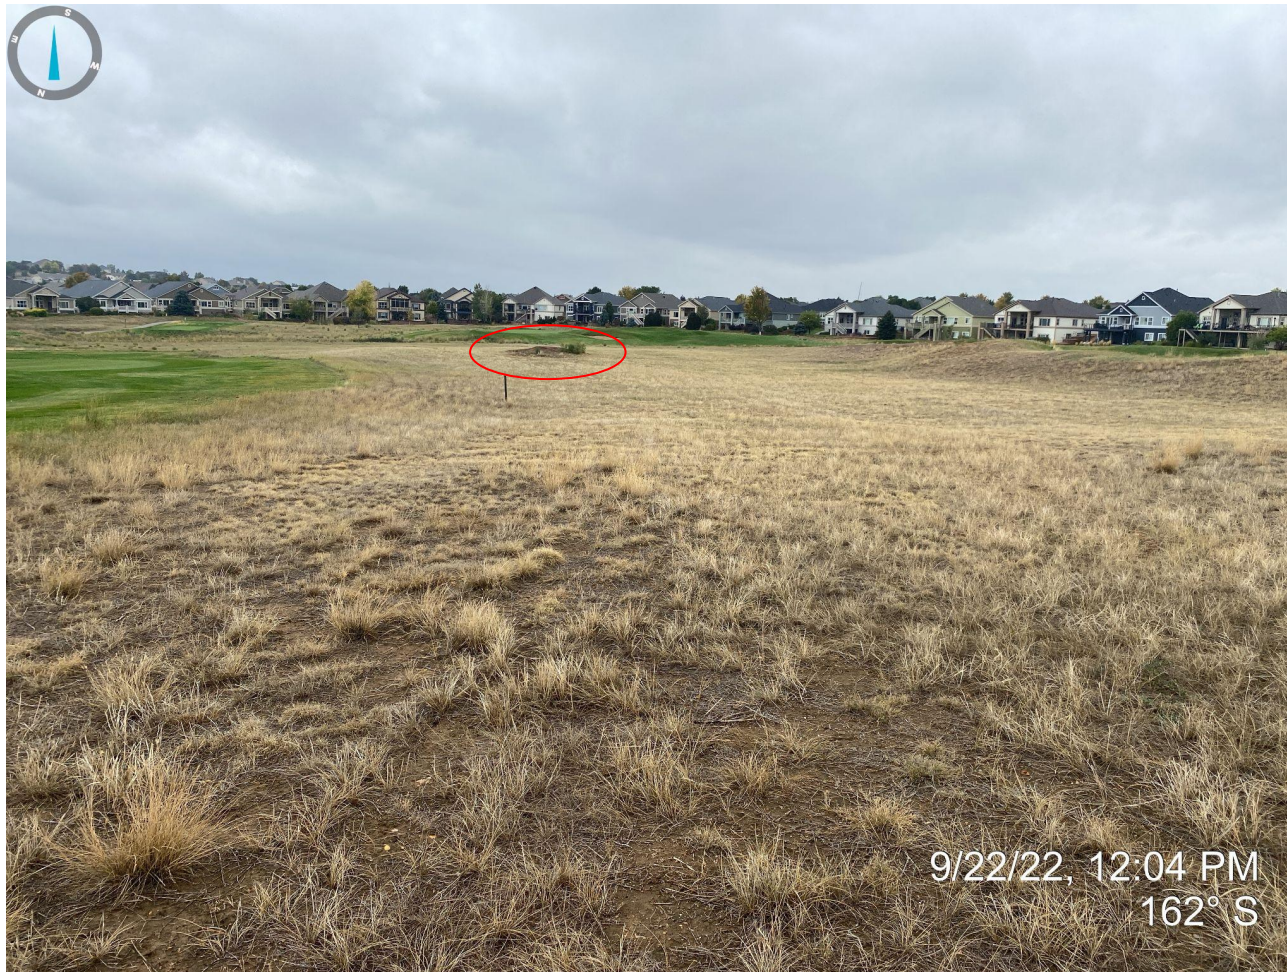
**Photo 3.** Taken north of location, facing south. Soil stockpile outlined in red. Photo illustrates former access road has been reclaimed with uniform vegetation cover and contoured/graded to reflect reference areas.
