Response to: MACKINAW 12-28/KING 12-28 API #: 043-06201, 06211; FIR Doc#:695106751

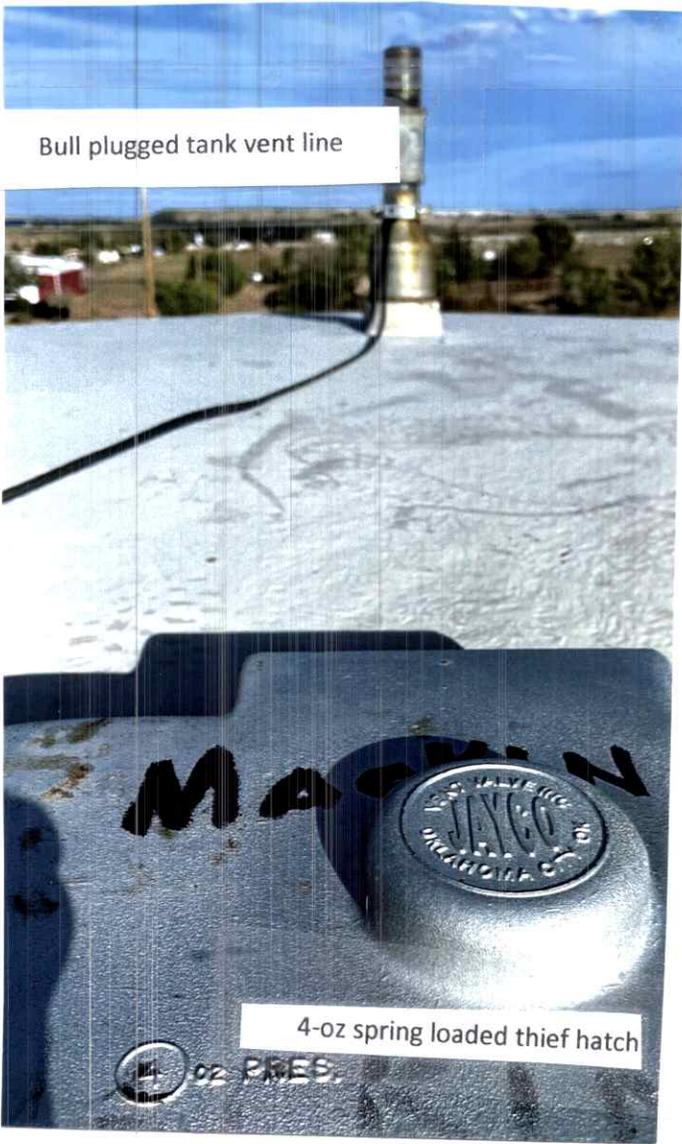
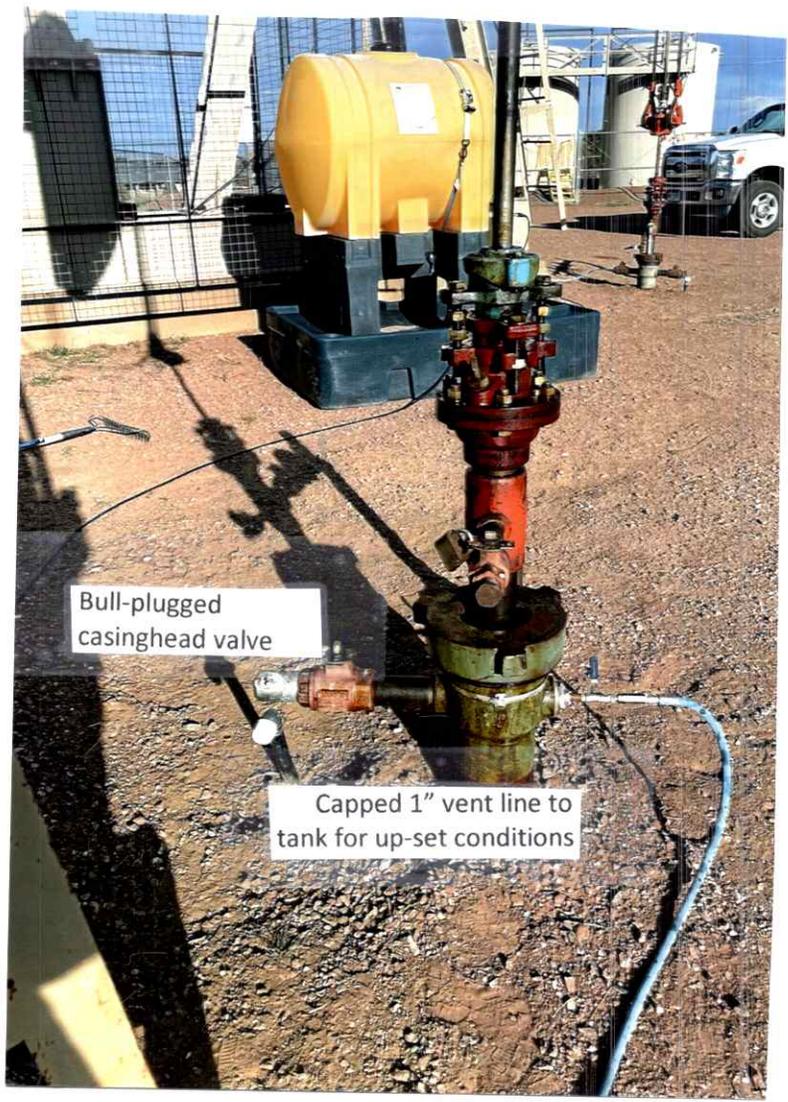
Gas being vented or flared during non-upset condition without prior approval from COGCC. **THIS INSPECTION DUE TO COMPLAINT DOC #403164238, IN REFERENCE TO APPEARANCE OF VENTING.** CA: Immediately cease venting/flaring. PER RULE 903. Contacted Liz Harkins appearance of continuous venting out of the 2" on top of both tanks. It appears that the backside is plumbed to tank battery with a buried 1" line. At time of inspection the 1" line is closed.

-Upon phone notification by COGCC Field Inspector Tom Beardslee, Operator immediately dispatched crew to investigate suspect venting out of tank (casinghead valve plumbed to 1" upset condition vent line to tank was supposed to be in closed position). Crew advised that ball valve was leaking and took immediate action to bull plug valve and also capped 1" vent line at inlet and outlet; Also bull plugged vent stack on top of tank.

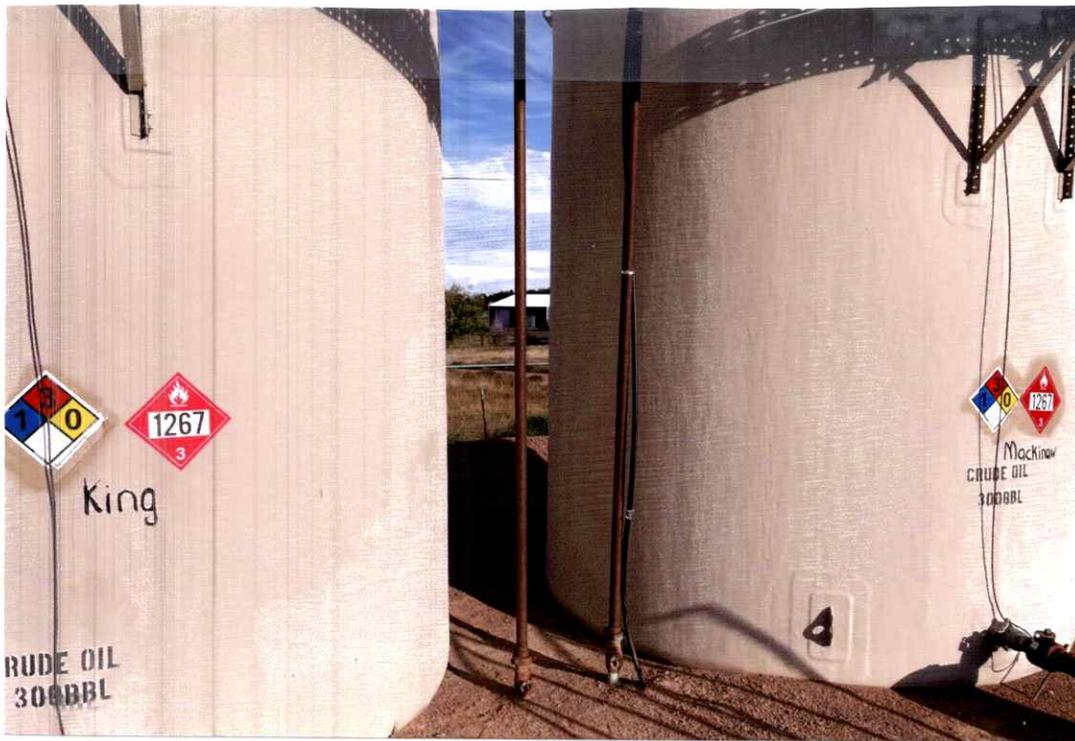
Tank labels (NFPA, Capacity, Contents). CA: Install sign to comply with Rule 605.h.
-Crew replaced worn placards and identified well names.

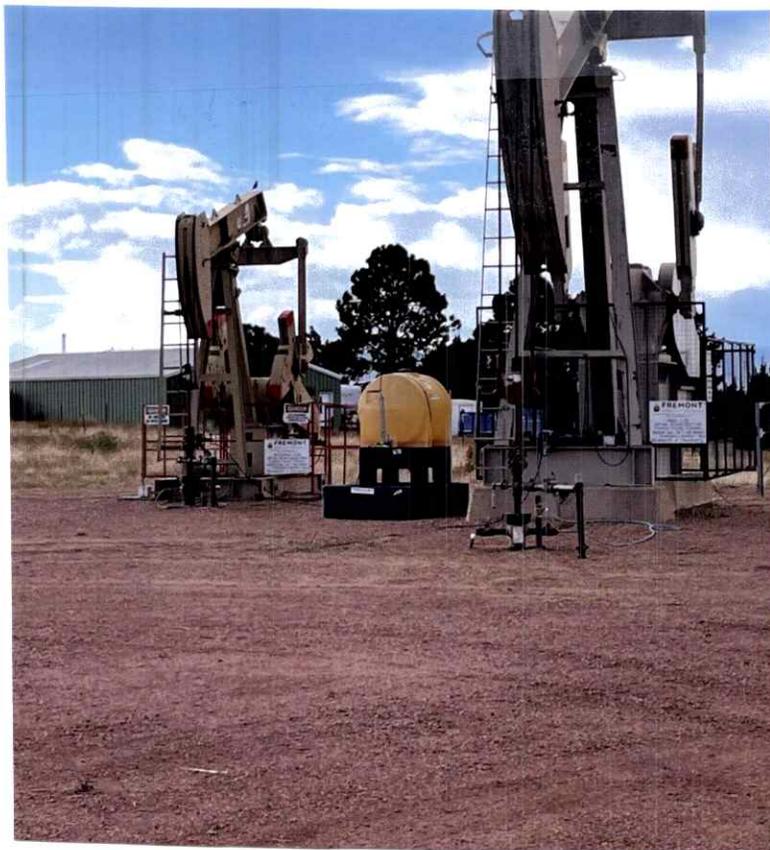
Unused equipment stored on location. CA: Remove unused equipment per Rule 606.
-Removed 28 damaged rods on ground that had been retrieved during a rod-part repair.
