# Inspection Photos and Issue Report

Operator: GORDON ENGINEERING INC -  
34720

Location #334074  
Mesa County, CO

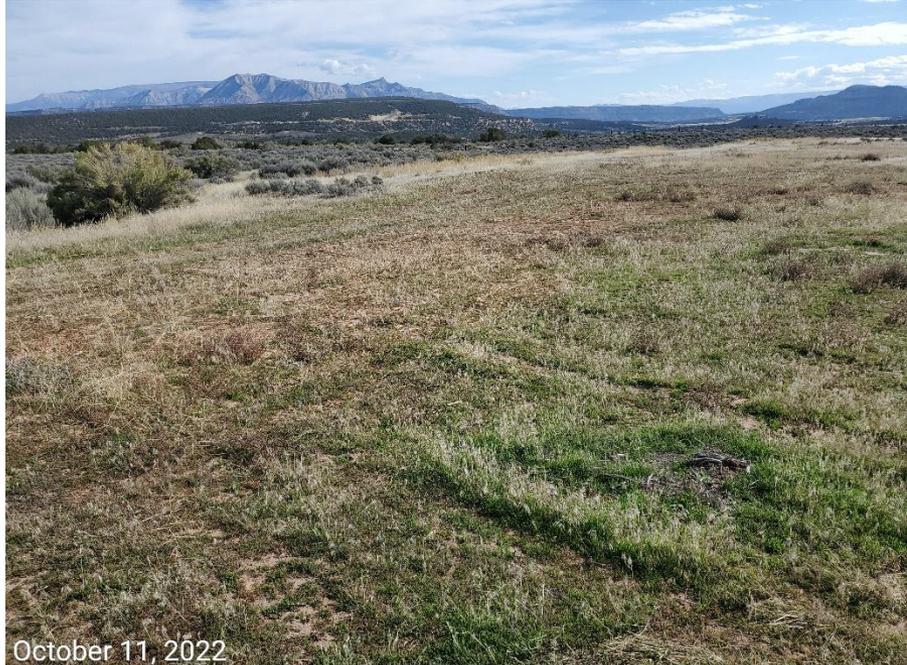
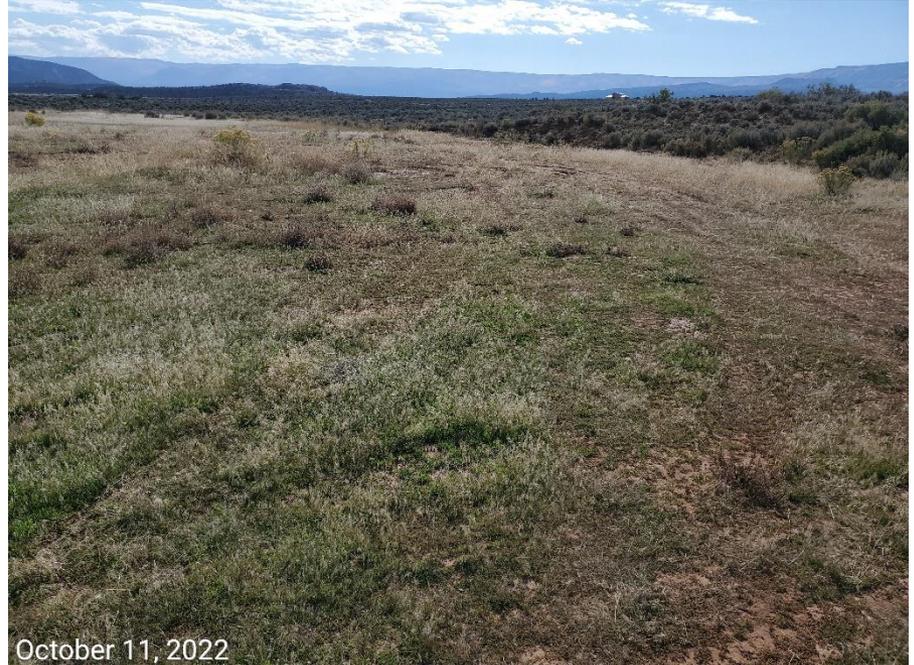
**Photo 1:** Photos taken from the west end of the Location, facing northwest and southeast. Location and access road has not been reclaimed per 1004 Rules including, but not limited to, compaction alleviation (cross ripping to a minimum depth of 18 inches), contouring/regrading, replacement of soils and revegetation activities. Vegetation observed in photo is predominantly Undesirable Weedy Plant Species such as cheatgrass.

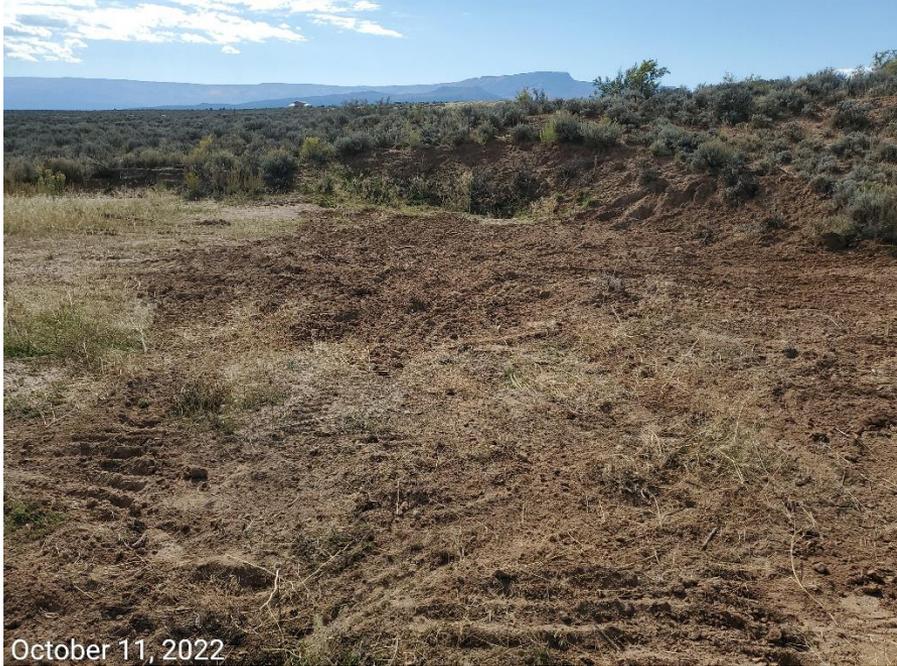
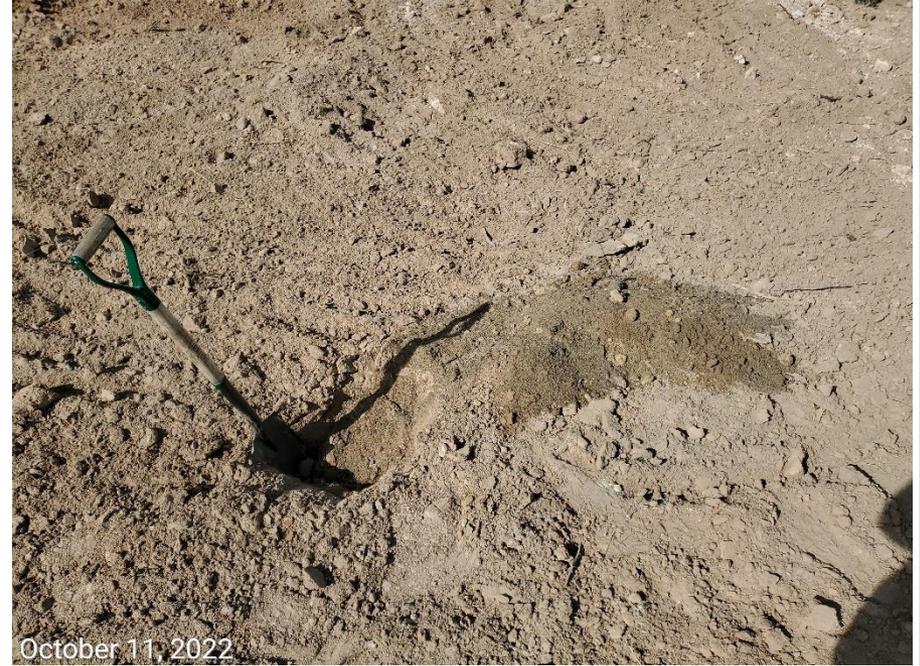
**Photo 2:** Photos taken from the south end of the Location. Photos show Operator appears to have removed the cement blocks buried on site, however, Operator appears to have backfilled using sand post excavation activities. Sand material used is not comparative in quality, composition or agronomic properties to that of the adjacent reference areas.

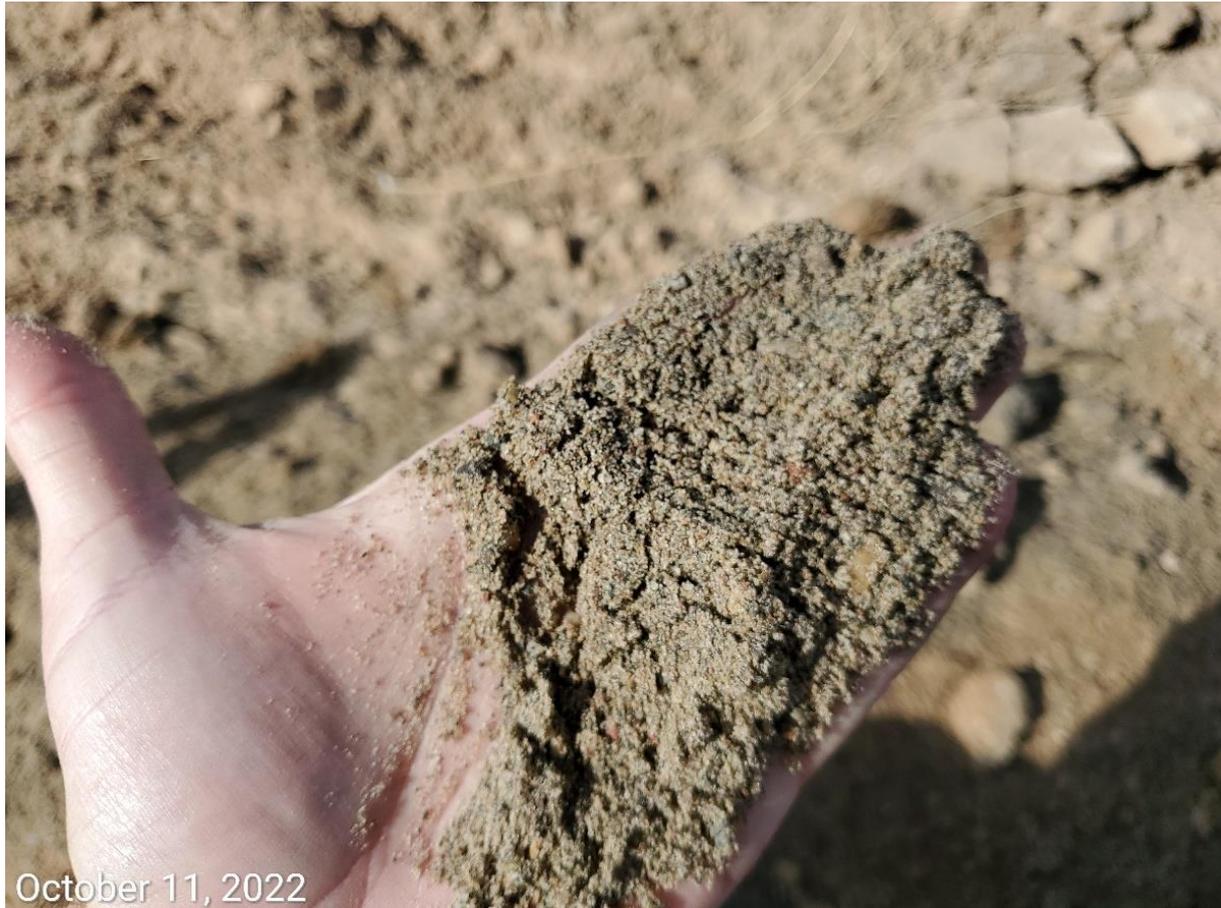
**Photo 3:** Continued from photo 2. Photo shows Operator appears to have backfilled using sand post excavation activities. Sand material used is not comparative in quality, composition or agronomic properties to that of the adjacent reference areas.

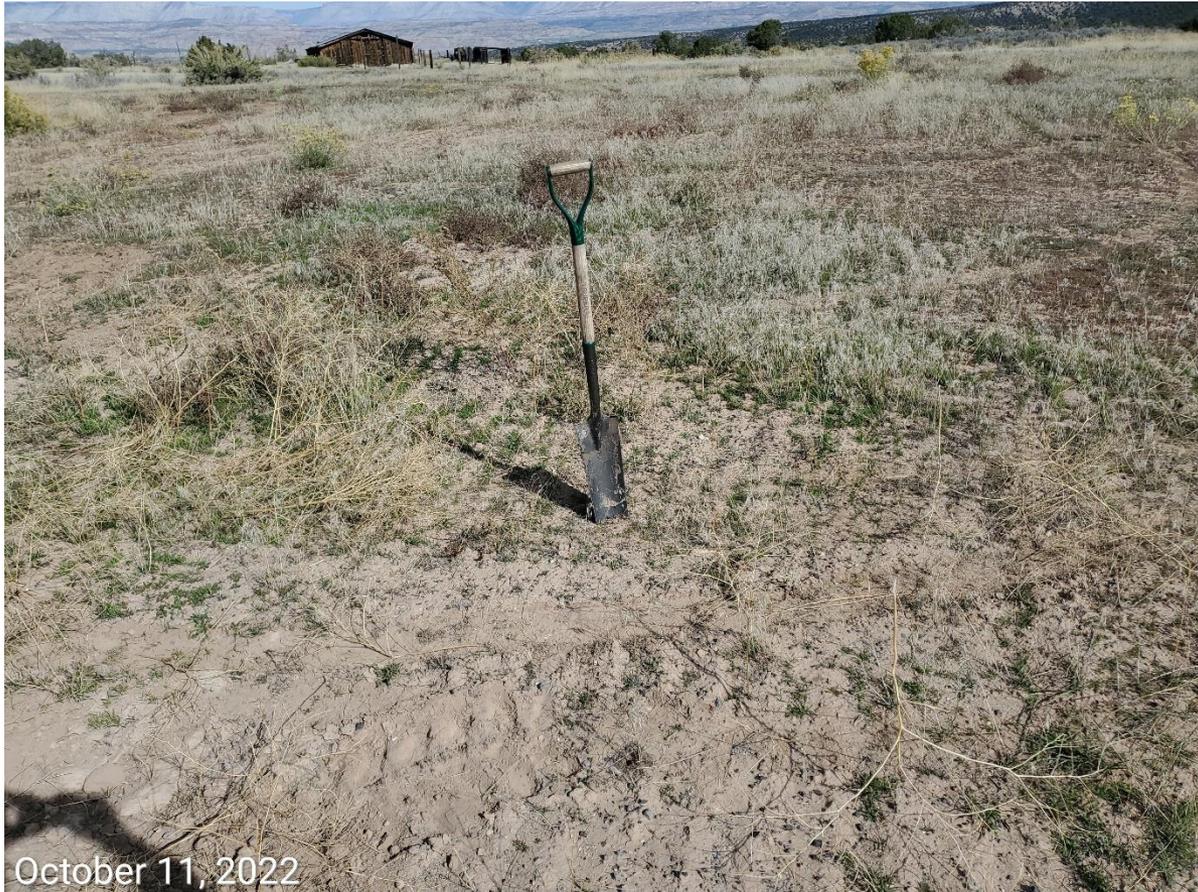
**Photo 4:** Reclamation Specialist attempted to conduct a soil compaction test pit on the Location. Photo shows compaction issues exist beginning at the soil surface; compaction alleviation has not been conducted on Location.

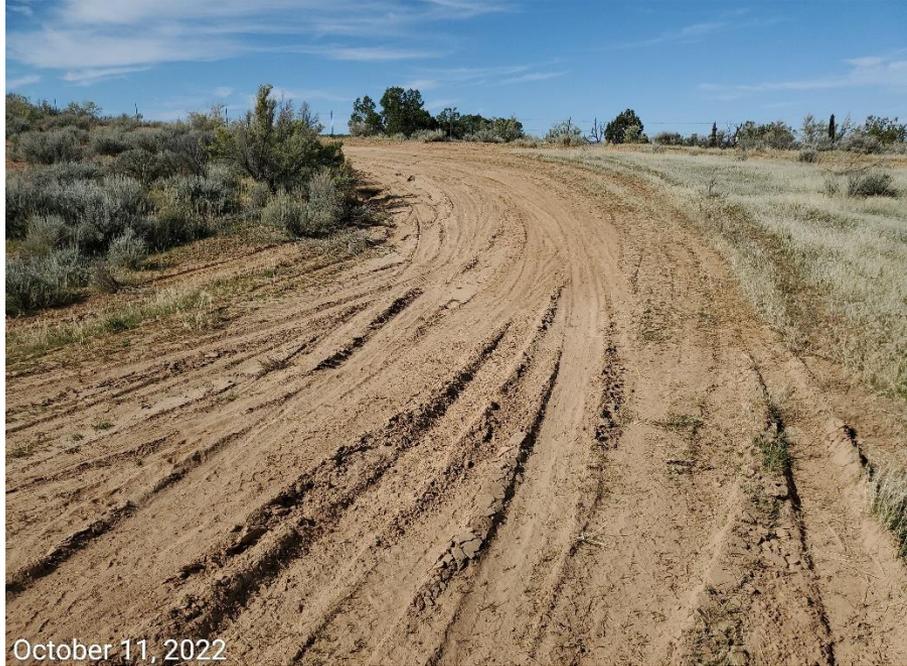
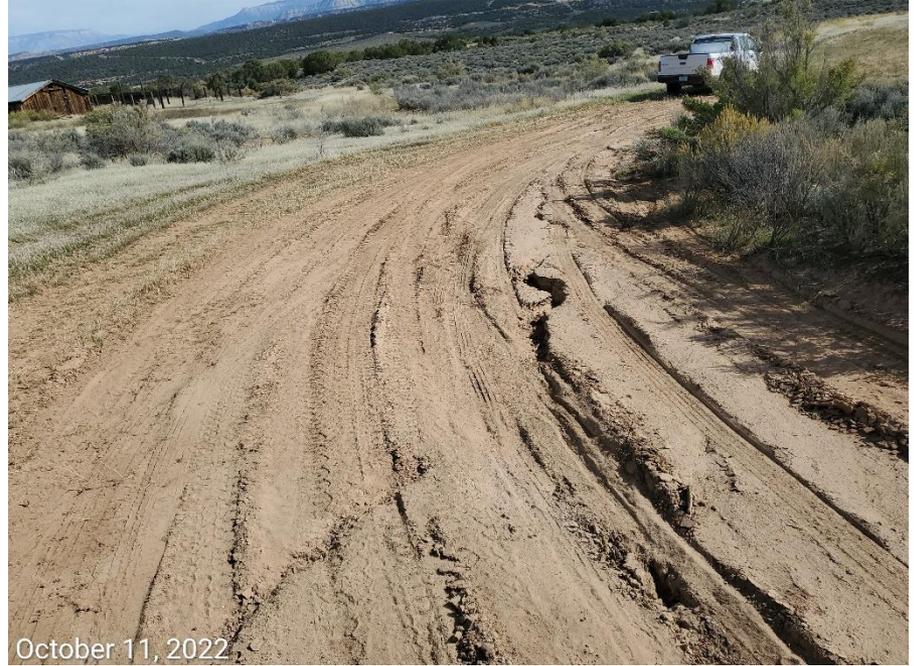
**Photo 5:** Photo shows access road spur has not been reclaimed.
