ATTACHMENT B

SITE NAME: Wacker 10G-302 Wellhead							DATE: 7/18/2022	REM. PROJECT #:	WEATHER: 100 & sunny
SITE DIRECTIONS: From CR60 and 55.5 travel S.06 Mi, Turn West down dirt drive for approximately 2,000 ft							CLIENT: PDC		
LEGALS AND LAT/LONG: 40.416253, -104.543353							TASMAN PERSONNEL: David vigil		
SOIL TYPES: Clayey Sand							SURFACE GRADIENT: South		
SOIL SAMPLING							FACILITY INFRASTRUCTURE		
Date/Time	Soil Sample ID	PID (ppm)	Visual	Olfactory	Photo?	Grab or Lab Sample?	EQUIPMENT		Quantity
							Above Ground Storage Tank (AST)		
7/18/2022 13:20	SB01 @ 0-6"	0.4	No Staining	No Odor	Yes	Lab	Buried or Partially Buried Vessel		
7/18/2022 13:40	SB02 @ 0-6"	0.0	No Staining	No Odor	Yes	Lab	Separator		
7/18/2022 13:55	SB03 @ 0-6"	0.0	No Staining	No Odor	Yes	Lab	Emission Control Device (ECD)		
7/18/2022 14:05	SB04 @ 0-6"	0.0	No Staining	No Odor	Yes	Lab	Dump Line		
7/18/2022 14:10	SB05 @ 0-6"	0.1	No Staining	No Odor	Yes	Lab	Wellhead		1

Photographic Log

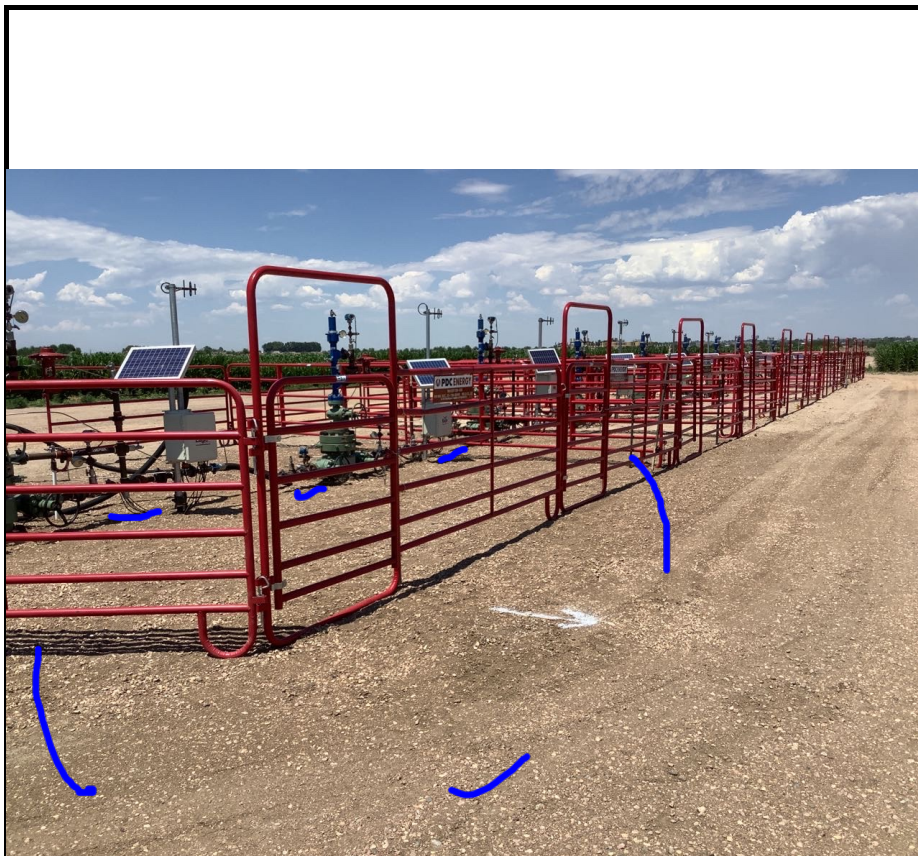
Equipment ID:Site overview

Notes/Conditions:Blue lines indicate estimated release extent. White arrow indicates direction of release/spray.
