BNL (ENTERPRISE) INC.
BBB 33 SESE 2860
SEC 33 T28S R60W (SE/4 SE/4)
LAS ANIMAS COUNTY, CO
GEOLOGIC HAZARDS

BNL (Enterprise) Inc.
BBB 33 SESE 2860
Sec. 33 T28S R54W (SE/4 SE/4)
Las Animas County, Colorado

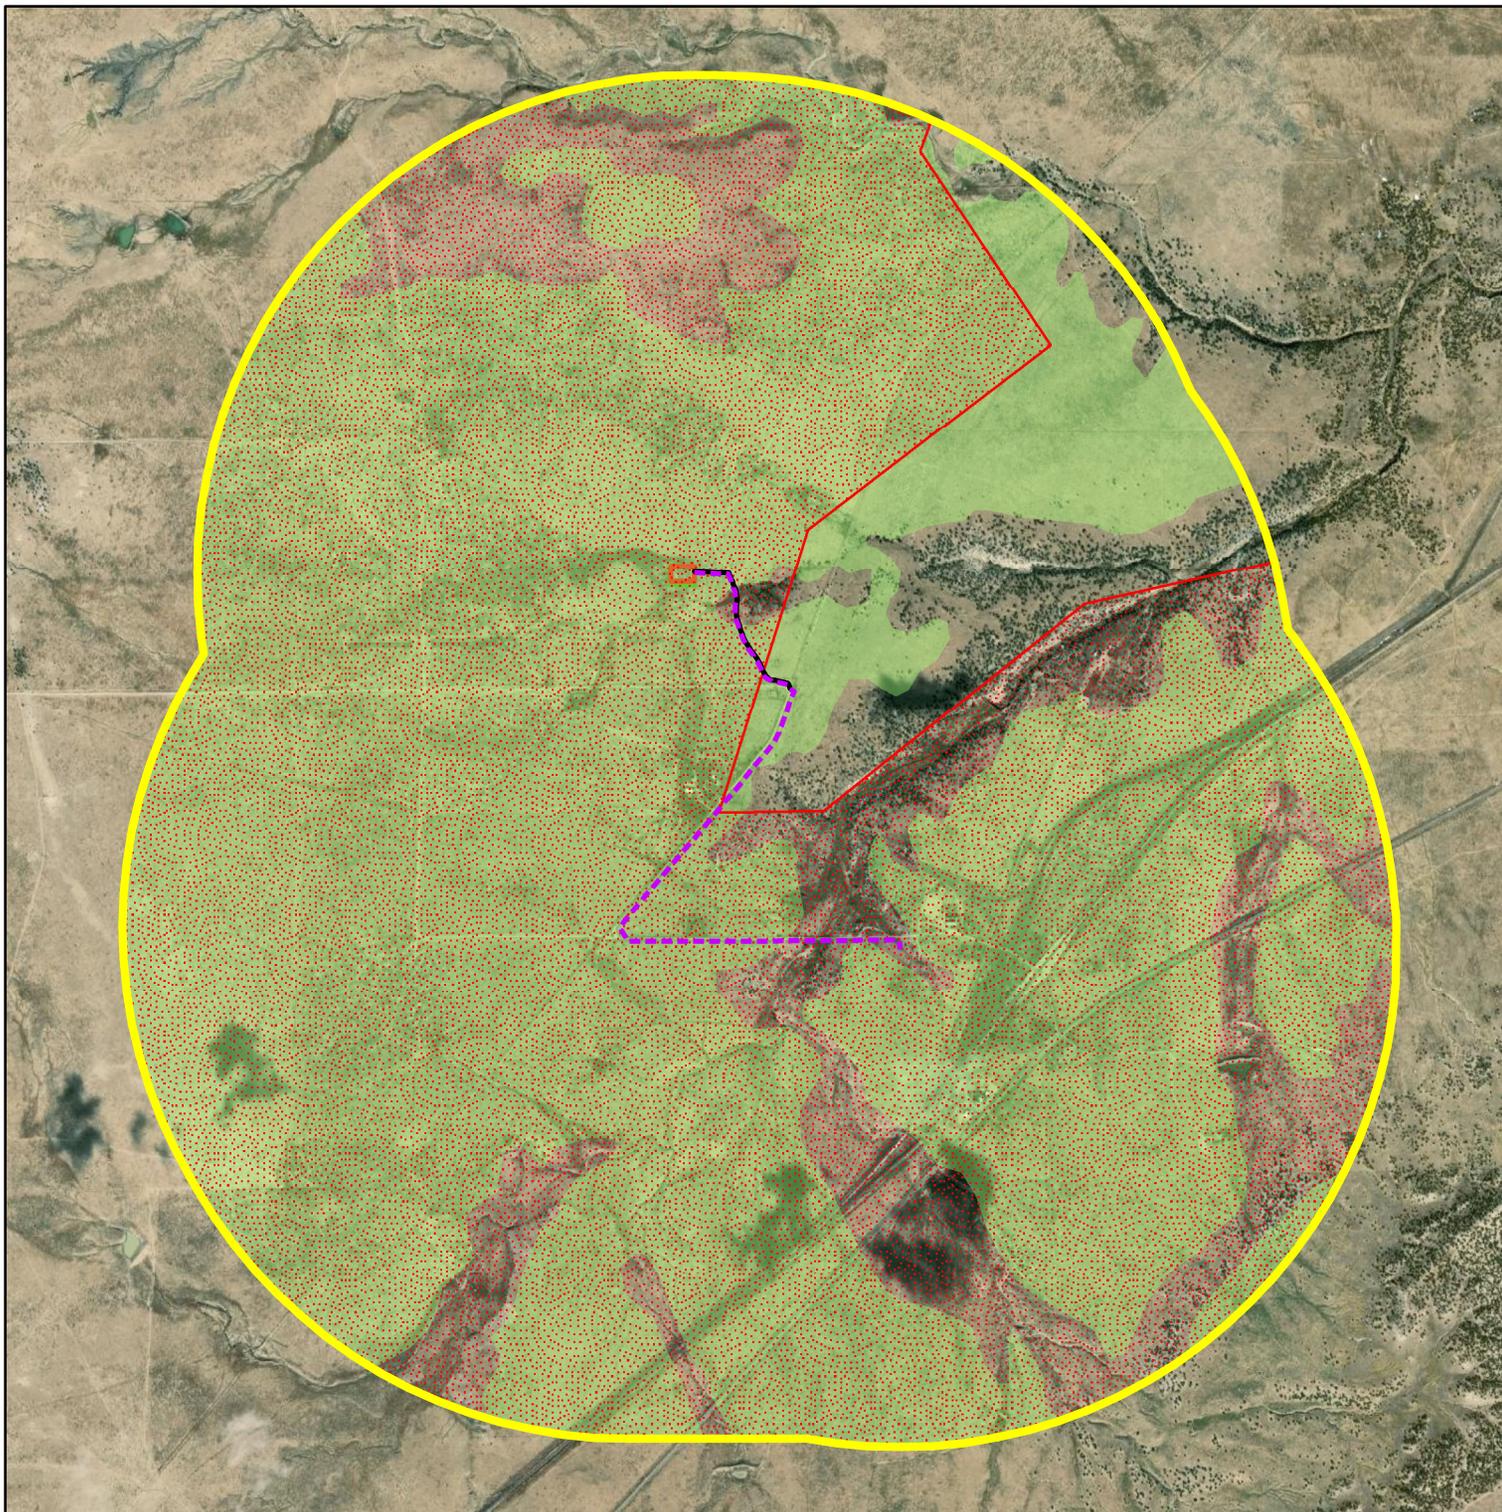
- Proposed Disturbance Area
- Proposed Working Pad Surface
- Proposed Pipeline
- Proposed Access Road
- Buffer_BBB_33
- EG-14 Cretaceous and Tertiary Formations
- EG-14 Eolian (wind-blown) deposits

Source: Colorado Geological Survey
 No faults, landslides, expansive soils, dikes, radioactive soils, earthquakes, floodplains, avalanches, or mudflows were evident in the area.

I certify that I am a Professional Geologist, having met the educational requirements and professional work experience required by C.R.S. § 23-41-208(b). Based on review of published geologic data, information obtained from the Colorado Geological Survey and NRCS soils data, it is my opinion that the Geologic Hazards displayed on the Geologic Hazard Map of the proposed BBB 33 SESE 2860 Oil and Gas Location are not significant nor do they pose a concern per Rule 304.d. The Eolian (windblown) Deposits (EG-14) and Cretaceous and Tertiary Formations (EG-14) are not deemed to be geohazards for the proposed drilling operations in term of long-term damage to the surface or a hazard to the drilling operations that could result in compromising public health, safety, welfare, the environment and wildlife resources.
