GOLDEN EAGLE 35-05 API# 05-071-08419 – OGRIS OPERATING  
COGCC OPERATOR NUMBER 10758 - DATE: OCTOBER 26, 2022  
CORRECTIVE ACTIONS COMPLETED REGARDING COGCC FIR DOCUMENT #690203391

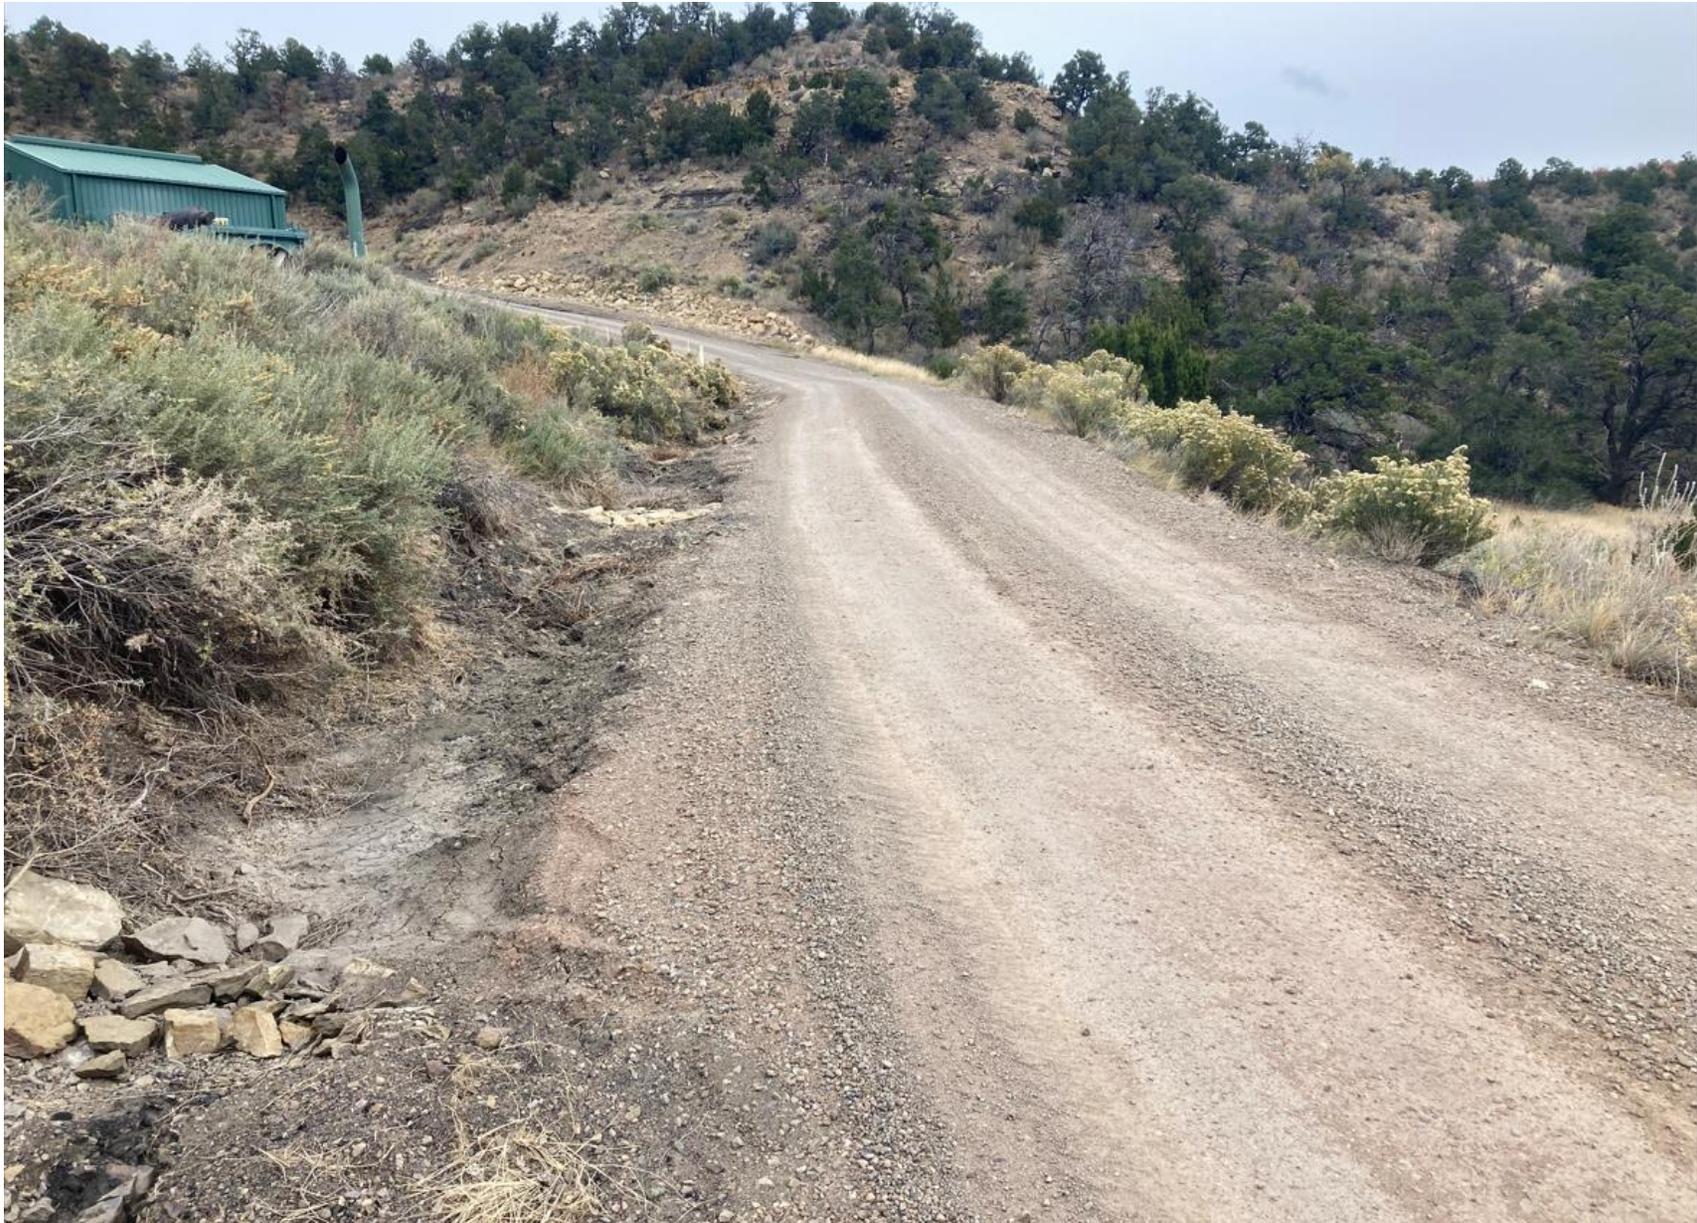
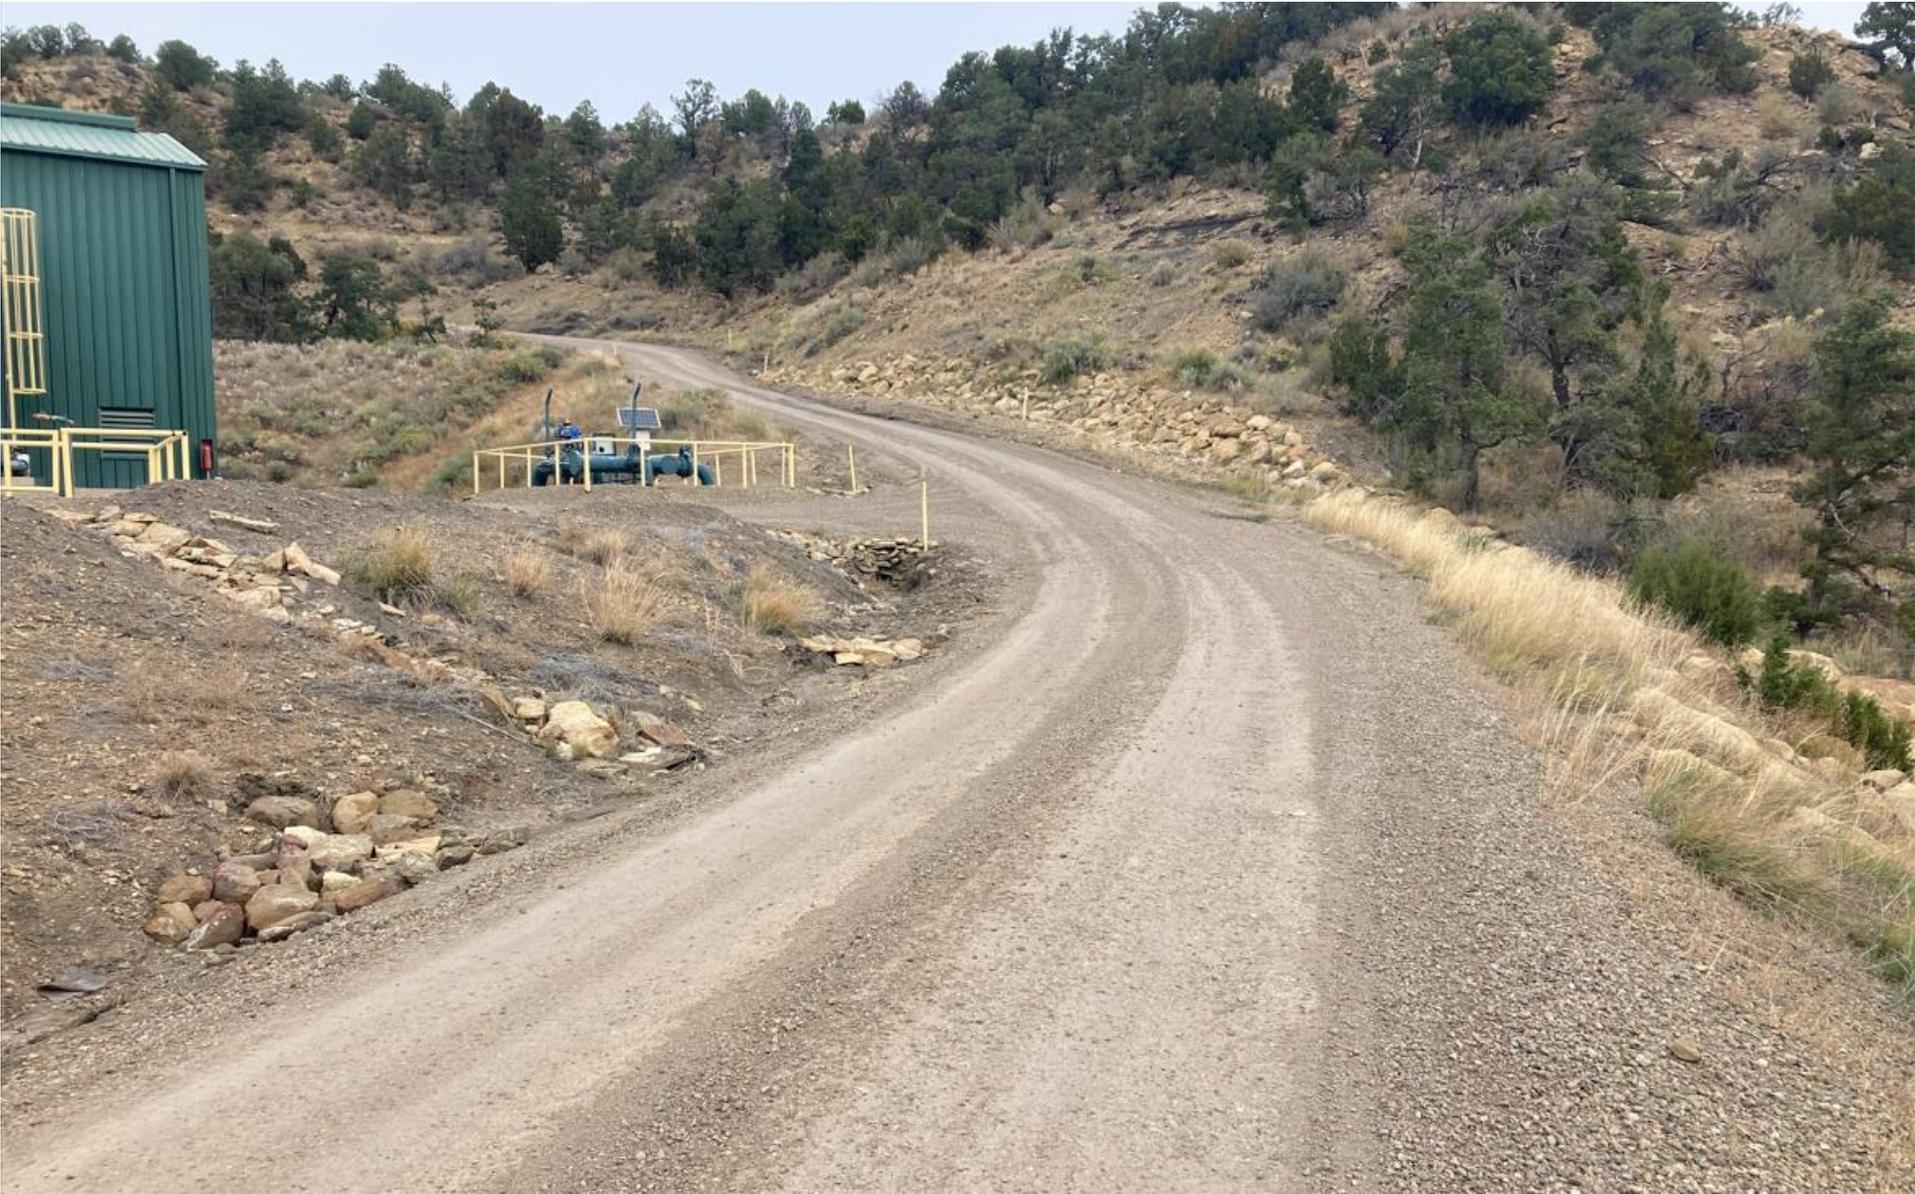
PHOTO 1 & 2: MAINTENANCE HAS BEEN PERFORMED TO THE ACCESS ROAD TO CORRECT ERROSION CHANELS AND VEHICLE RUTTING. THE DIVERSION DITCHES ALONG THE ROAD SIDE HAVE BEEN REDEFINED AND CHECK DAMS ADDED TO PROPERLY SLOW AND DIVERT STORMWATER.

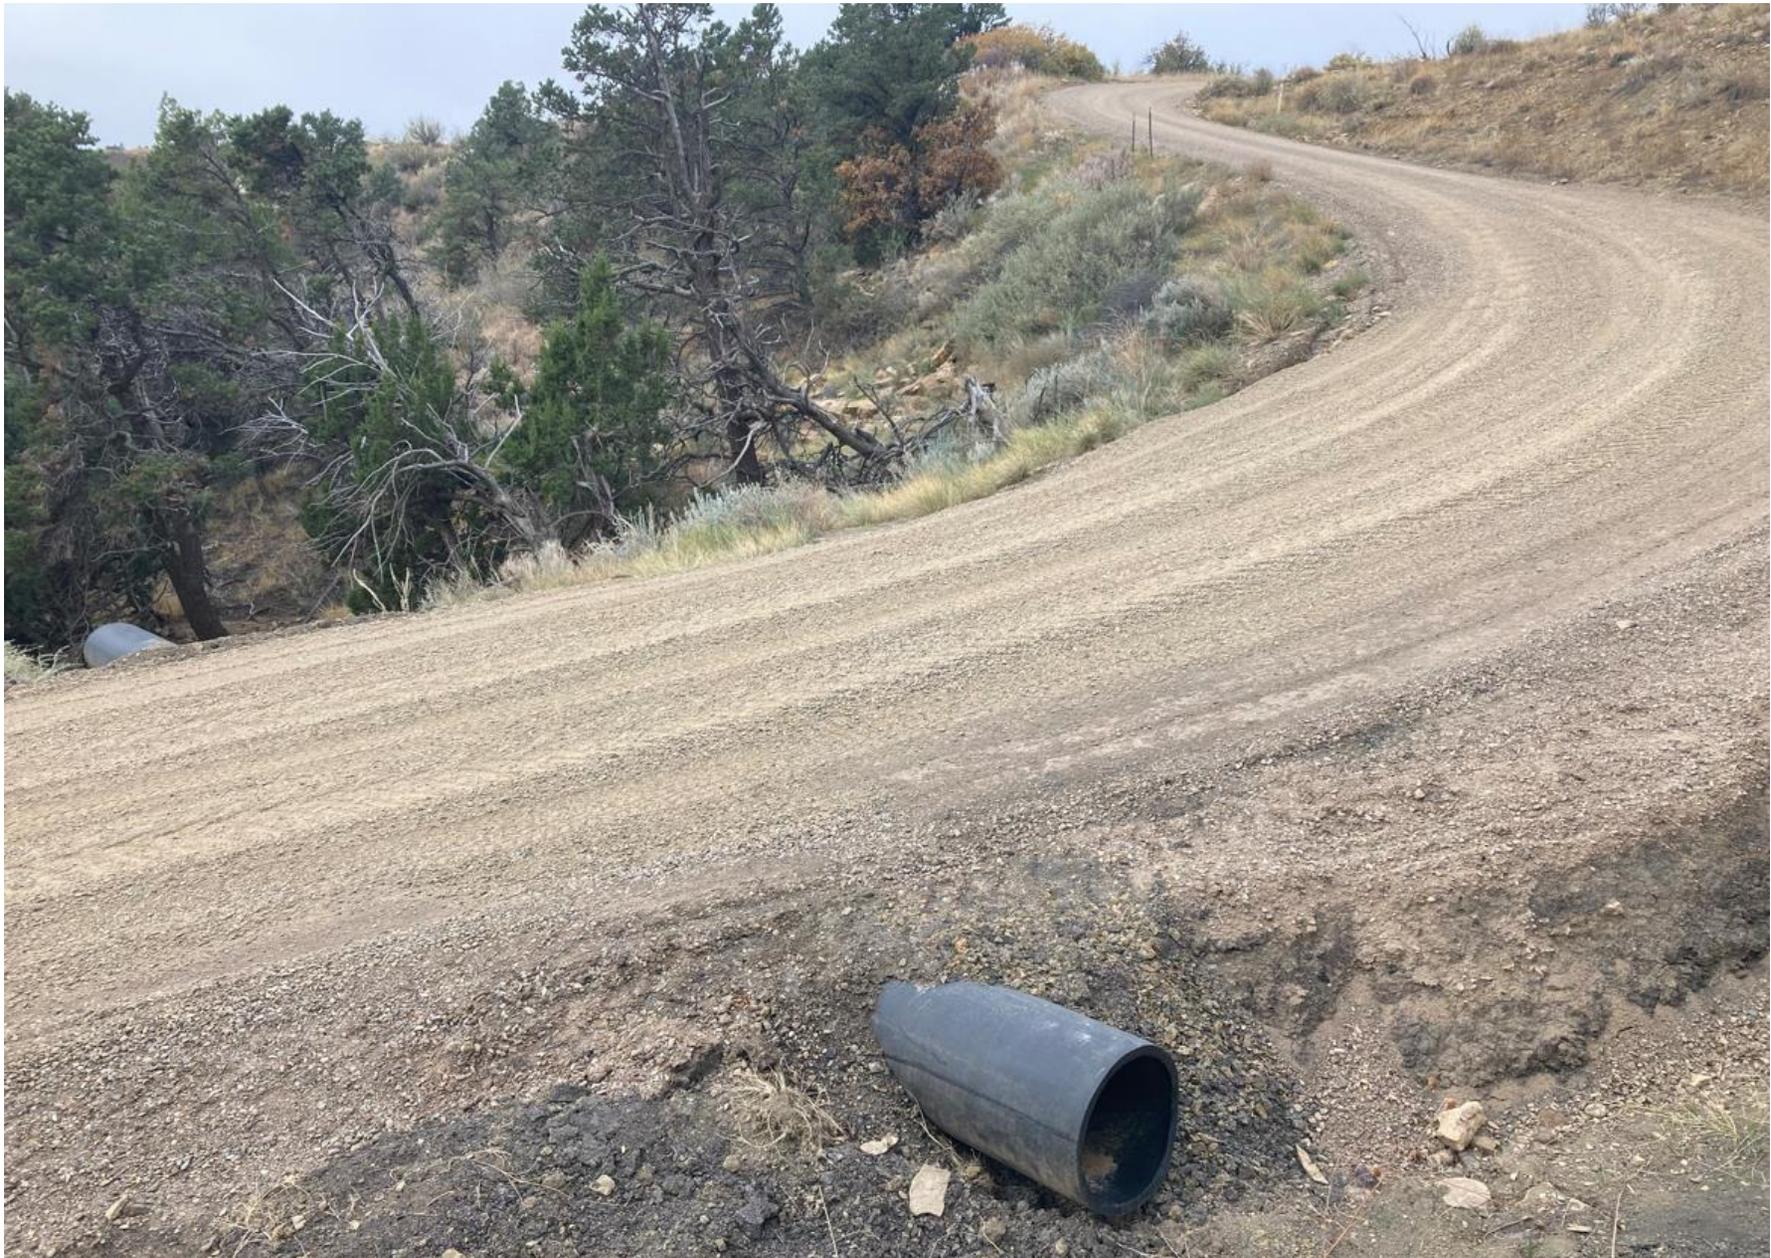
PHOTO 3: A CULVERT HAS BEEN ADDED ON THE MAIN ACCESS, CLIMBING ABOVE THE COMPRESSOR LOCATION. ROAD MATERIAL WAS ADDED ALONG THE MAIN ACCESS, THE ROAD SURFACE WAS CROWNED TO CREATE SHEET FLOW AND PROPERLY DIRECT SURFACE RUN OFF.

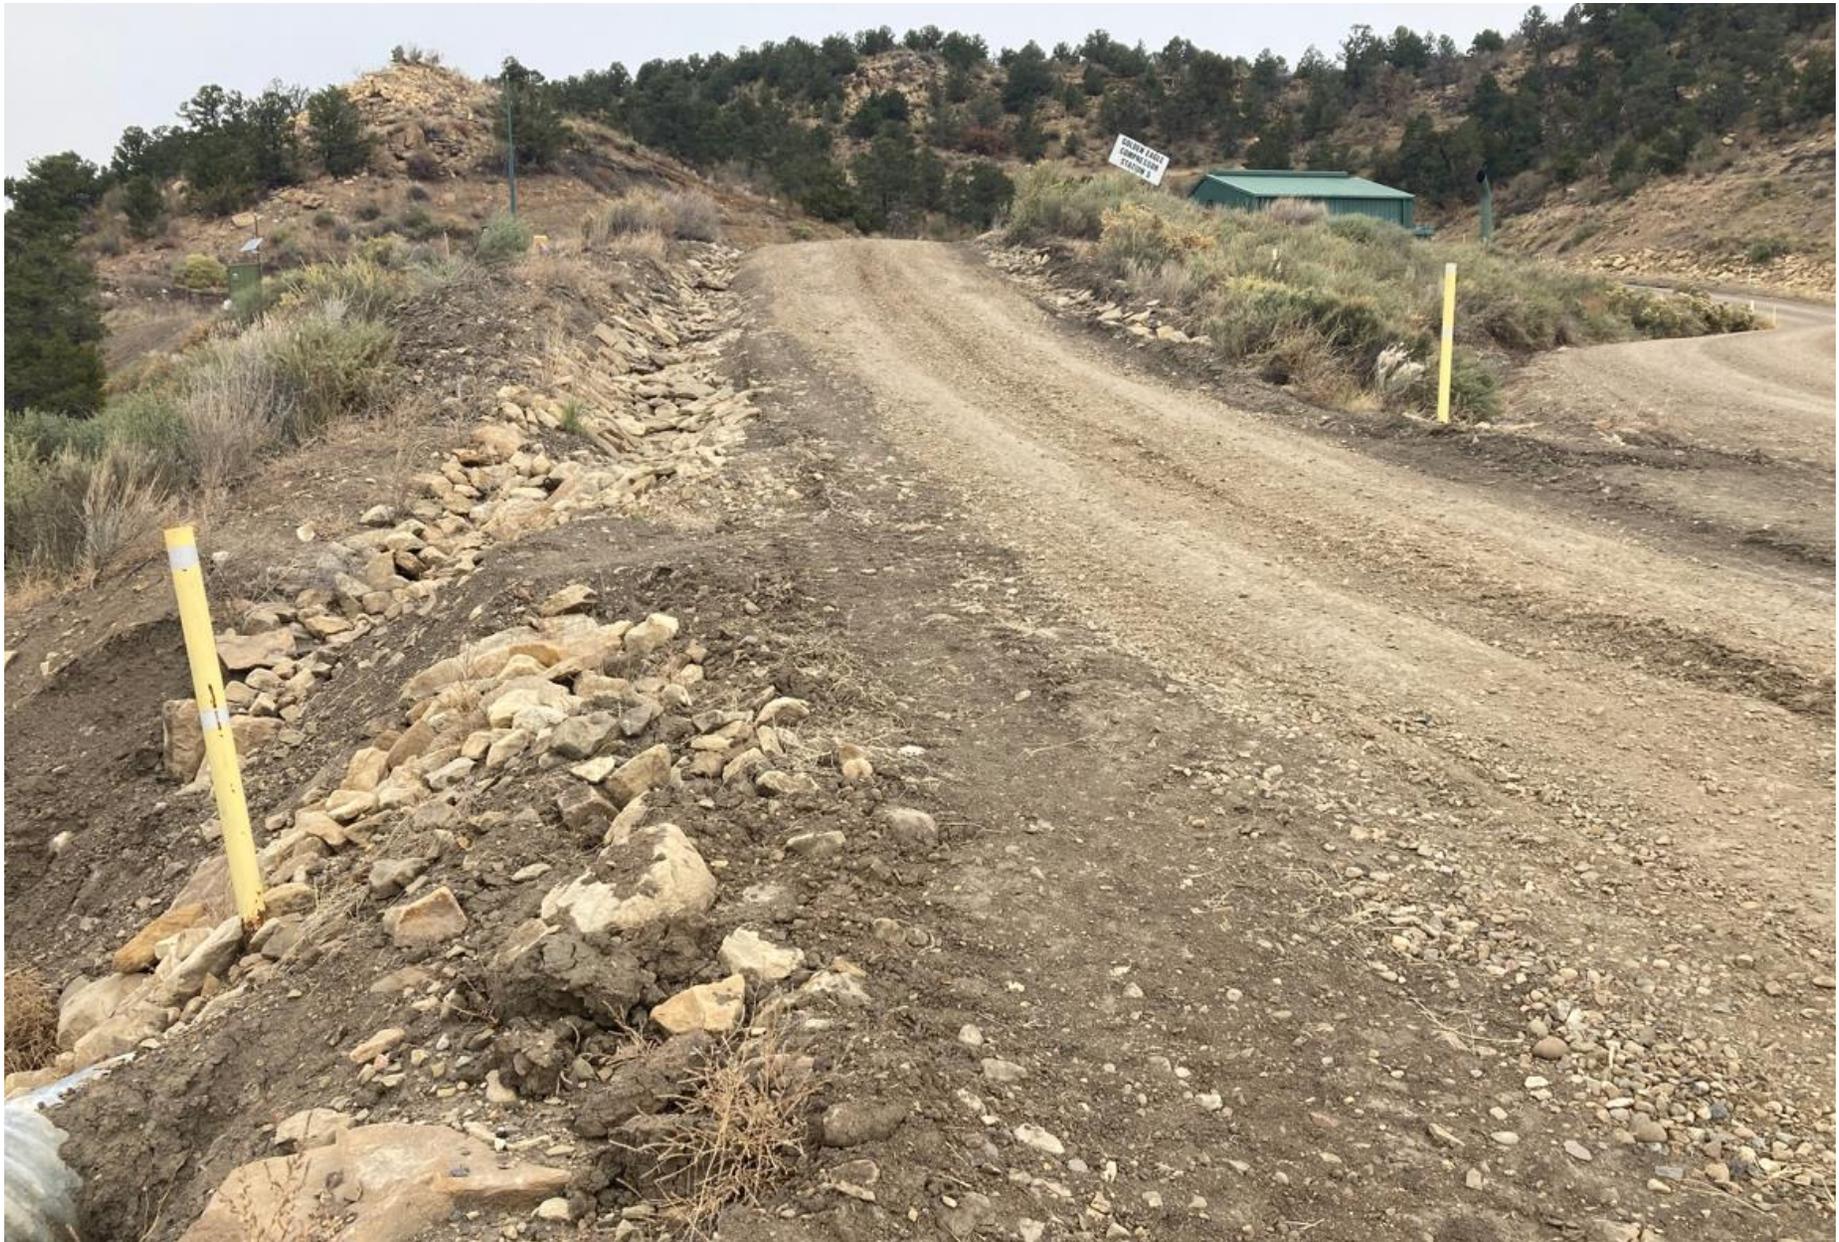
PHOTO 4: ROAD MATERIAL HAS ALSO BEEN ADDED TO THE LOCATION ACCESS AND IT HAS BEEN CROWNED TO ENCOURAGE SHEET FLOW AND DIRECT SURFACE RUN OFF TO THE ROCKED DIVERSION DITCH. THE CULVERT INLET HAS ALSO BEEN CLEANED AND RESET.
