BMP Corrective Actions
Location Name: Eagle Hill 1-32
Location ID: 466705
API#: 057-06625

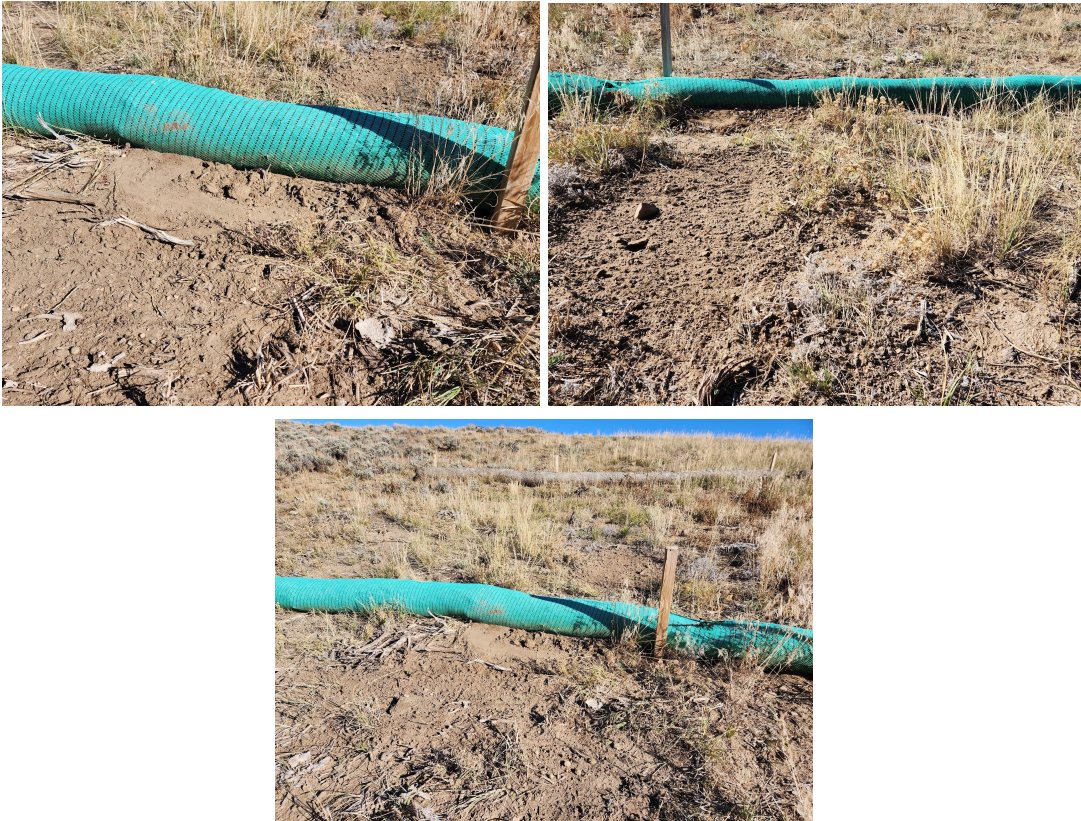
Photos 1-3: Undercutting on wattle repair.

Undercut wattle repair. On 10/07/2022 EcoPoint personnel backfilled, compacted and surface roughened area to repair undercut wattle and avoid any potential for future rilling.
