ARKOMA OPERATIONS LLC

Well Name:	Hahn 1-A	API #	067-08112	Location ID #	311911
	IGE 100		067-09022		
	IGE 135		067-09346		
Inspector:	Alex Klink				
Date Inspected:	11/4/2022				
Date Submitted:	11/4/2022				
Document Number:	702500725

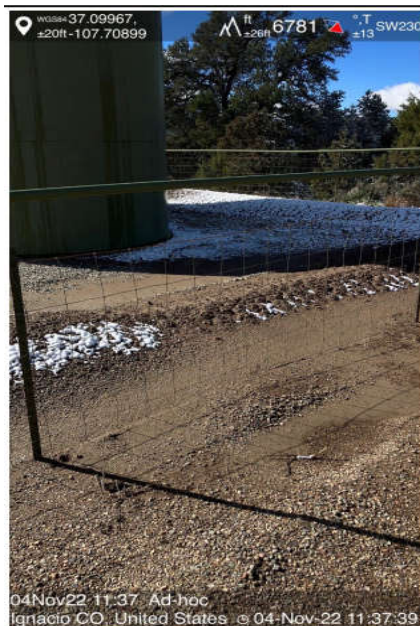
IMG 05

Comment:	Berm height is diminished at produced water tanks (IMG 05).	
Corrective Action:	Repair/maintain berms or other secondary containment devices per Rule 603 o.	Date: 12/04/2022

Berm height is diminished

Action Taken: Repaired berm to appropriate height

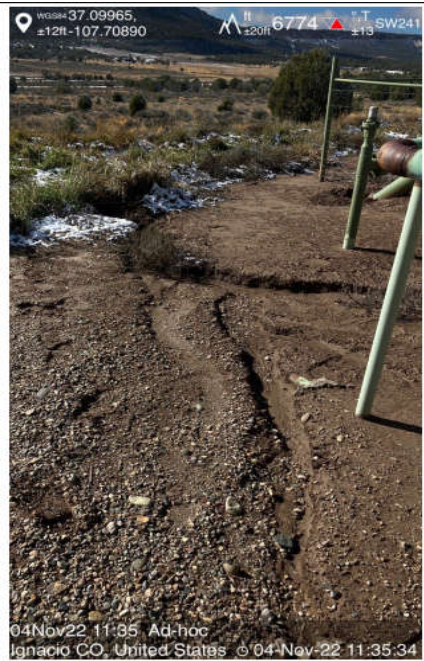
IMG 03

Comment:	Erosion channel on southwest corner of location (IMG 03). Erosion channel at produced water tank (IMG 04). Stormwater BMP's not maintained.	
Corrective Action:	Install or repair/modify required BMPs per Rule 1002.f.(2)C	Date: 12/04/2022

Erosion channel on southwest corner of location

Repaired erosion channel on the southwest corner of the location and channel at the produced water tank

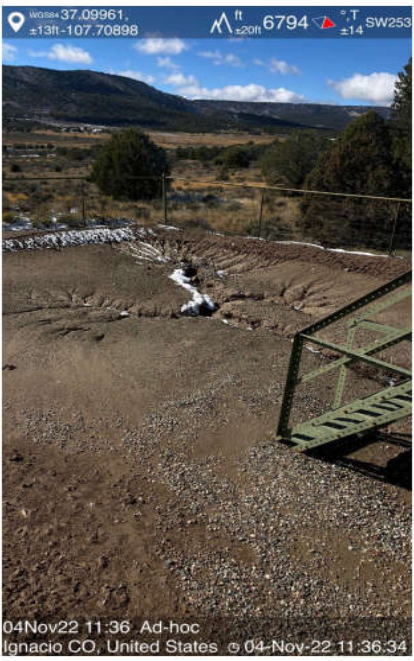
IMG 04

Erosion channel within secondary containment
