# Final Reclamation Inspection

Operator: NOBLE ENERGY INC - #100322

Location ID: 323313

Inspection Photos  
Location Name: ANDERSON-COOMBS #4  
Location ID: 323313

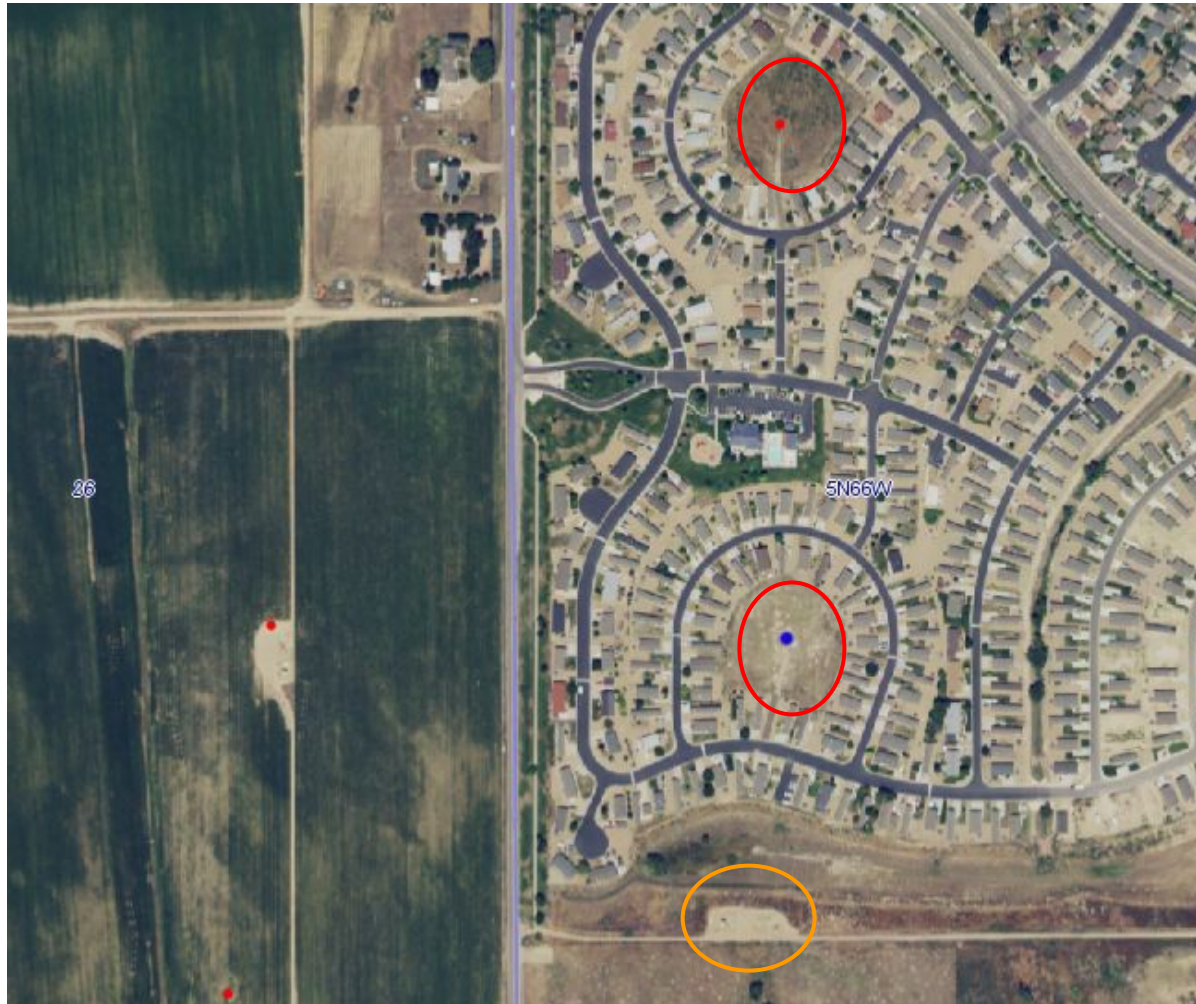
**Photo 1.** COGCC GISOnline aerial imagery from 2015 illustrates active operations. Red circles are the well locations that the tank battery (orange circle) serviced. The well locations pass vegetation requirements but the tank battery fails.

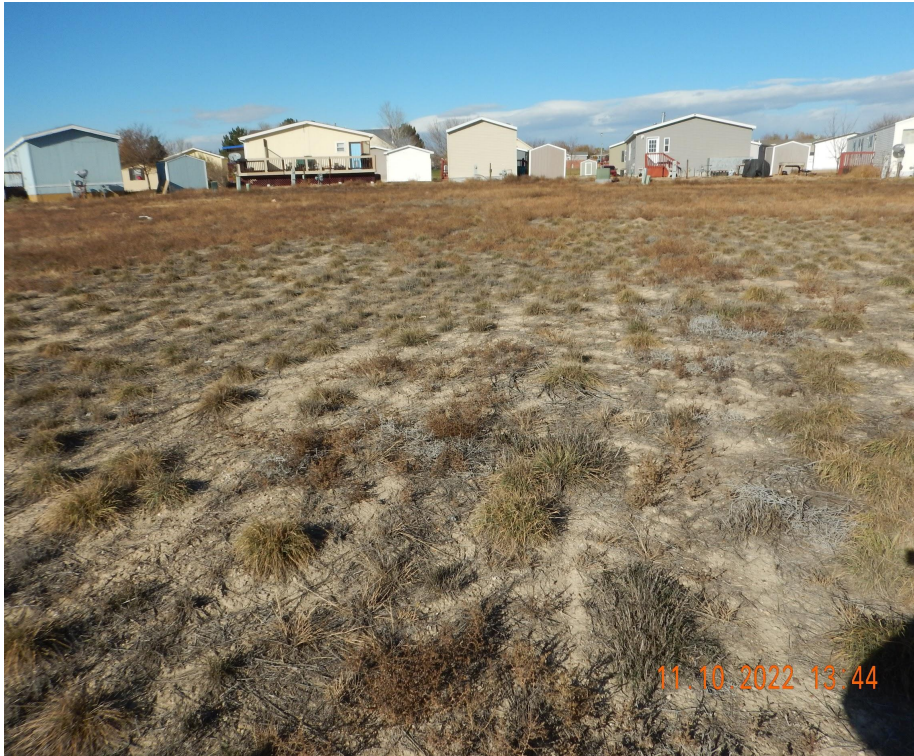
**Photo 2.** Photo taken from the well location, facing North. Photo illustrates perennial vegetation and location is now part of a mobile home park.

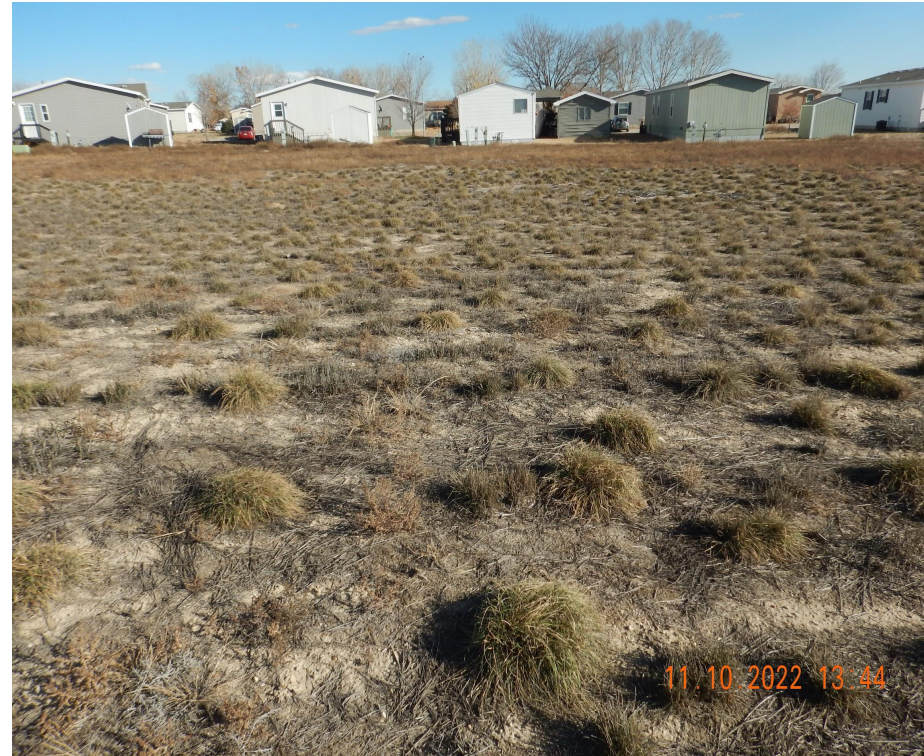
**Photo 3.** Photo taken from the well location, facing East. See comments under Photo 2.

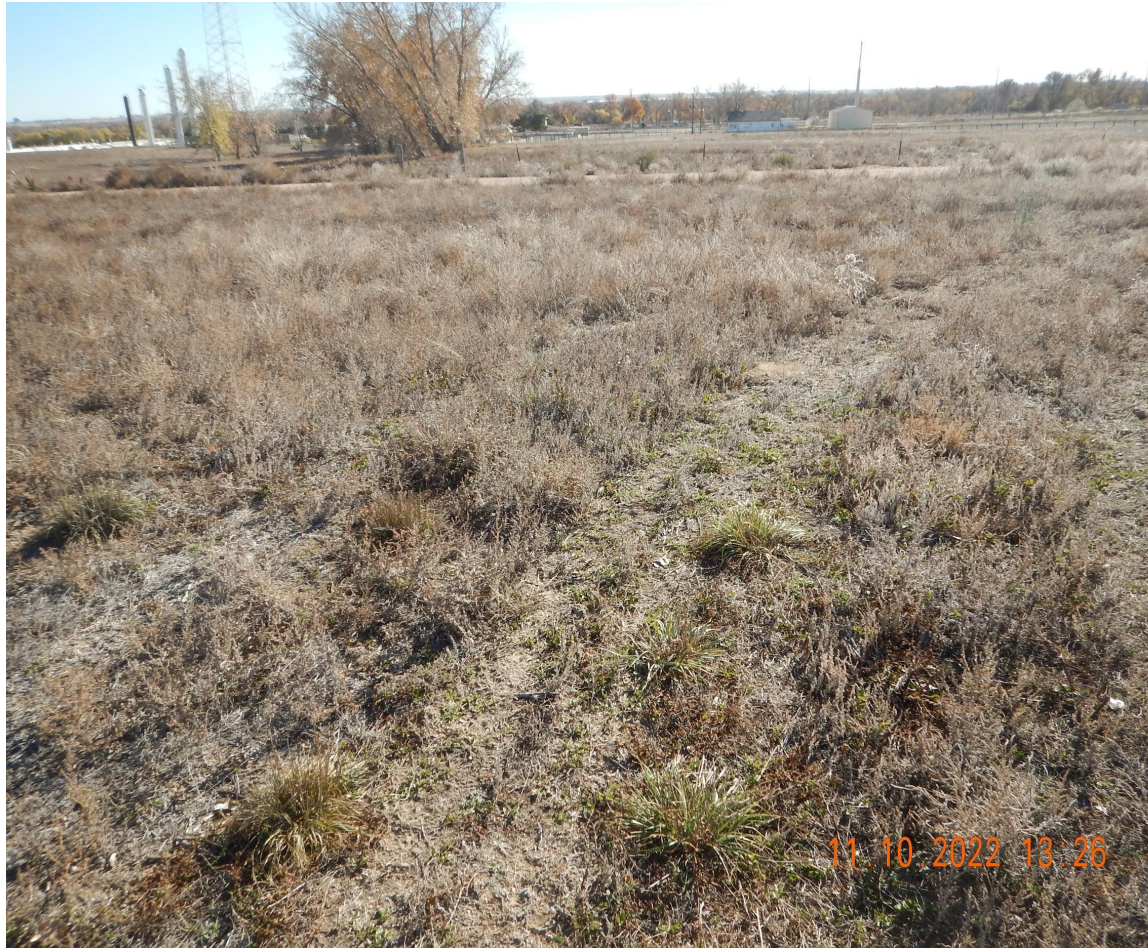
**Photo 4.** Photo taken from the associated tank battery, facing South. Photo illustrates the edge of reference with some perennials visible but then mostly annual tumbleweeds.

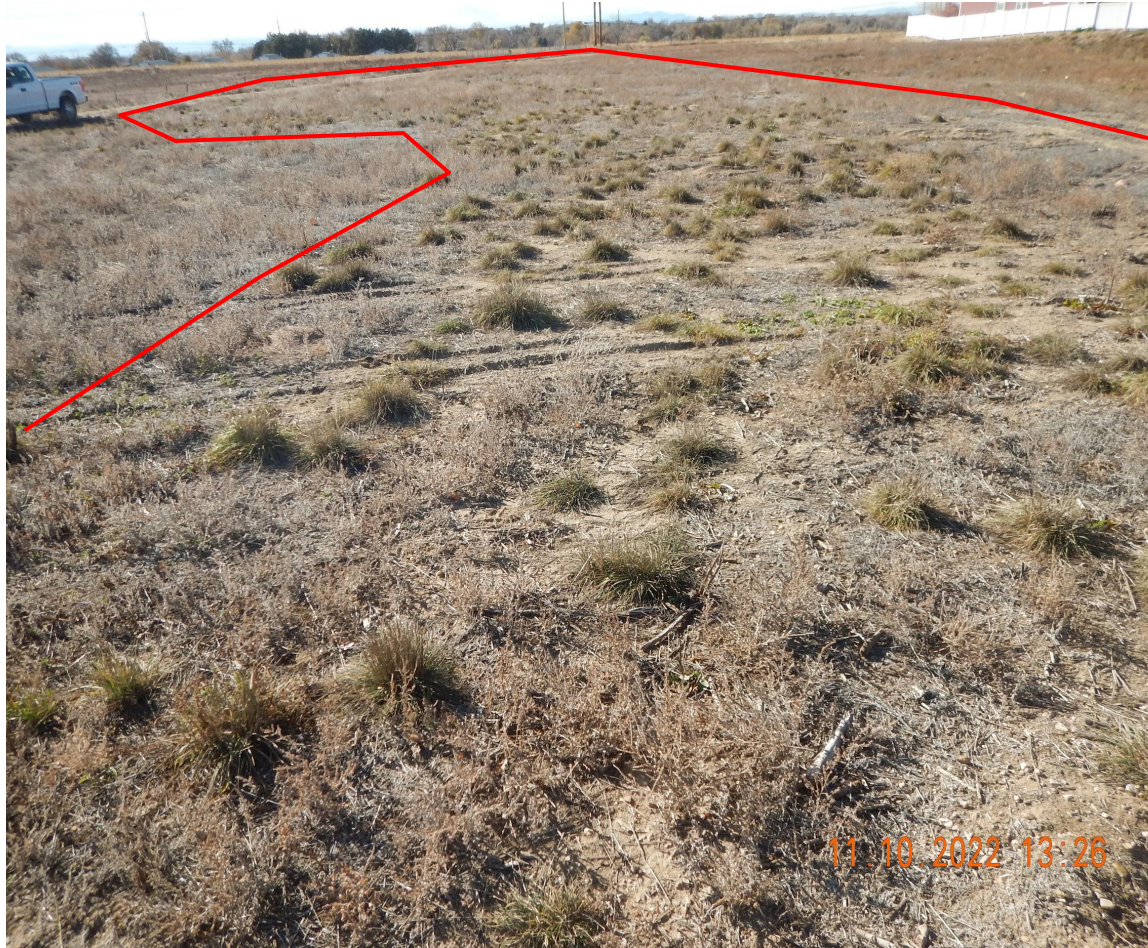
**Photo 5.** Reference areas are everything inside the red line, facing West. Photo illustrates the establishment of perennials with annual tumbleweeds.
