Final Reclamation Inspection

Operator: NOBLE ENERGY INC - #100322

Location ID: 322565

Inspection Photos
Location Name: ANDERSON-COOMBS #1
Location ID: 322565

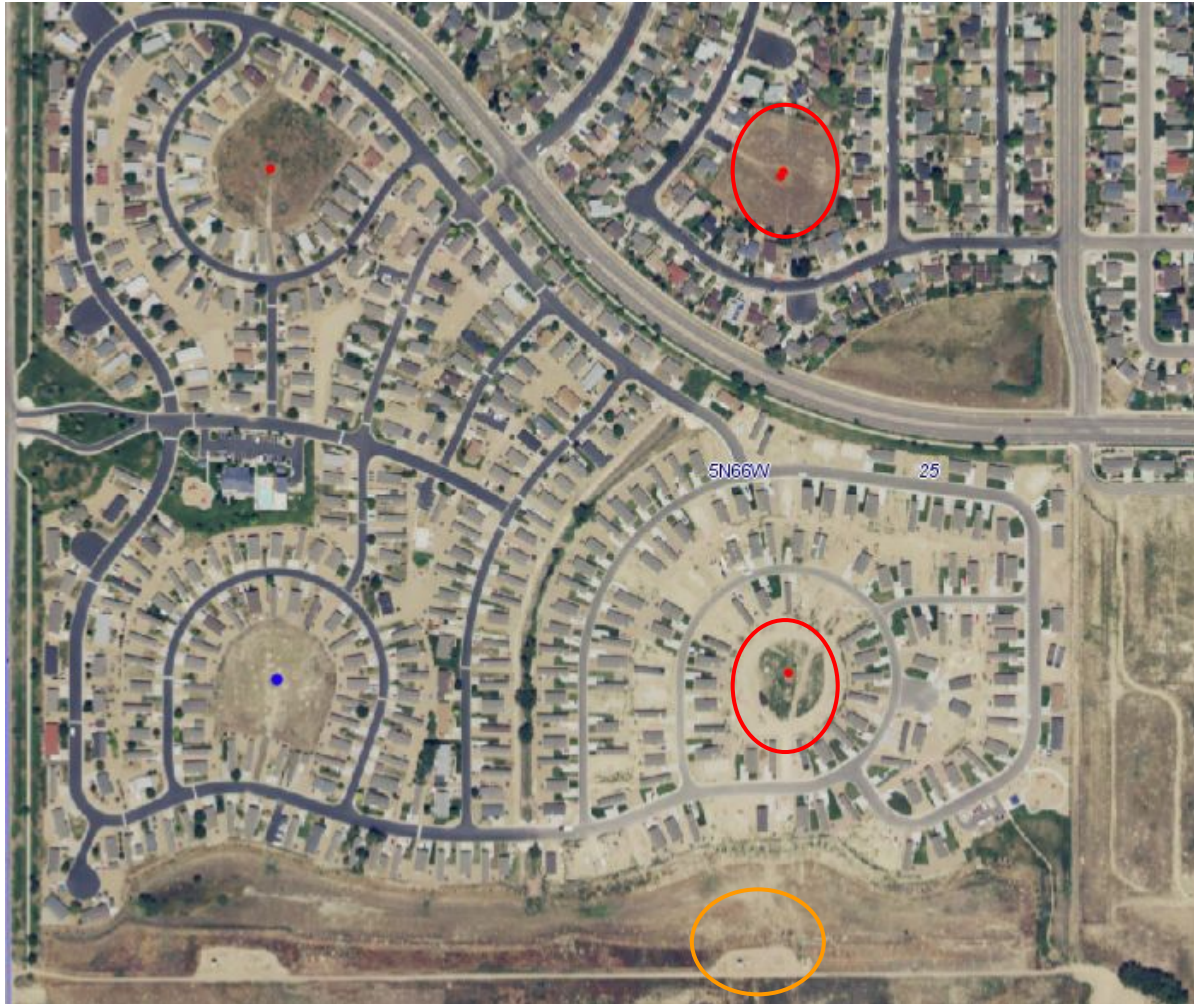
Photo 1. COGCC GISOnline aerial imagery from 2015 illustrates active operations. Red circles are the well locations that the tank battery (orange circle) serviced. The well locations pass vegetation requirements but the tank battery fails.

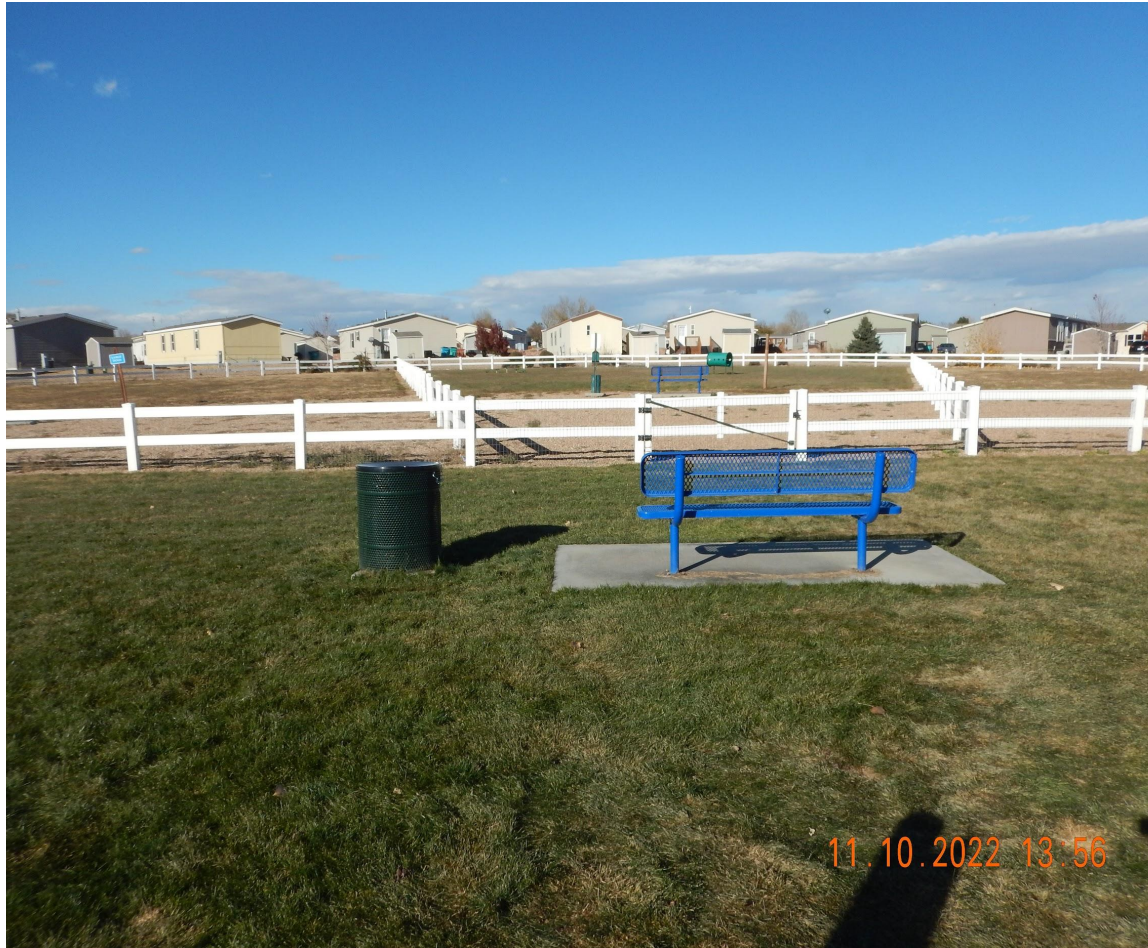
Photo 2. Photo taken from the well location, facing North. Photo illustrates a dog park and location is now part of a mobile home park.

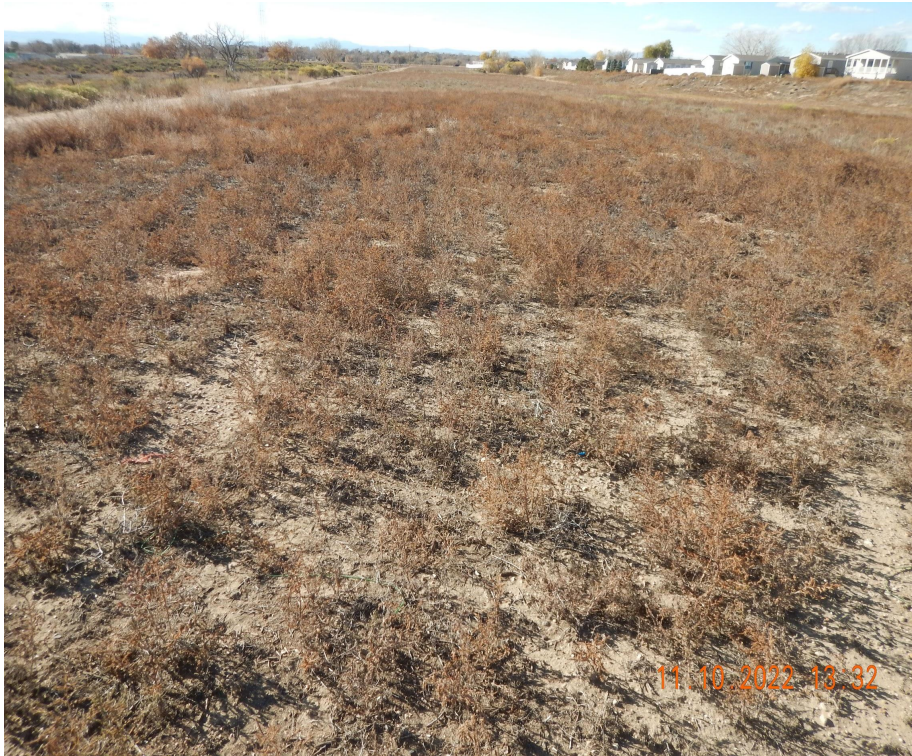
Photo 3. Photo taken from the associated tank battery, facing West. Photo illustrates mostly annual tumbleweeds.

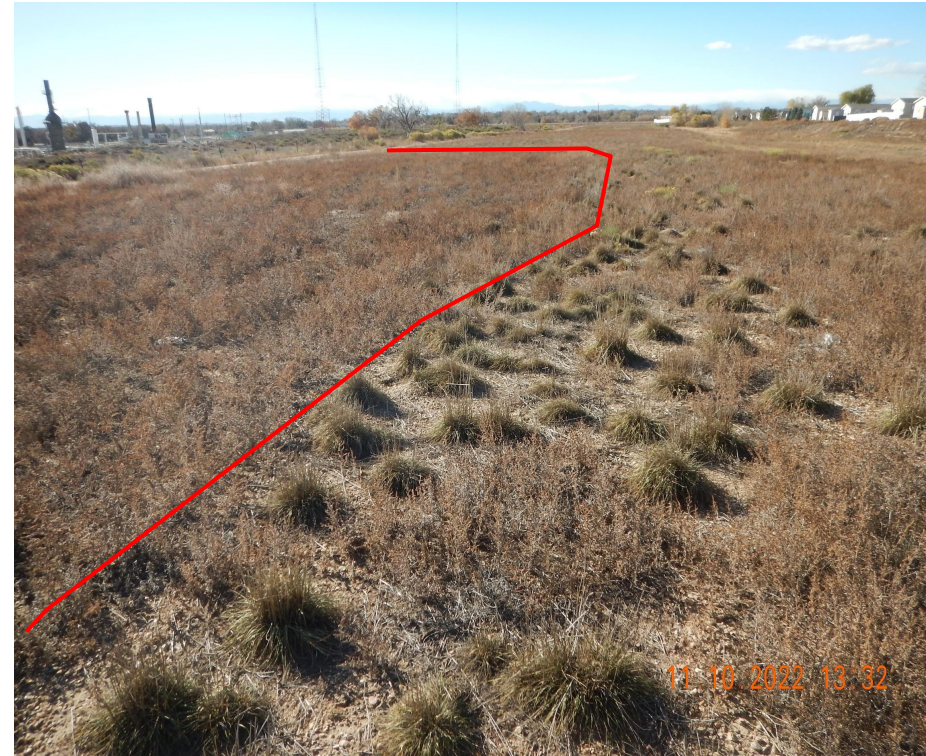
Photo 4. Reference areas are everything right of the red line, facing West. Photo illustrates the establishment of perennials with annual tumbleweeds.
