NEW ELK 25-08 API# 05-071-09496 – OGRIS OPERATING
COGCC OPERATOR NUMBER 10758 - DATE: JANUARY 13, 2023
CORRECTIVE ACTIONS COMPLETED REGARDING COGCC FIR DOCUMENT #690203741

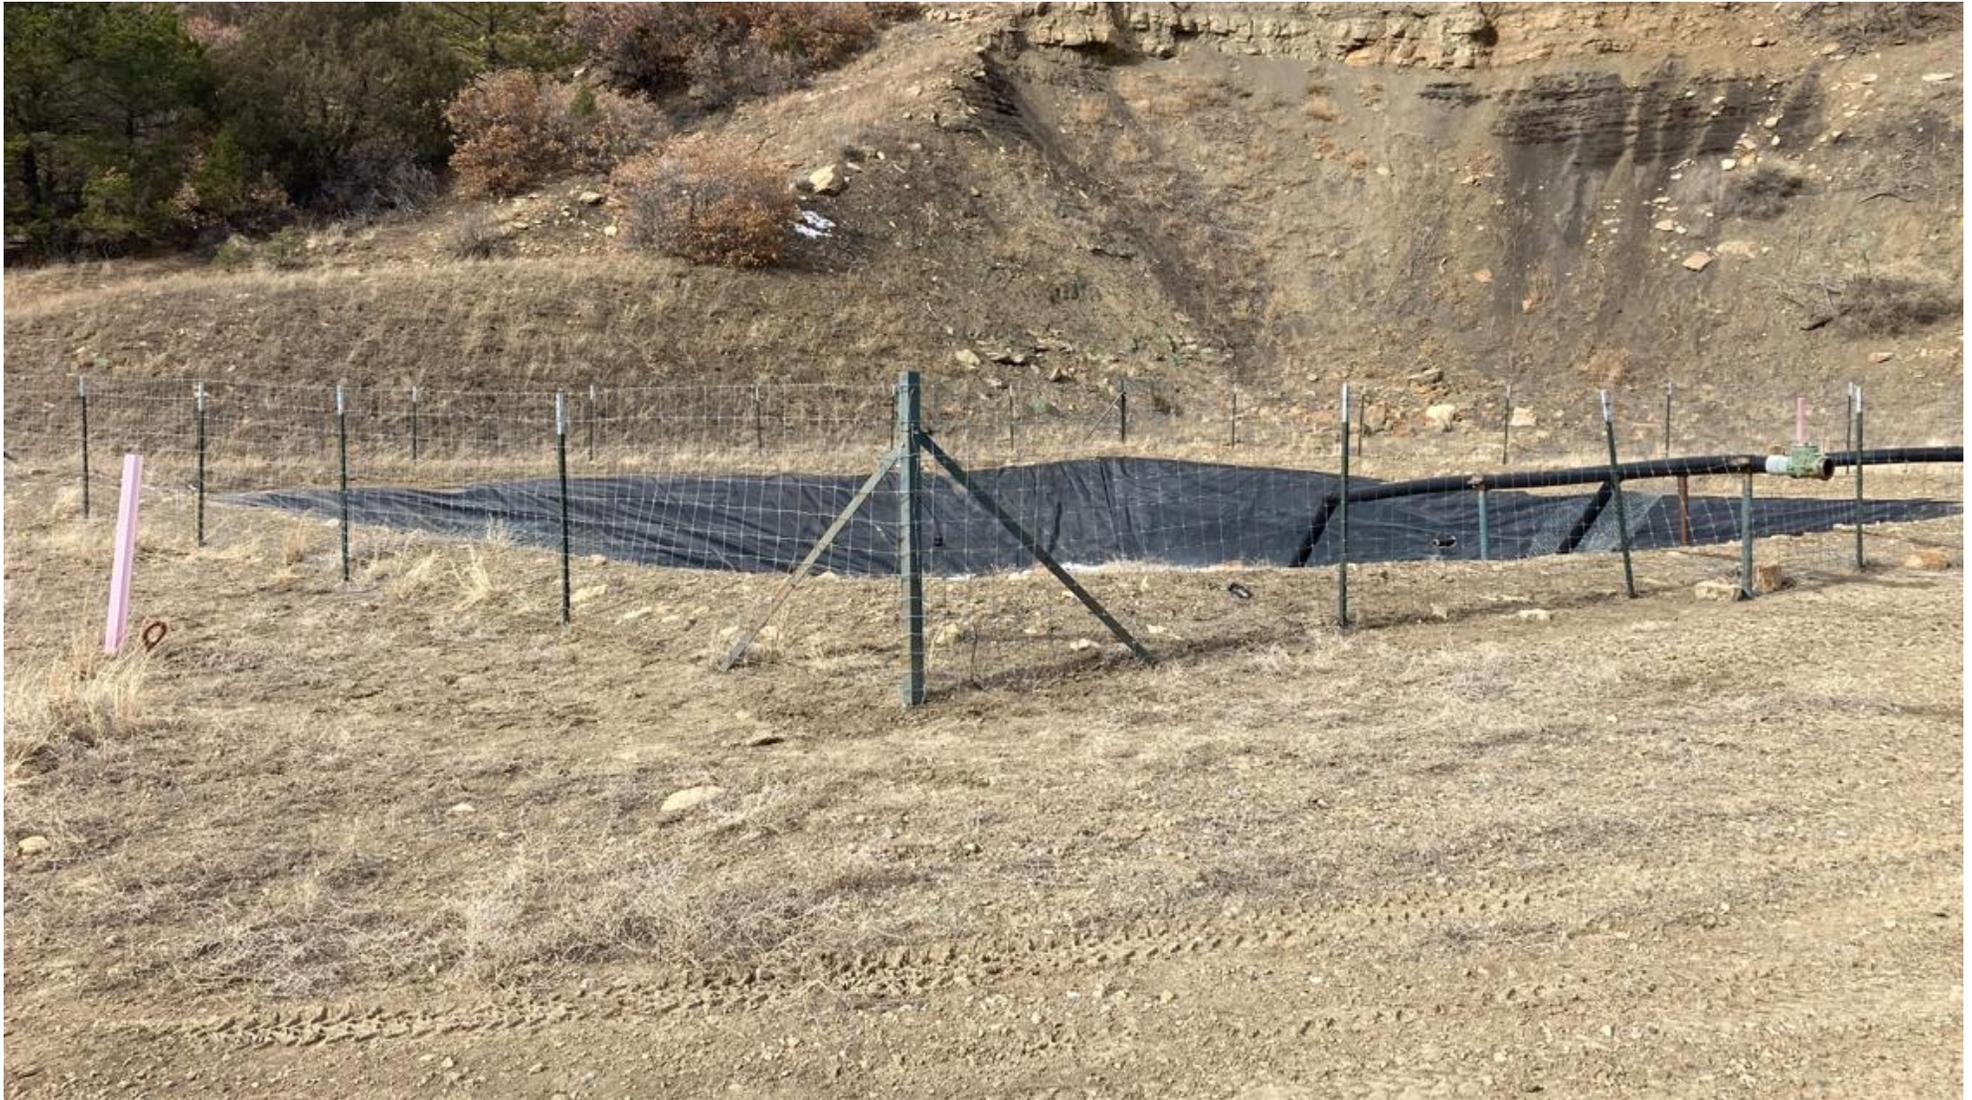
PHOTO 1: THE FENCING AROUND THE PIT HAS BEEN REPLACED TO COMPLY WITH 1002A RULES.

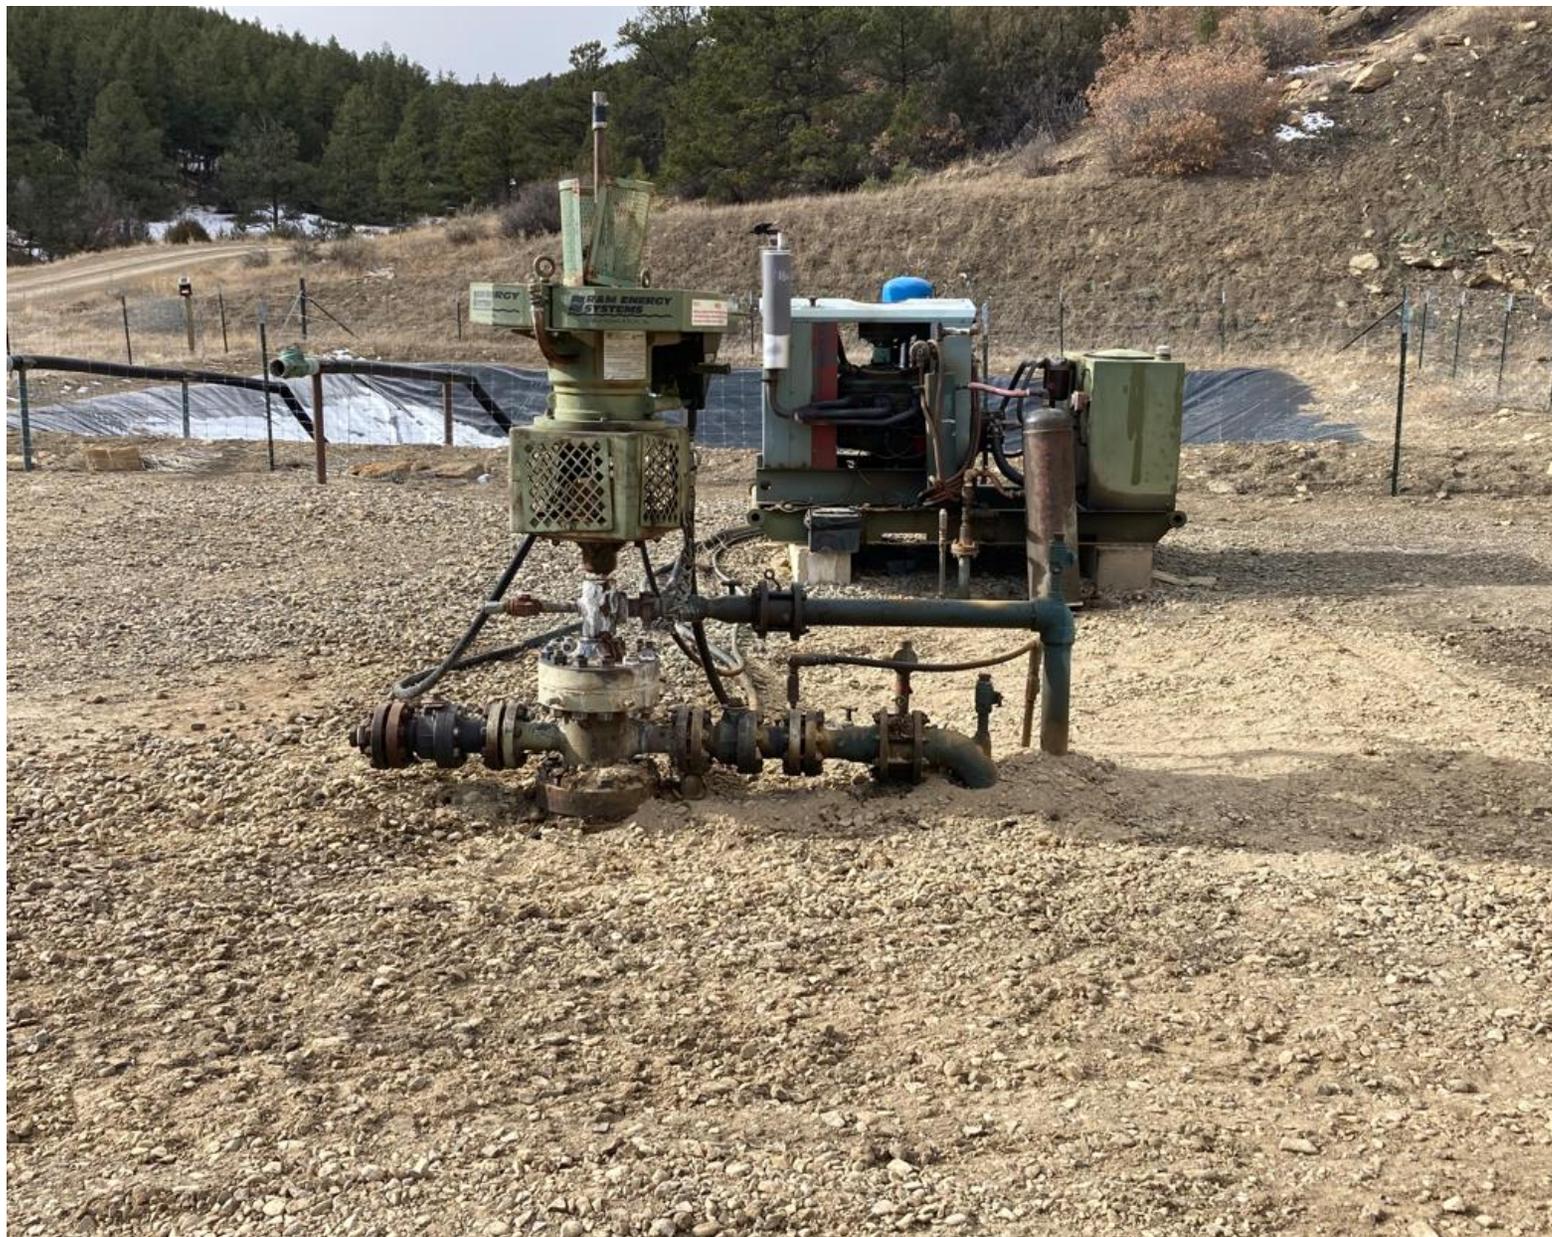
PHOTO 2: THE IMPACTED SOIL AT THE WELL HEAD HAS BEEN REMOVED AND PROPERLY DISPOSED IN ACCORDANCE WITH THE OGRIS OPERATING WASTE MANAGEMENT PLAN. MAINTENANCE HAS BEEN PERFORMED AND THE SELF INSPECTION PROCESS HAS BEEN REVIEWED.

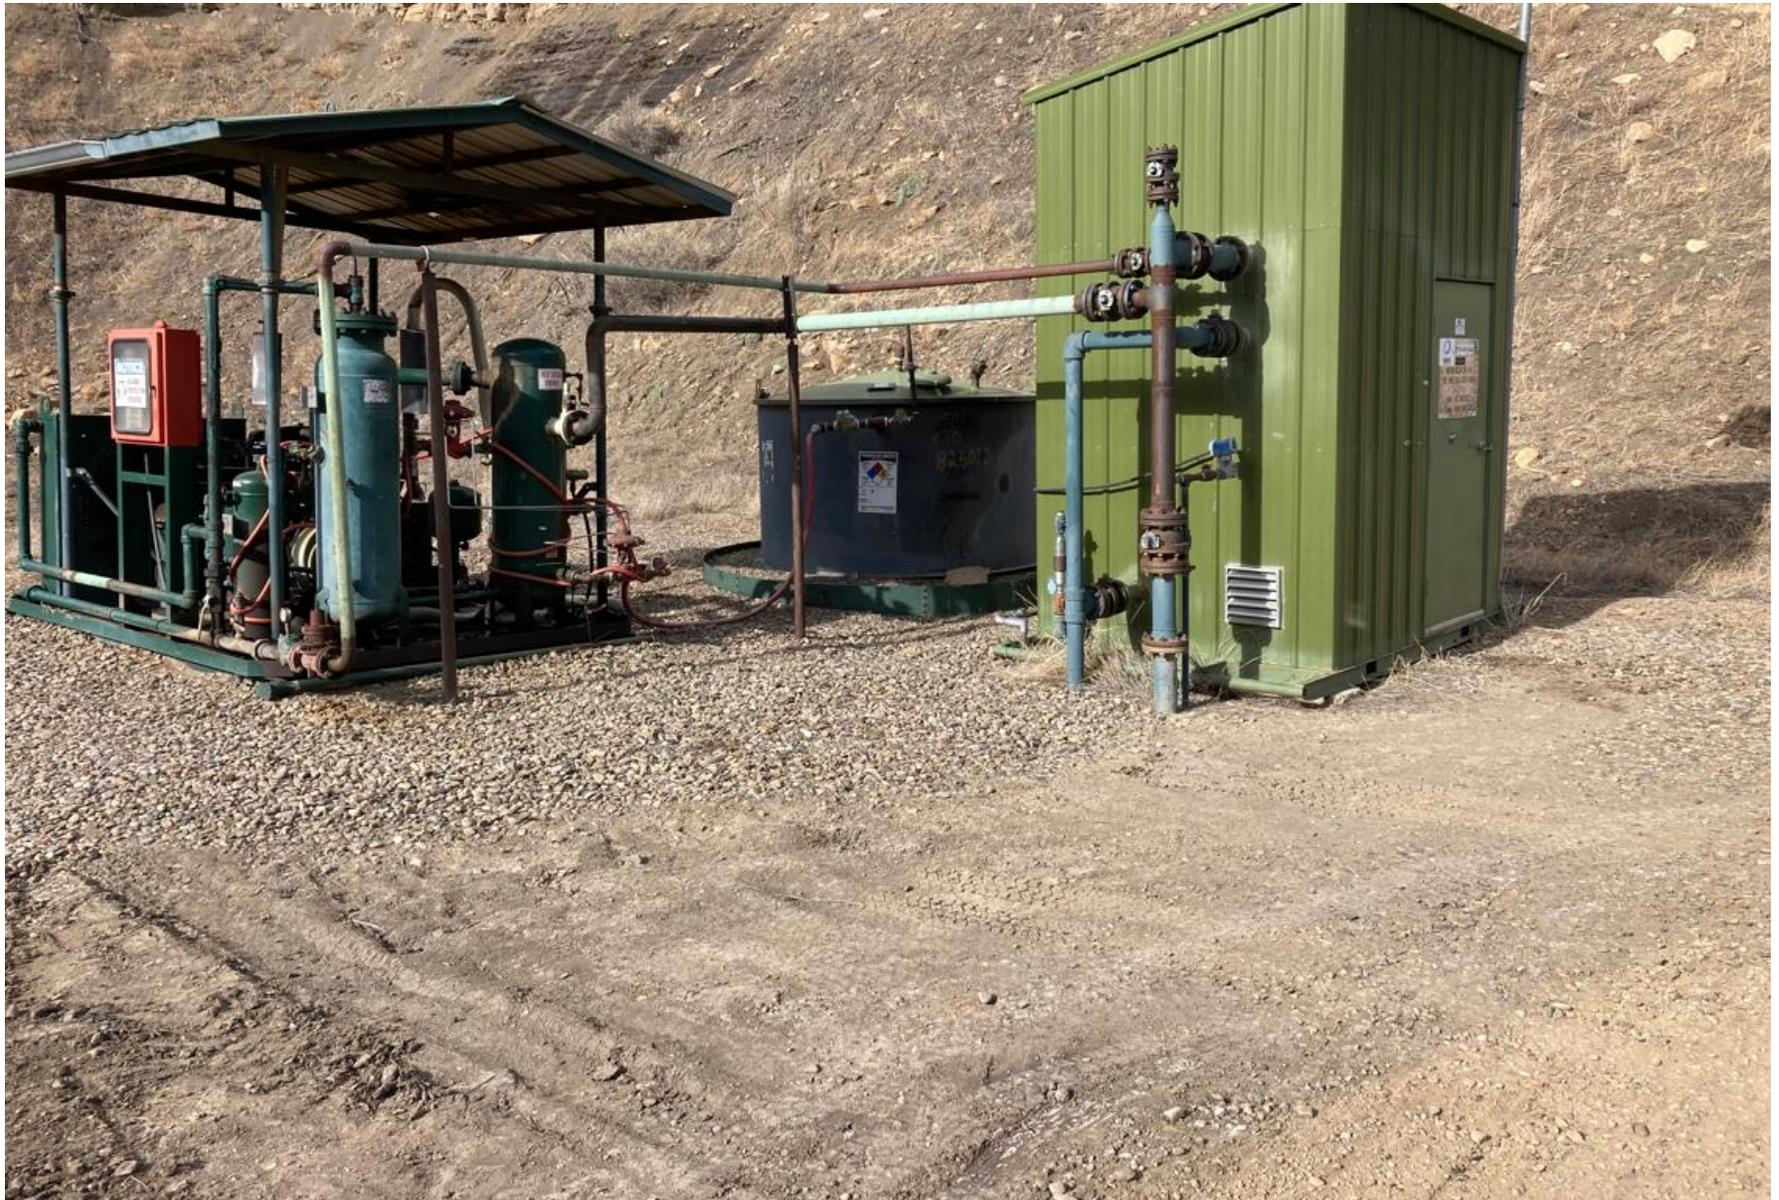
PHOTO 3: THE LEAK AT THE METER SHED HAS BEEN REPAIRED, IMPACTED SOIL HAS BEEN REMOVED AND PROPERLY DISPOSED. ALL VALVES, PIPES AND FITTINGS ARE SECURLY FASTENED AND THE SELF INSPECTION PROCESS HAS BEEN REVIEWED.
