# IKAV Energy/SIMCOE LLC Colorado COGCC Off Location Flowline Abandonment Record

Project Name: Miranda CDP (Decker NM) 10-inch Steel Pipeline Abandonment

Abandonment Date (MM/DD/YYYY): 11/06/2020

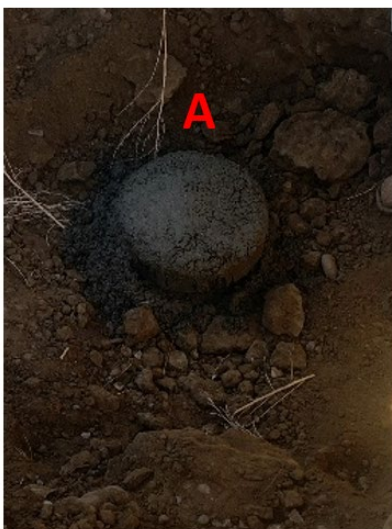
Point A

Comment: Removed abandoned half of riser at point 'A' and abandoned below grade.

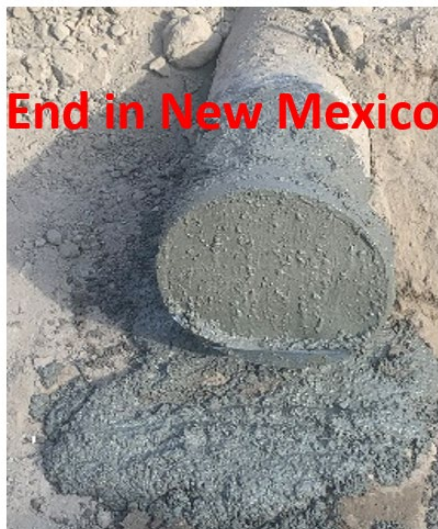
Additional Comments: Pipeline extends into New Mexico. Pipeline was not cut and capped at the State border. Southern cap point is in New Mexico.

Pipeline was not cut at the Colorado/New Mexico Border (Point B). Southern end abandoned in New Mexico; photos of its cut and cap are shown for thoroughness.
