Interim Reclamation and Stormwater Inspection

Operator: FOUNDATION ENERGY MANAGEMENT LLC -10112

Location ID: 331181

Inspection Photos
Location Name: Federal Osprey
Location ID: 331181

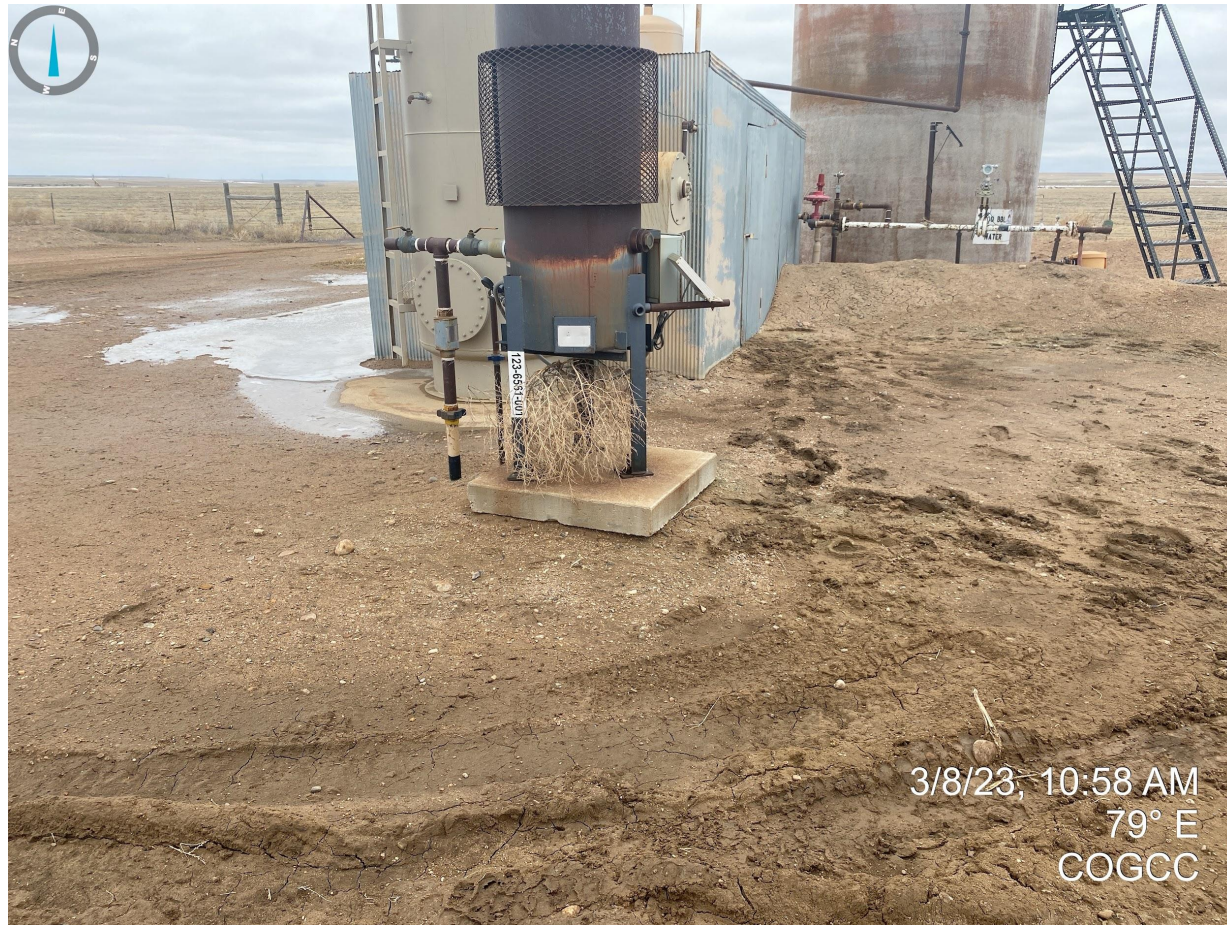
Photo 1. Facing east towards production area. Tumbleweed accumulations were observed in and around equipment and need to be removed as they present a fire hazard.

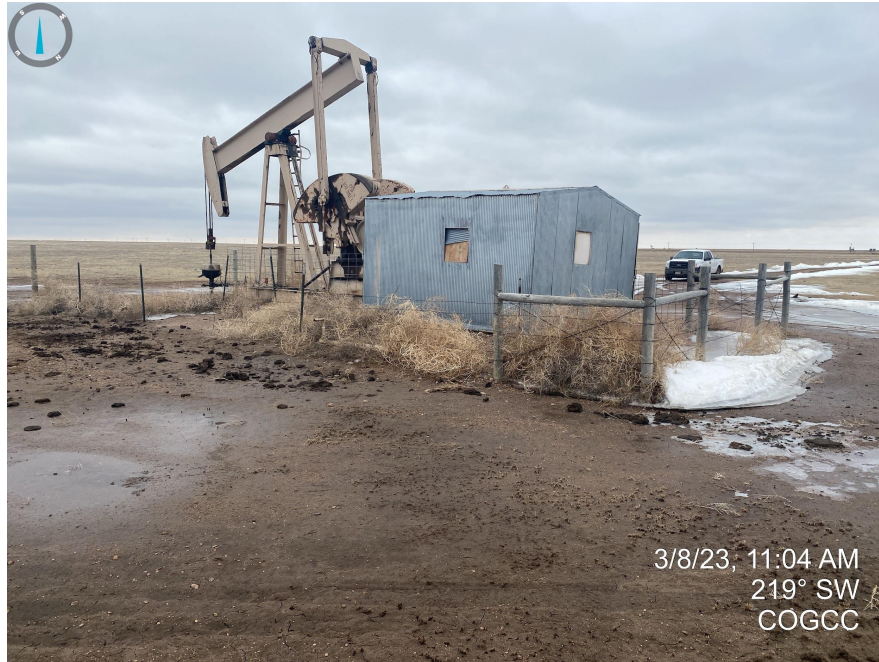
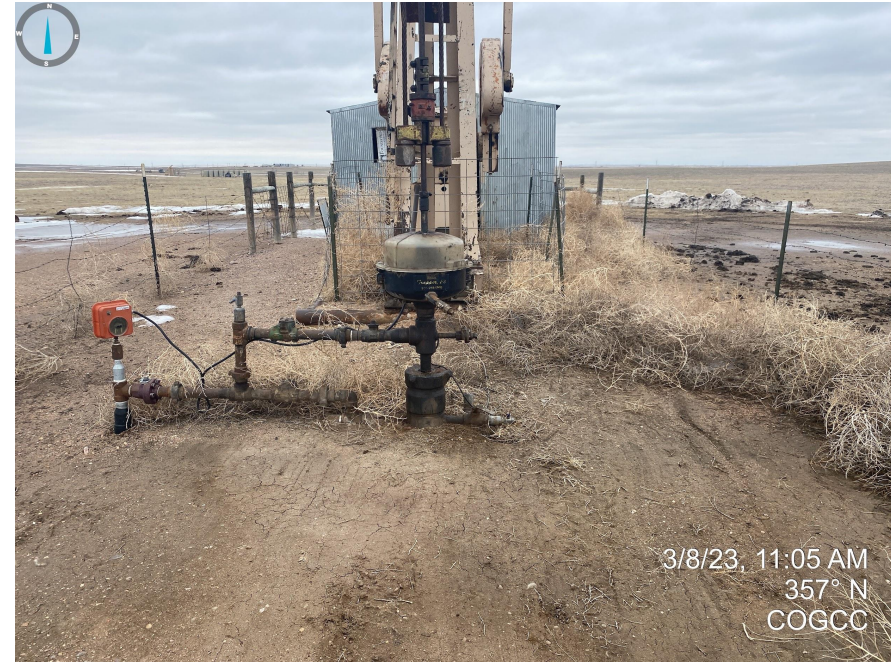
Photos 2 & 3. Facing southwest and north at pump jack. See comments in Photo 1.

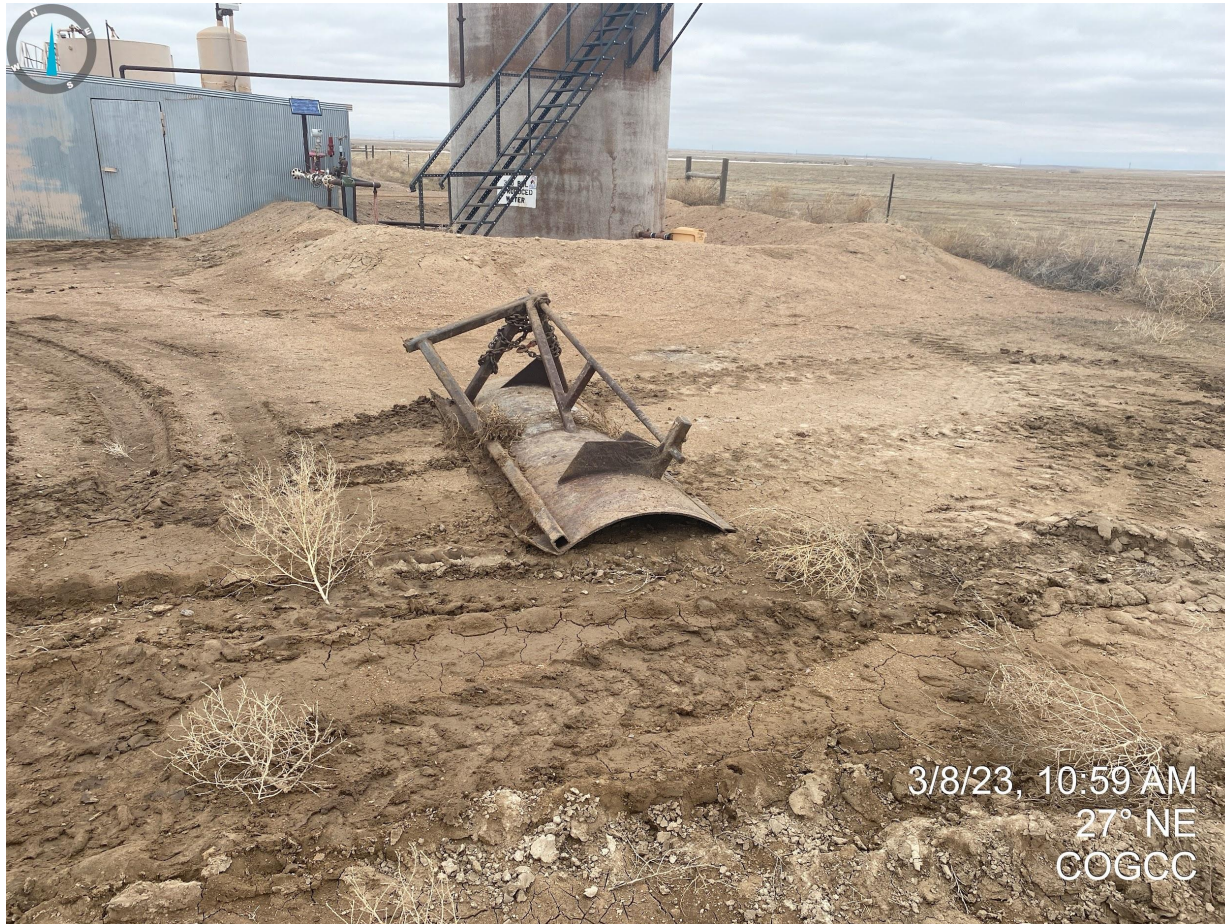
Photo 4. Facing northeast at production equipment. Photo illustrates a snow plow being stored on location; this is considered unused equipment and needs to be removed.

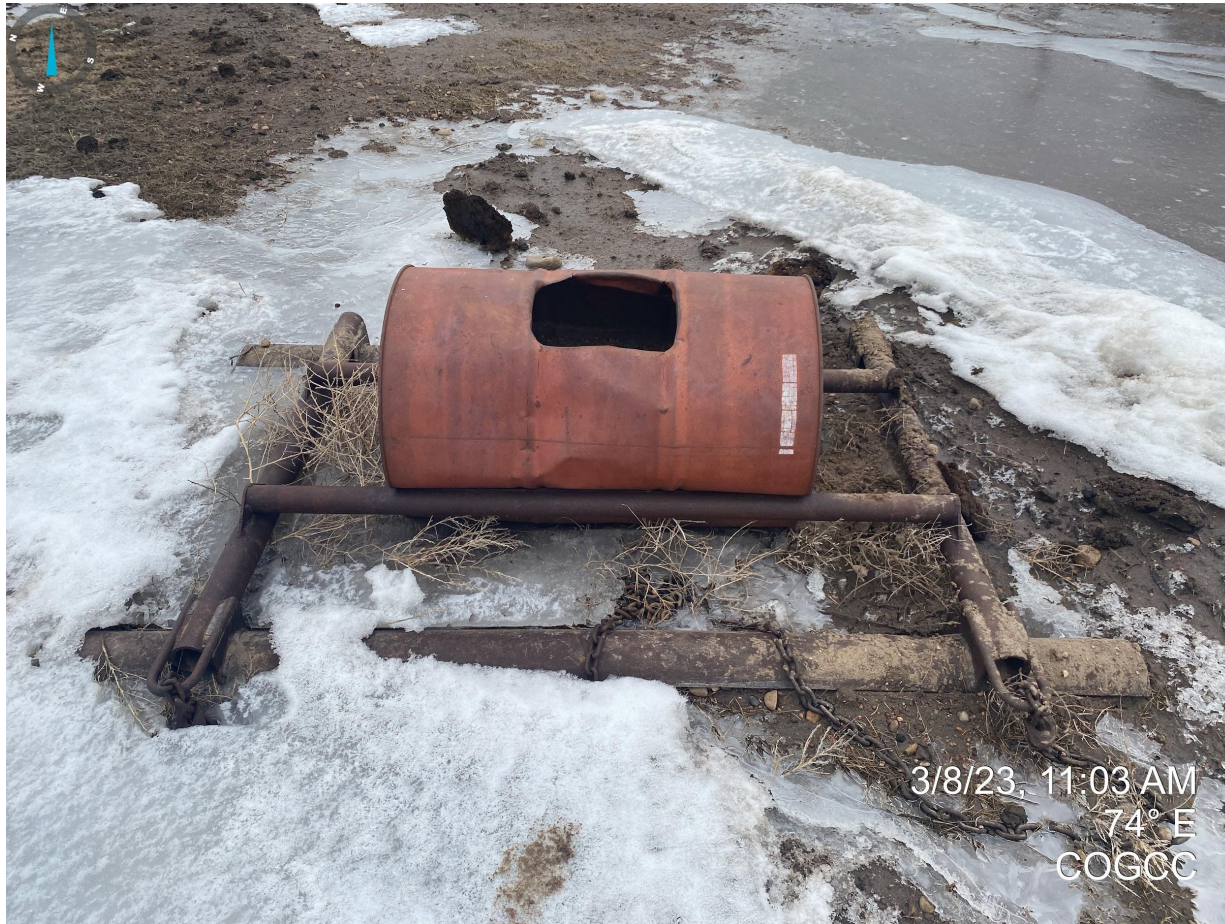
Photo 5. Road drag/maintainer near pumpjack; see comments in Photo 4.
