Inspection Photos

Operator: CHEVRON USA INC - 16700

Location #316728

Rio Blanco County, CO

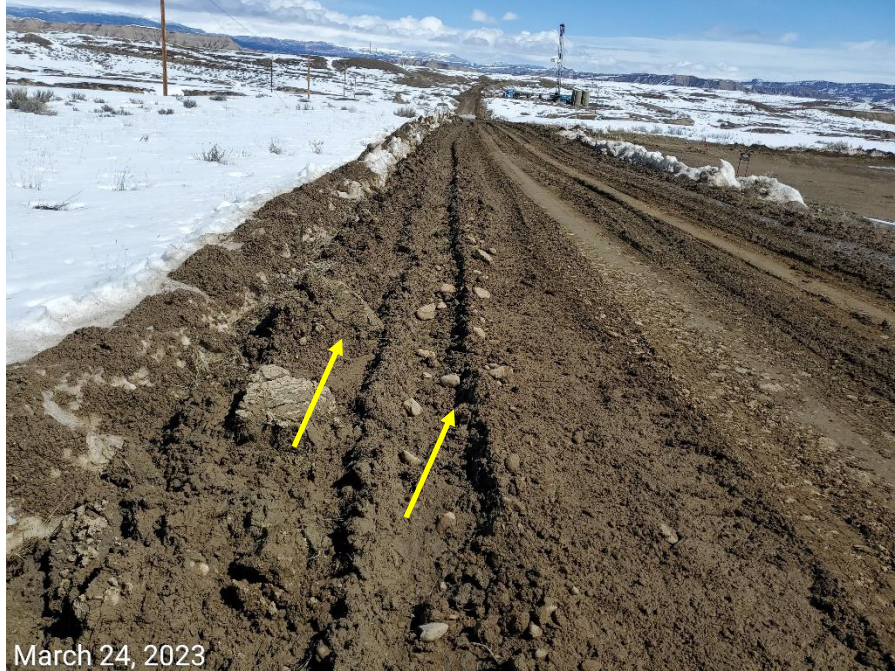
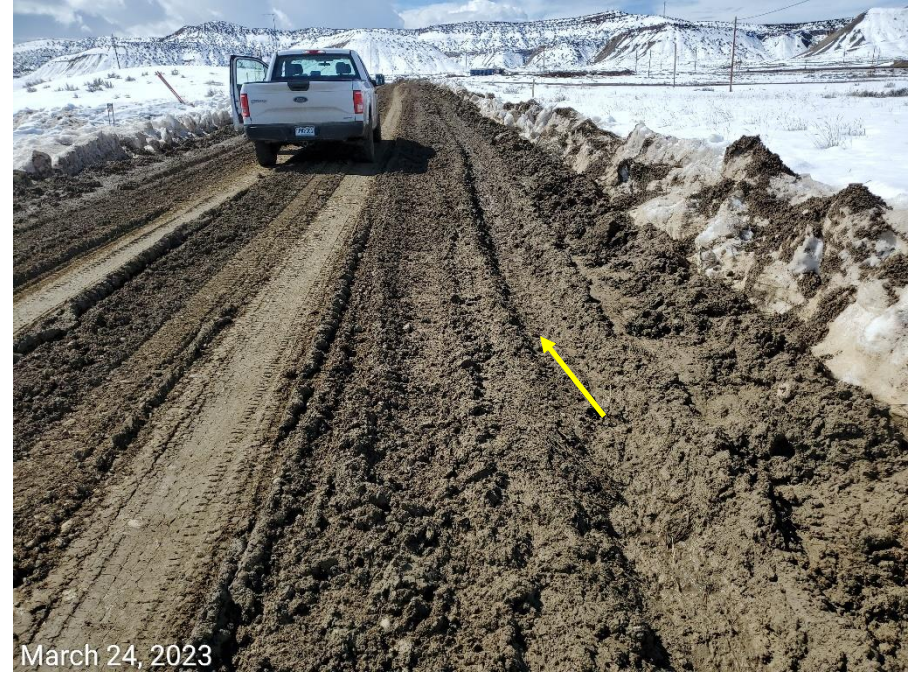
Photo 2: Photos 2-4 provide examples showing BMPs to stabilize, as well as to minimize degradation, tracking and off-site sediment transport are missing or insufficient at the Location and access road.
