# Inspection Photos

API: 055-06041

Operator: OXY USA INC

Inspection Date: 4/10/2023

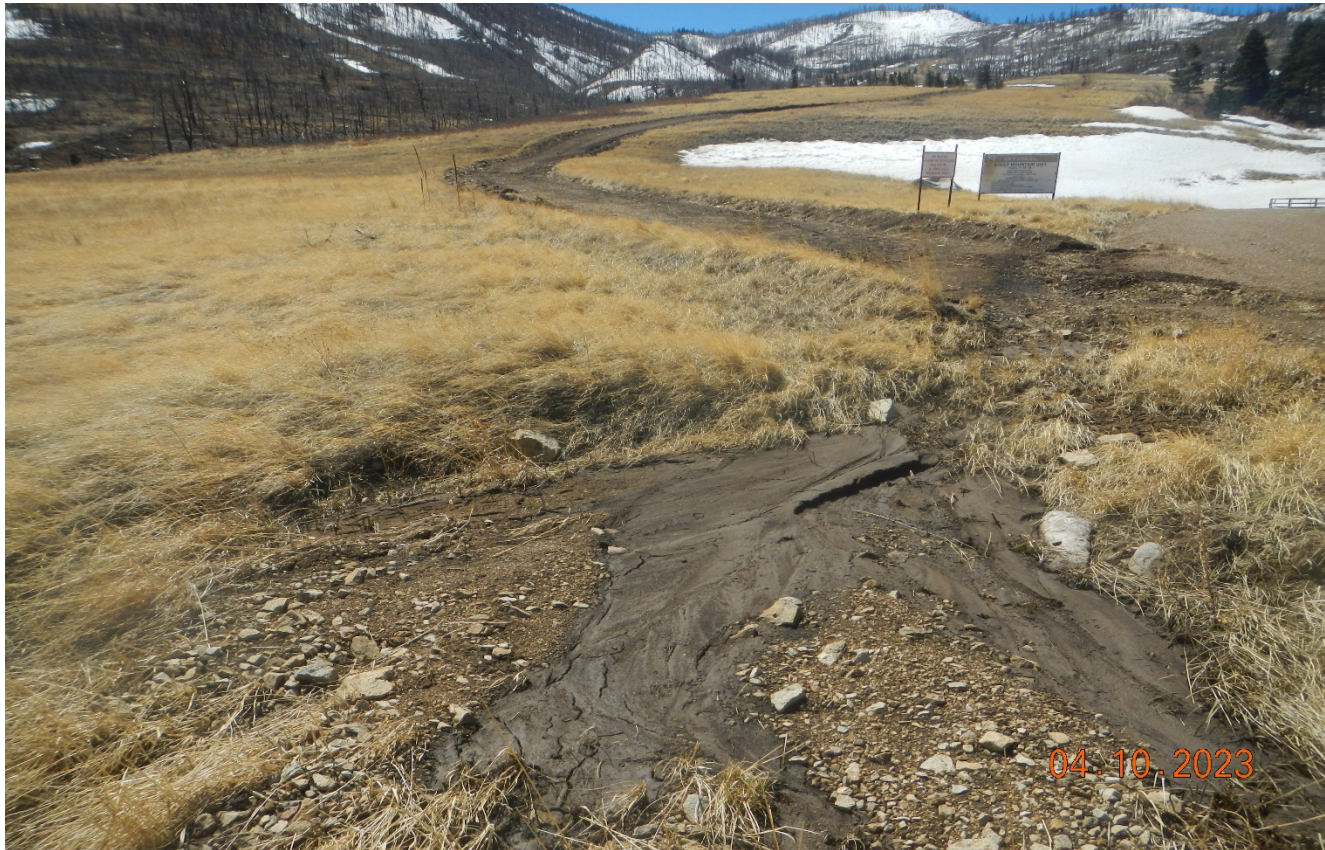
**Photo 1.** Facing southwest along the access road near the SMU #1-12-B . There is sediment from the road depositing in this area off the road causing additional disturbance. BMP's such as a sediment trap should be installed in this area.

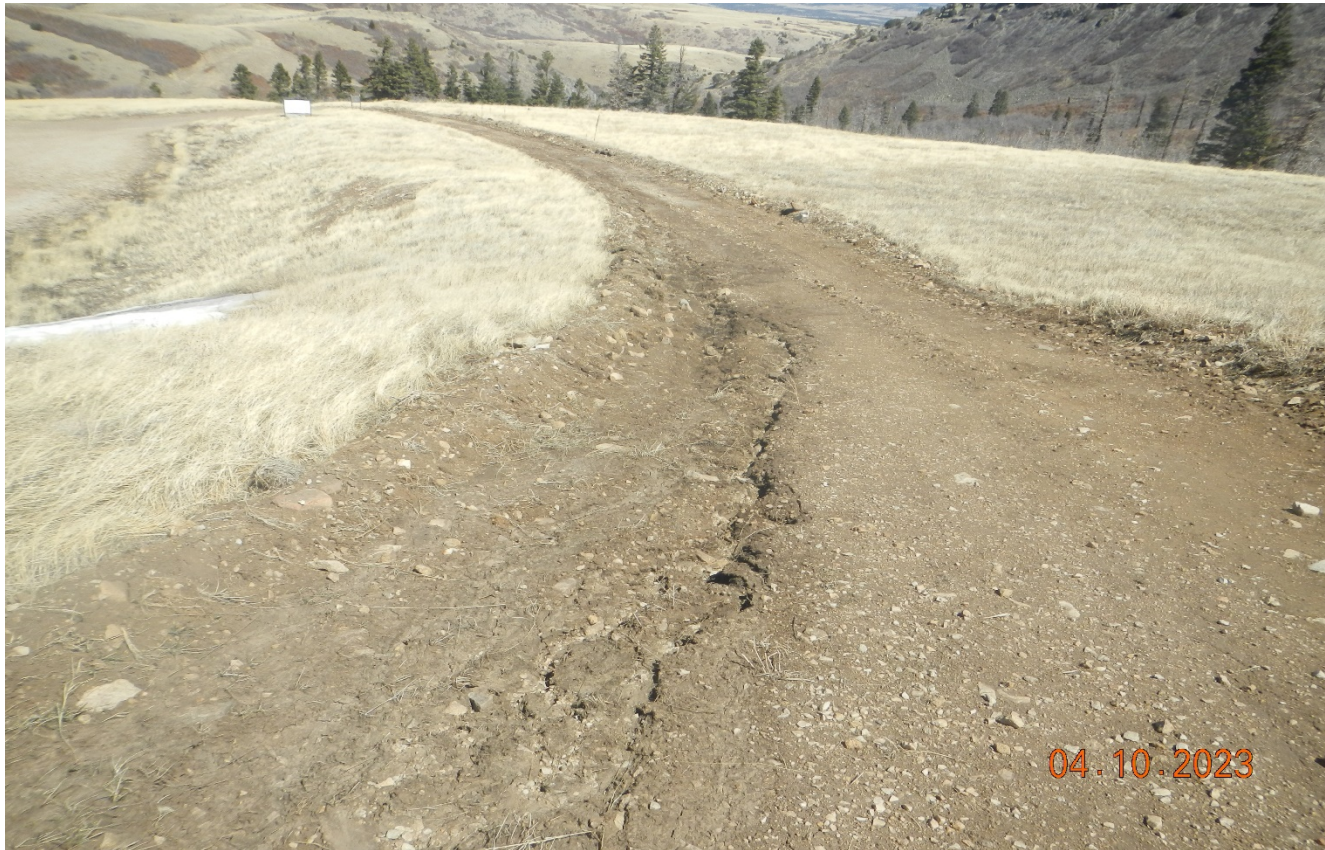
**Photo 2.** Facing southwest along the access road near the SMU #1-12-B . The road was graded along a portion of the road. The concern now is lack of BMP's on this long stretch or road which will direct stormwater and create more erosion.

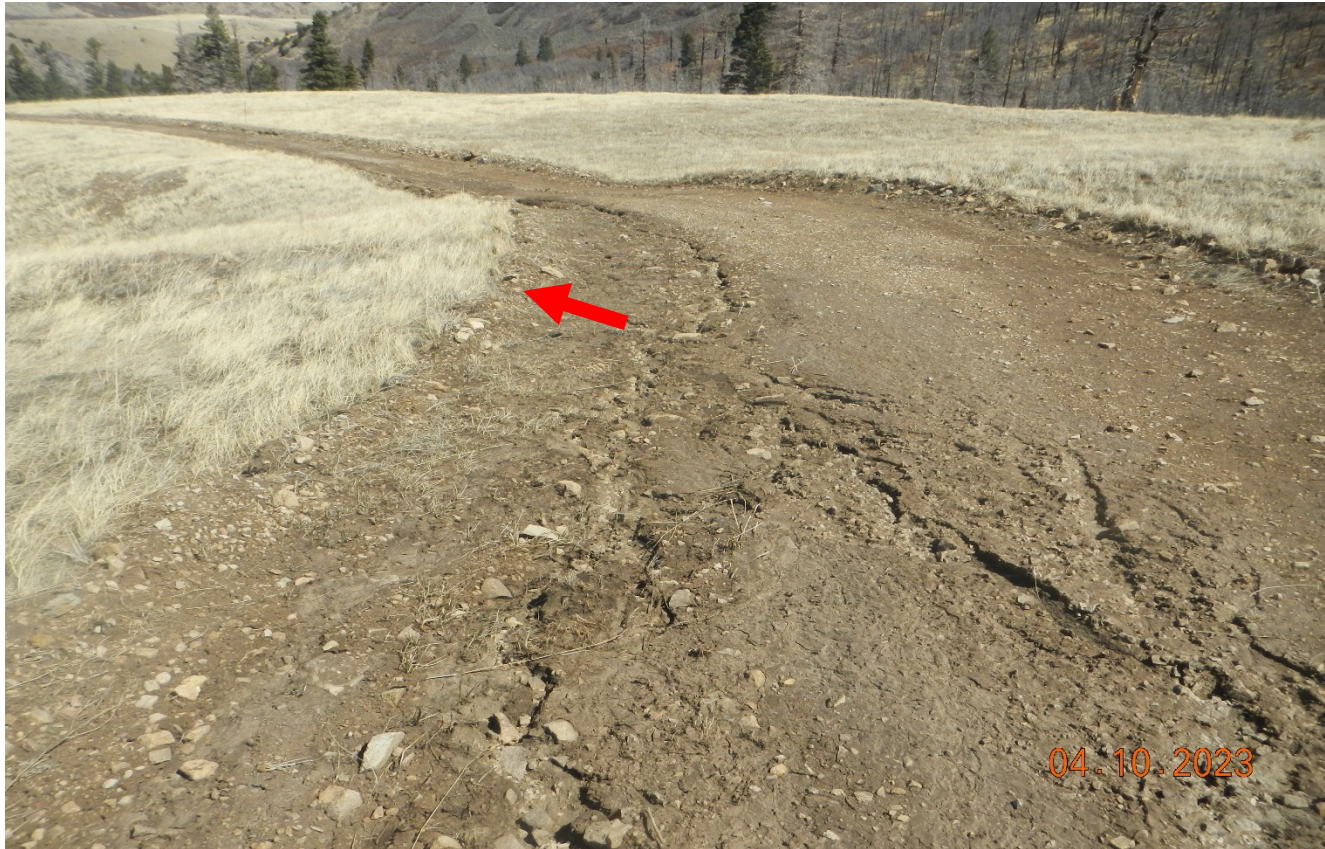
**Photo 3.** Facing northeast. The road will direct stormwater all the way down the road creating erosion. BMP's need to be installed to direct stormwater off the road and reduce stormwater concentration along the road. A diversion ditch would be helpful at the red arrow along with water bars, sediment traps, check dams, ect. For sediment control.

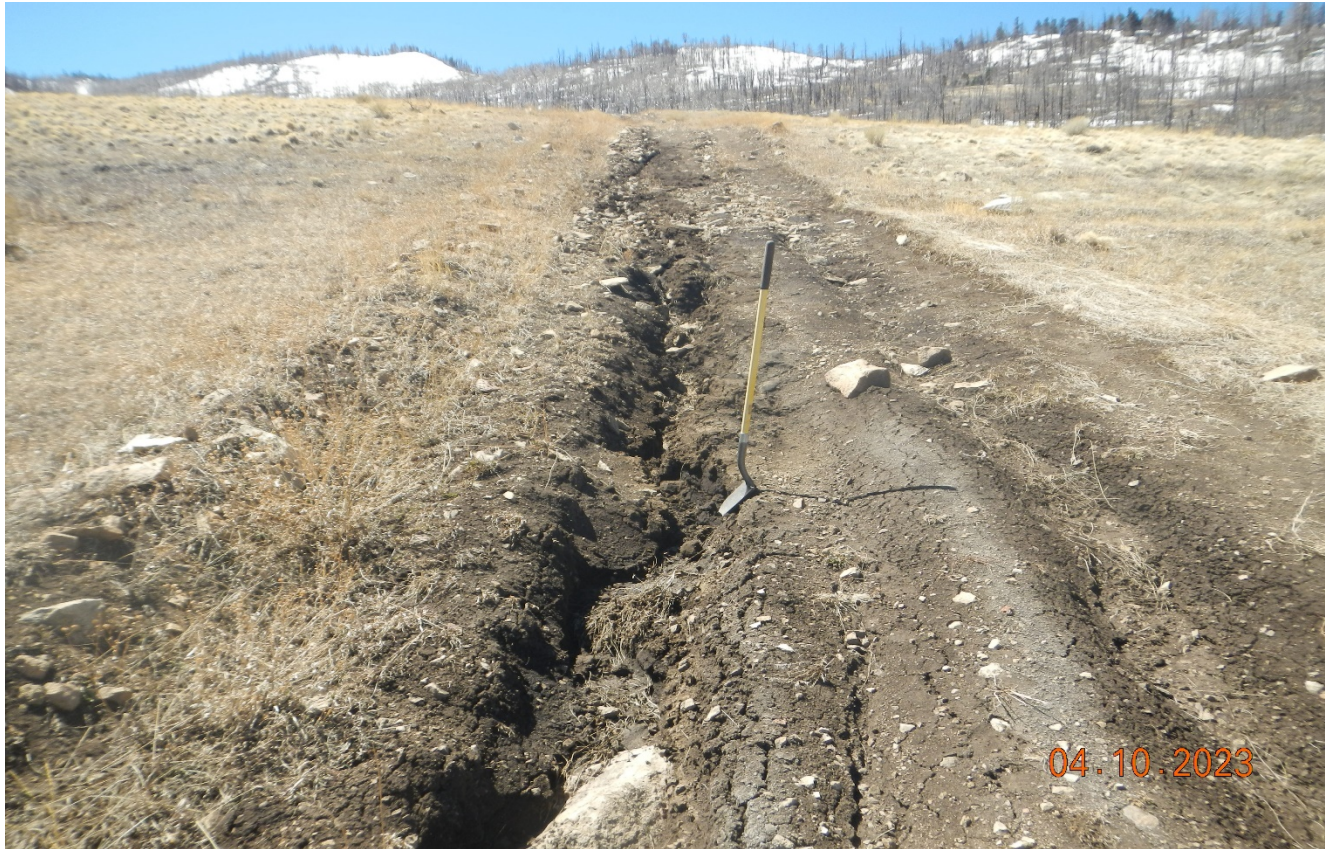
**Photo 4.** Facing southwest along the access road. There are areas of erosion occurring which need to be repaired and stabilized.

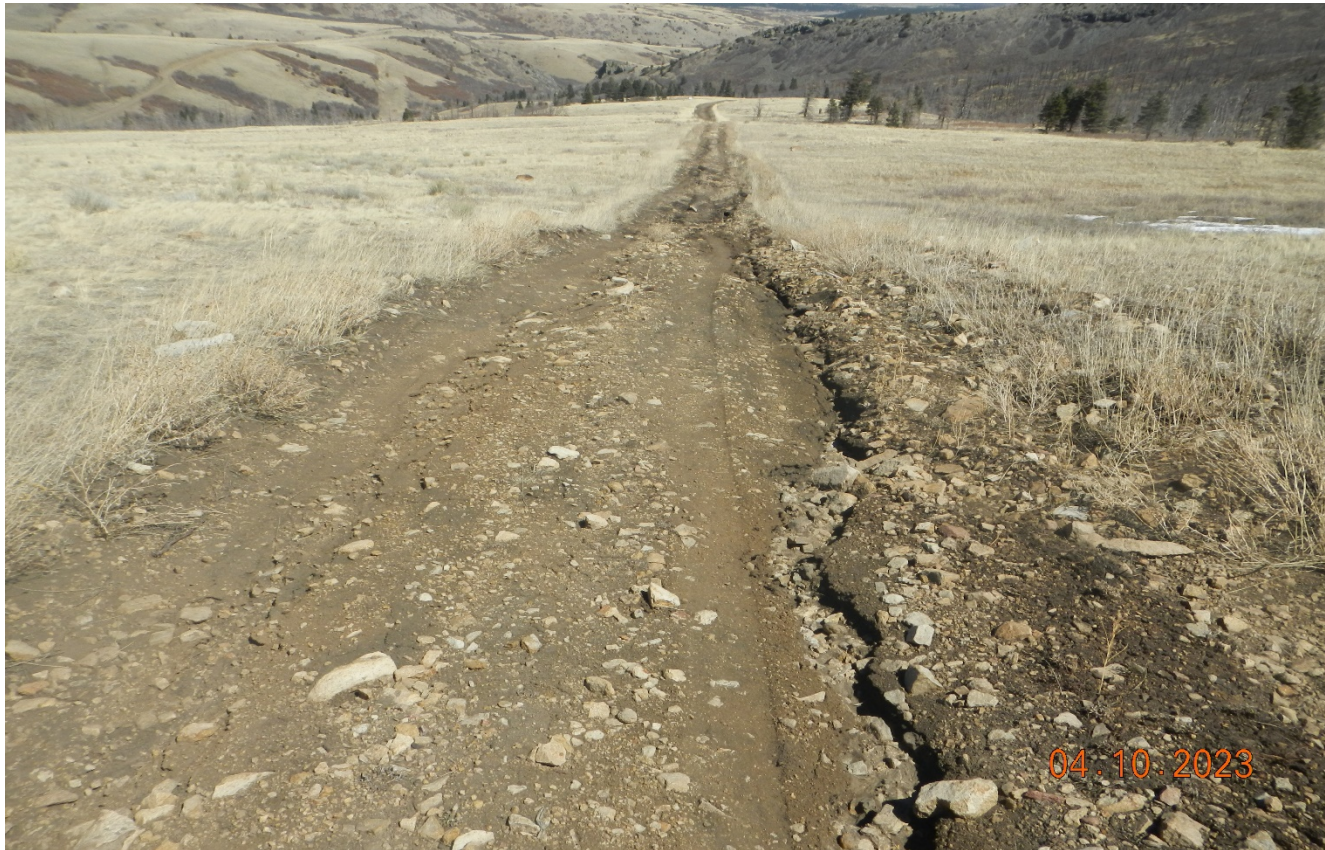
**Photo 5.** Facing back northeast along the access road. Stormwater is directed all the way down the length of the road with no BMP's to divert and control stormwater.
