# Final Reclamation and Stormwater Inspection

Operator: PAR PACIFIC HOLDINGS LLC - 16800

Location ID: 404527

Inspection Document #: 708200193

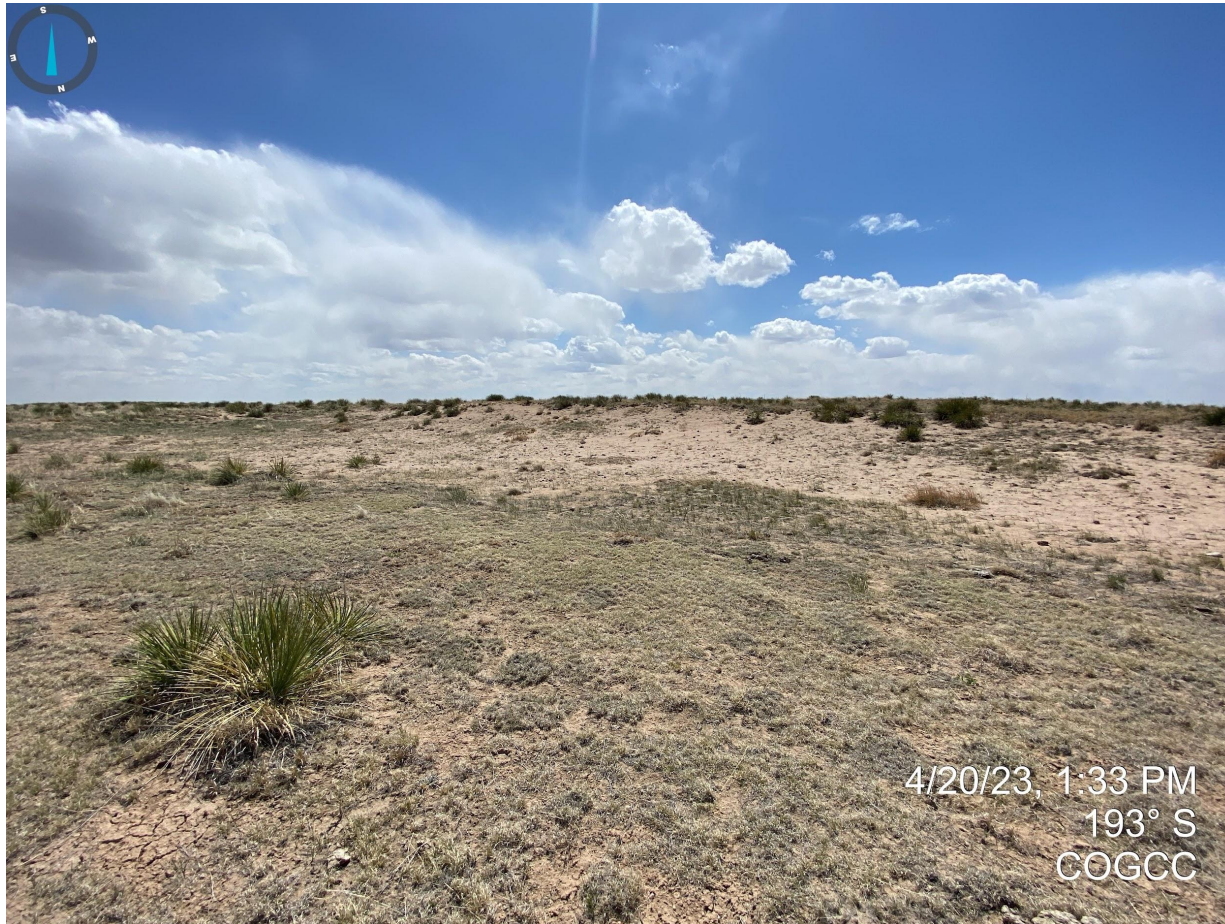
**Photo 1.** Photo illustrates that the cut bank on the southwestern portion of the location remains predominantly bare soil with little establishment of desirable plant species. The cut bank is not protected from wind and water erosion and requires additional reclamation activities to comply with Rule 1004.

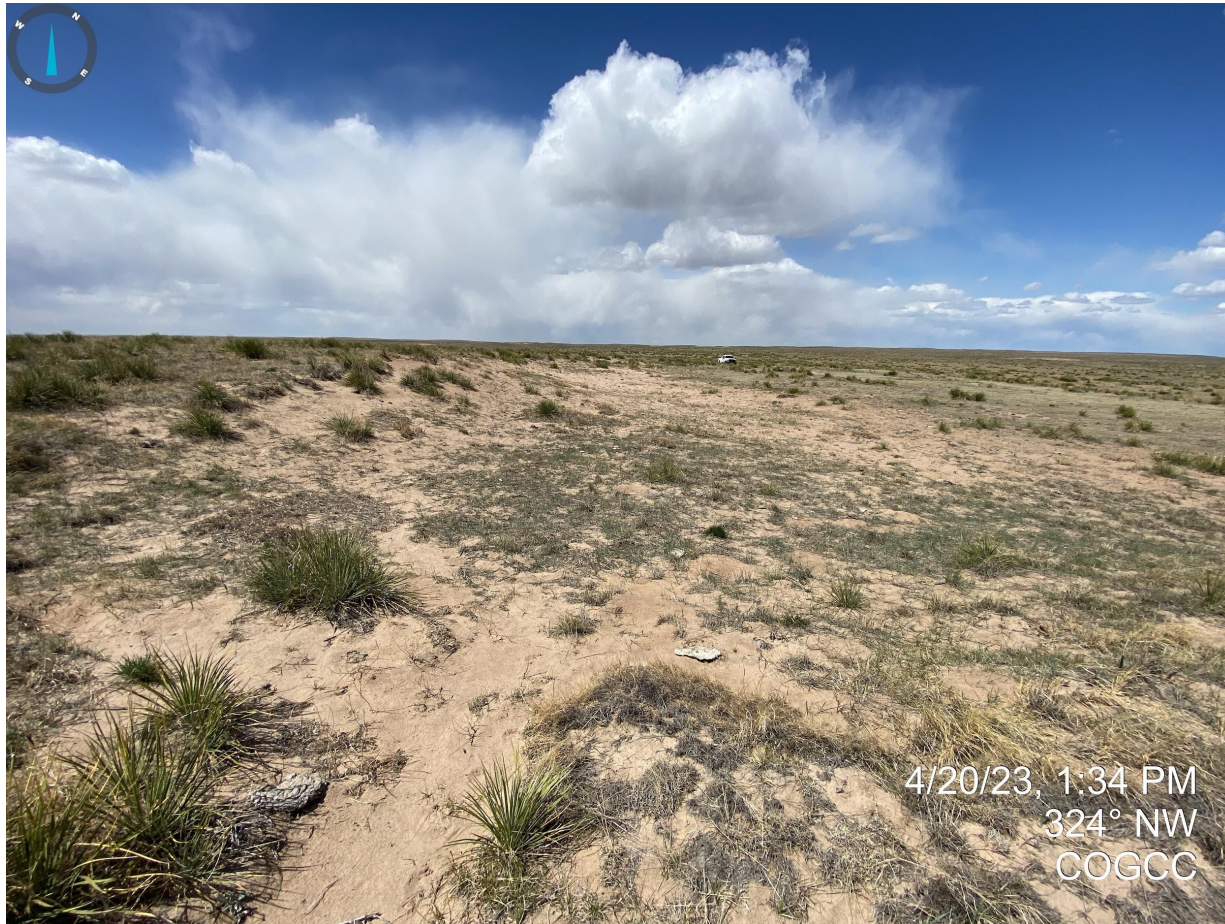
**Photo 2.** See comments in Photo 1.

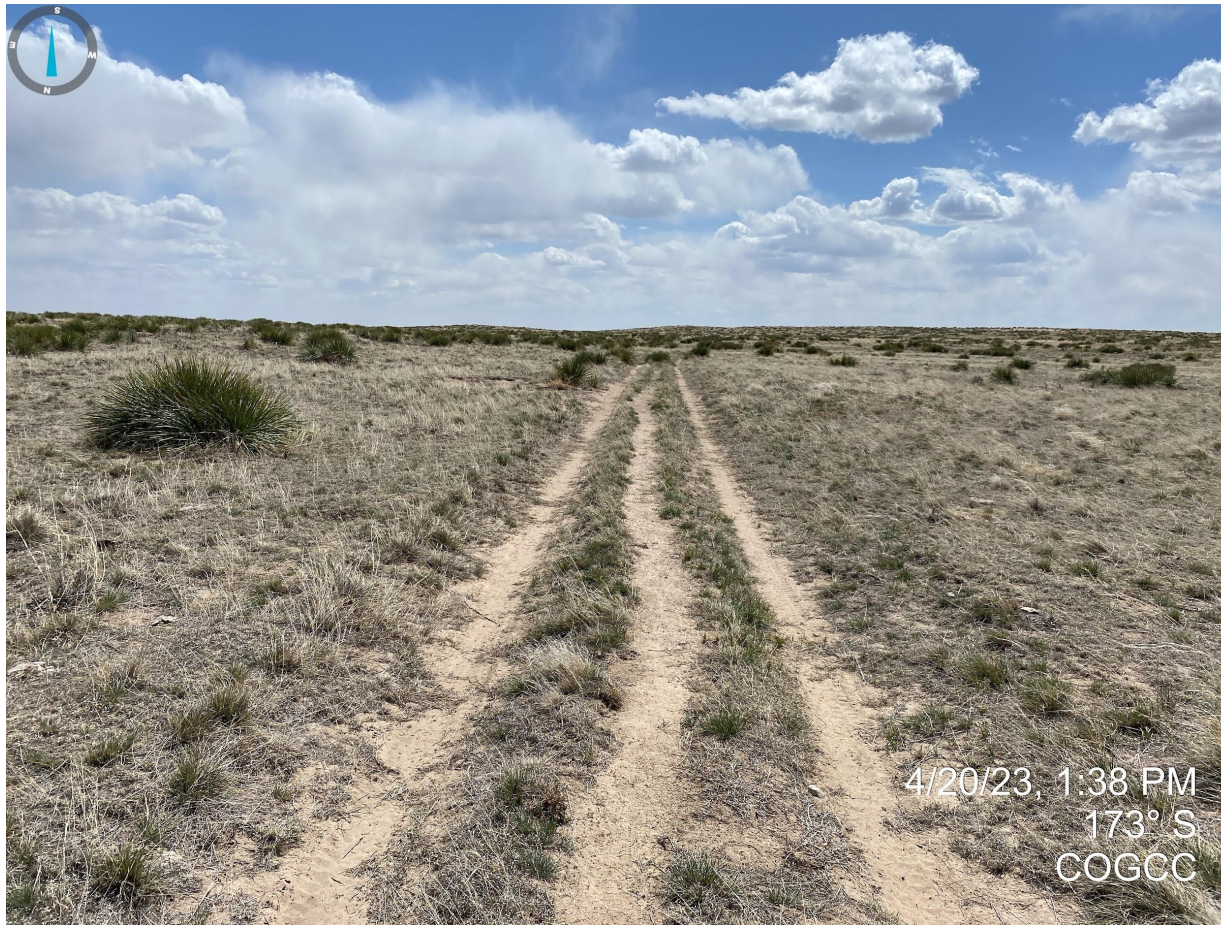
**Photo 3.** Access road leading to location will require additional reclamation activities to comply with Rule 1004 reclamation standards.
