Interim Reclamation and Stormwater Inspection

Operator: NOBLE ENERGY INC - #100322

Location ID: 302349

Inspection Document #: 697504661

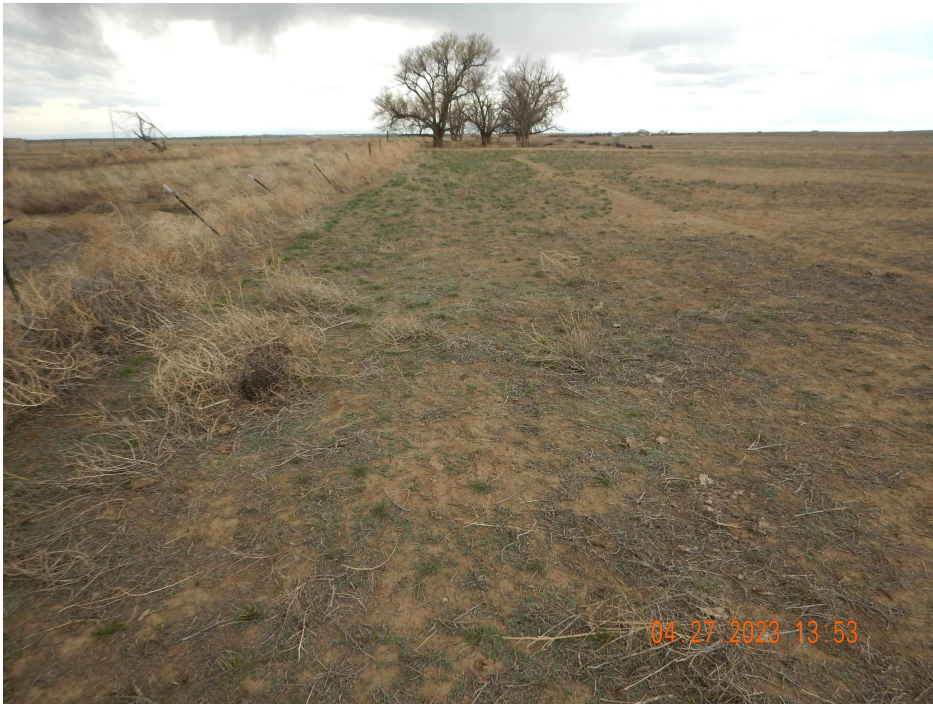
Photo 1. Photo taken from the associated offsite tank battery, facing West. Photo illustrates the division of the shared tank battery with PDC. PDC is to the right of the weedy fence line and Noble is to the left of the weedy fence line.

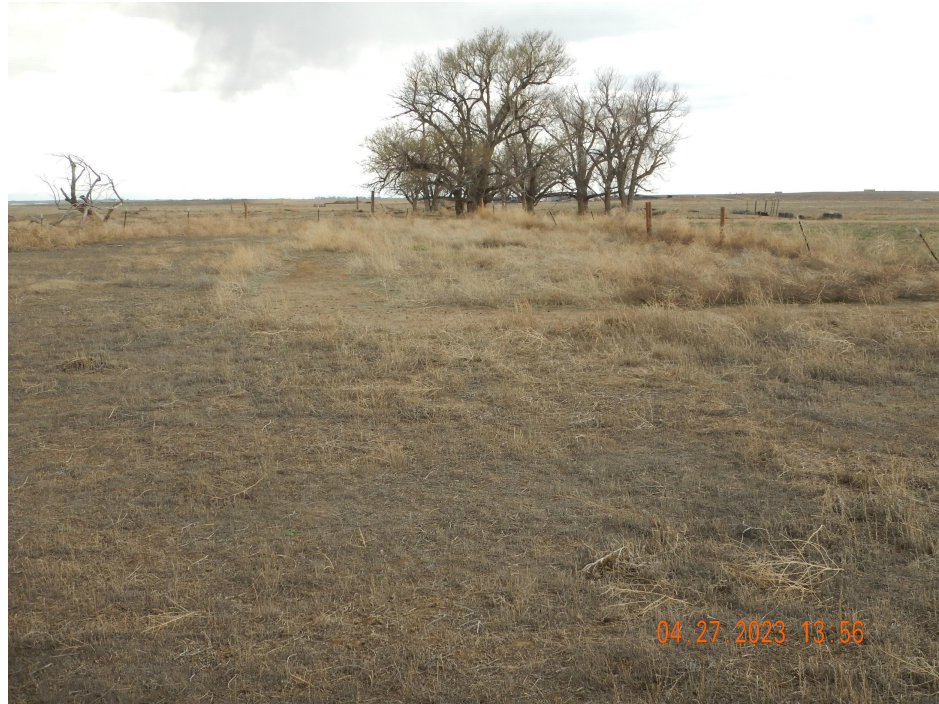
Photo 2. Photo taken from within the Noble tank battery, facing West. Photo illustrates weedy, annual vegetation that is not reflective of reference areas.

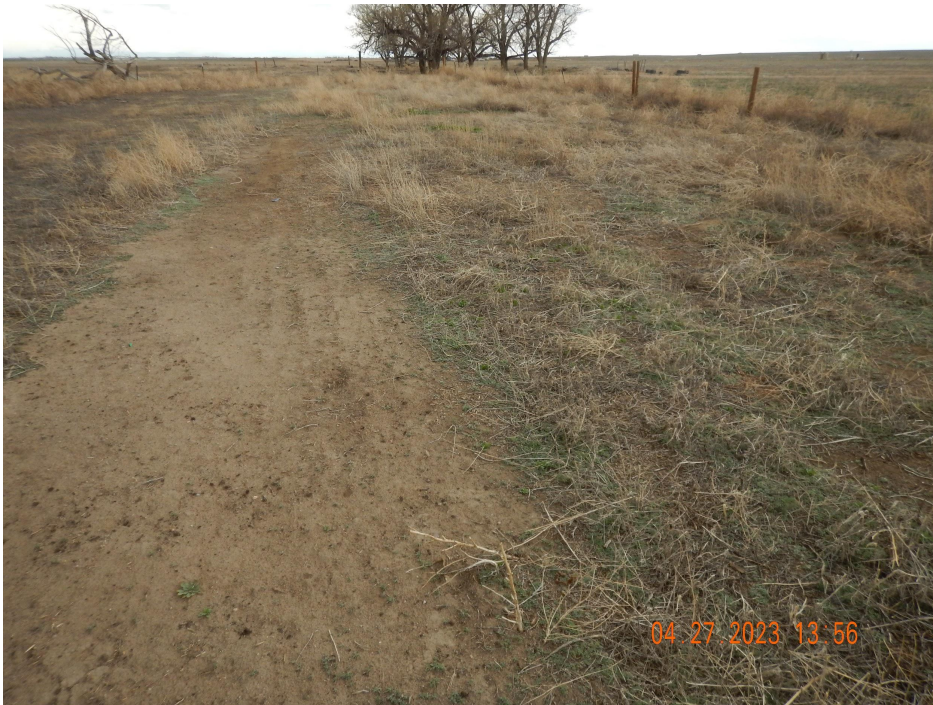
Photo 3. Photo taken from within the Noble tank battery, facing West. See comments under Photo 2.

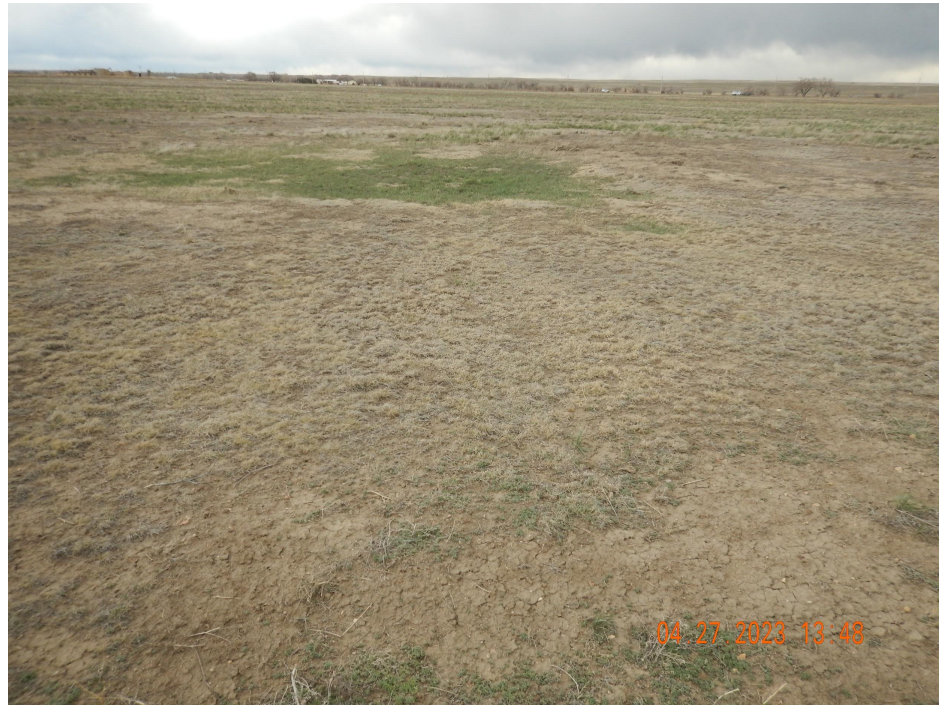
Photo 4. Reference photo taken north of the tank battery, facing East.

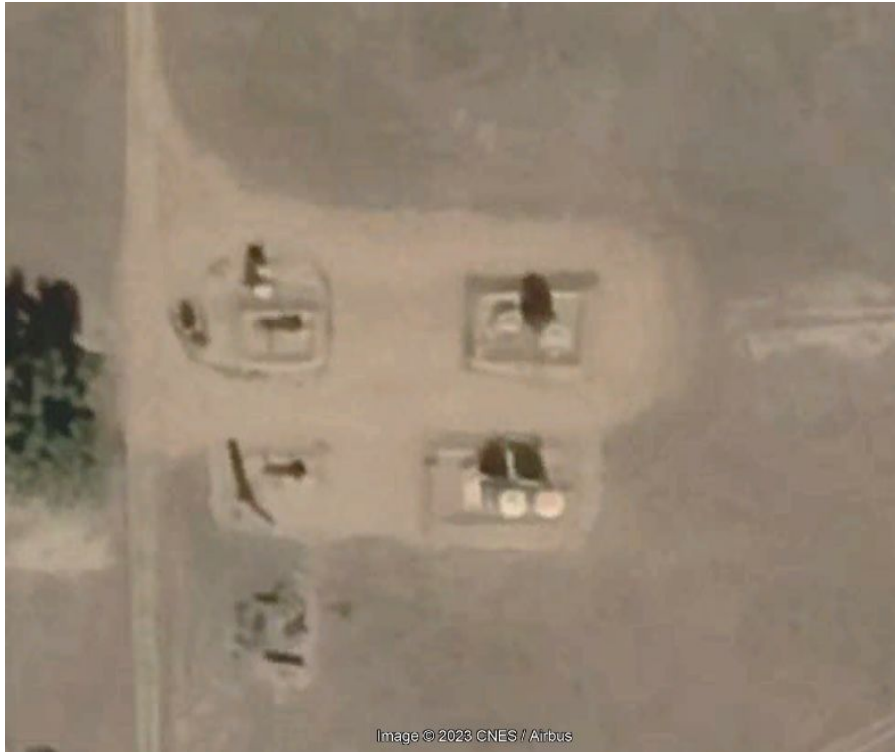
Photo 5. Google Earth aerial imagery from 9/25/2018 illustrates the shared tank battery. PDC's portion of the tank battery is the northern half, while Noble's portion is the southern half.

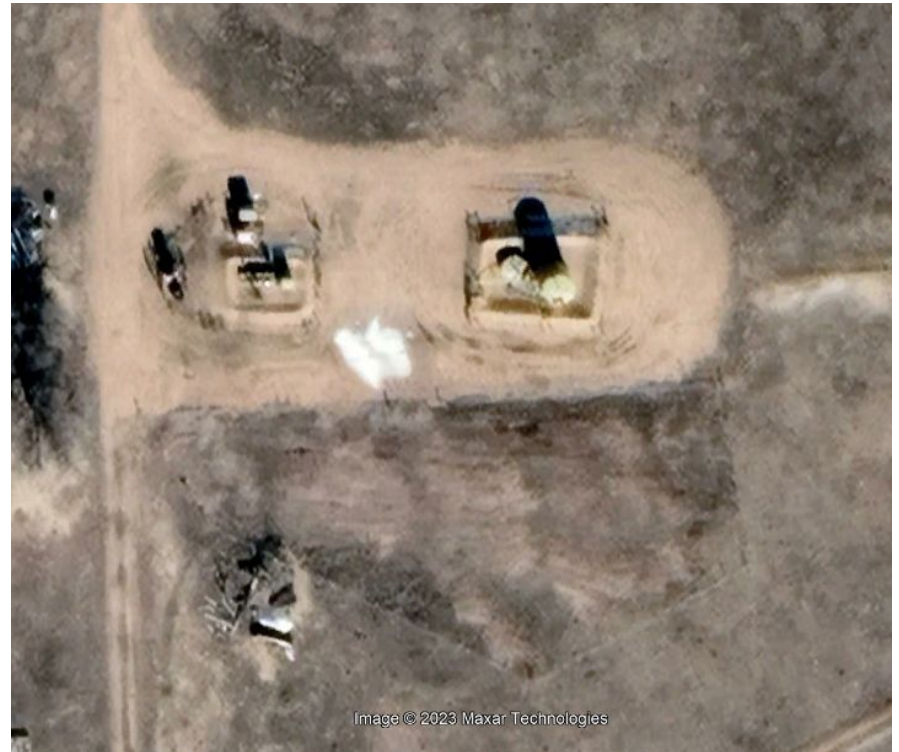
Photo 6. Google Earth aerial imagery from 2/2020 illustrates PDC's active portion, while Noble's portion has been fenced off.
