Inspection Photos

Operator: LOCIN OIL CORPORATION - 51130

Location Number: 323855

Garfield County, CO

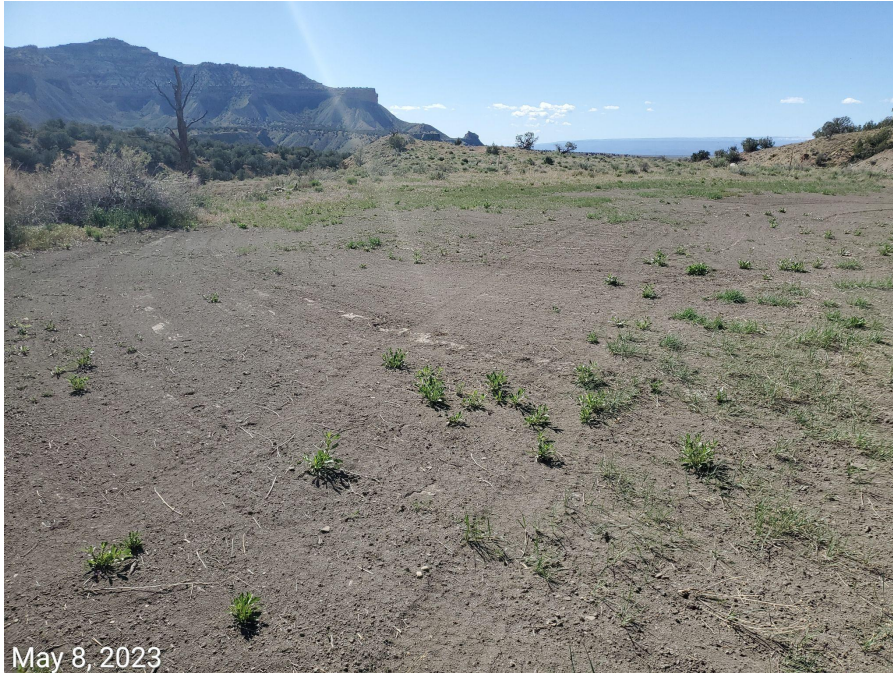
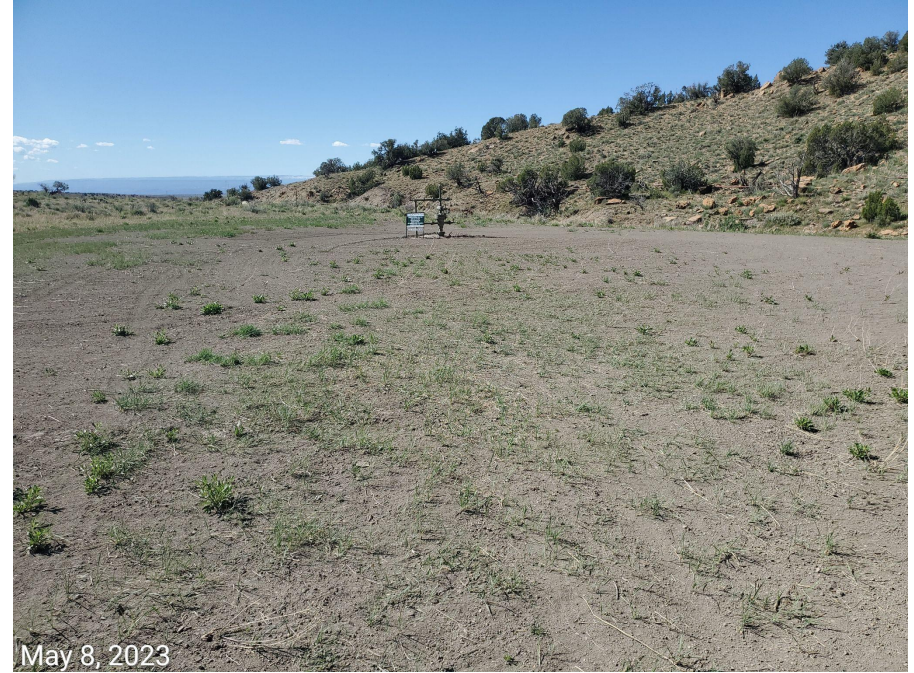
Photo 1: Photos 1-2 taken from the north end of the Location. Photos provide an overview of the Location from east, southeast, southwest to west.

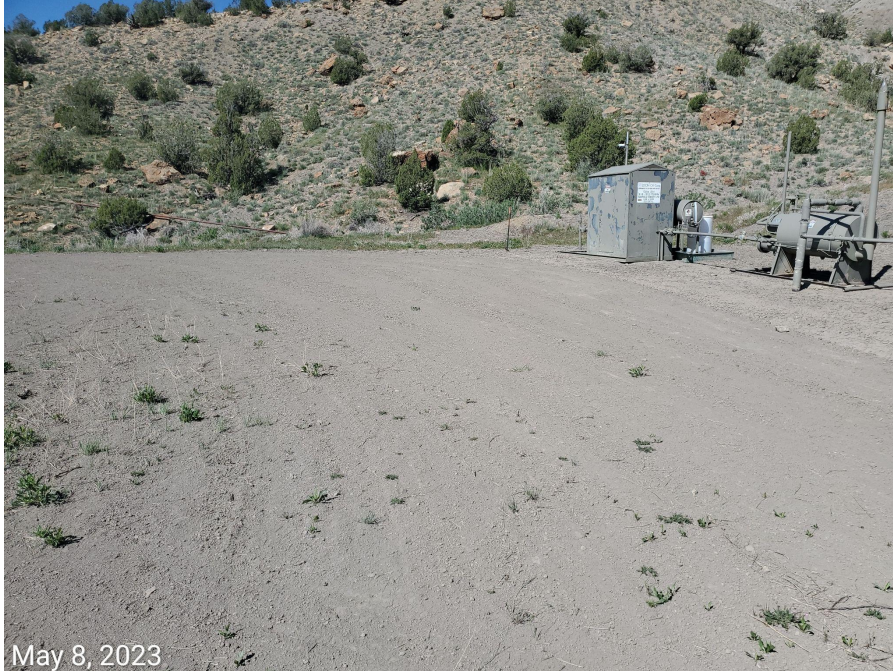
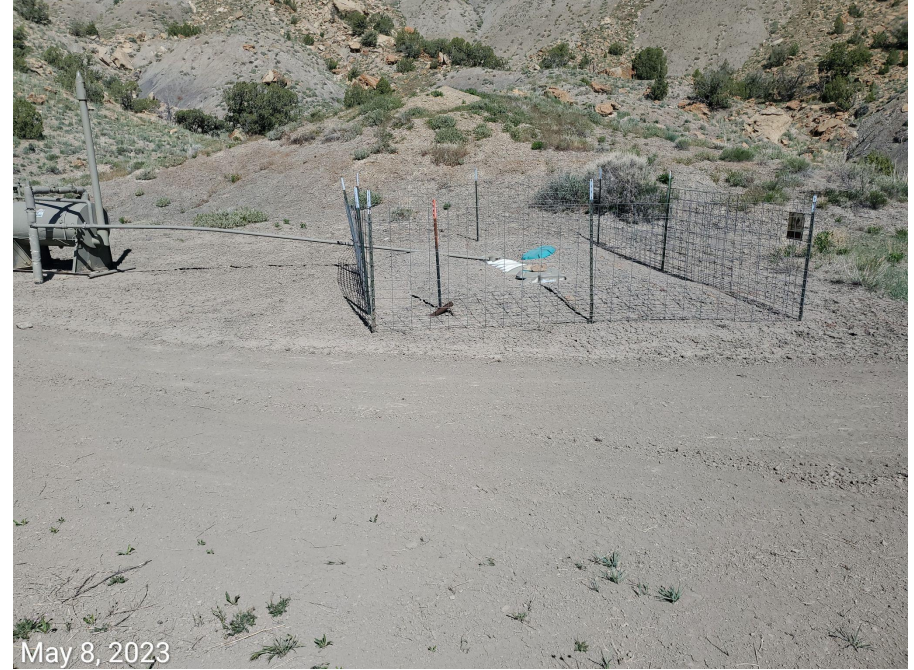
Photo 2: See comments under photo 1. Photo right also shows partially buried tank battery. Signage at facility does not comport with 605 Rules.

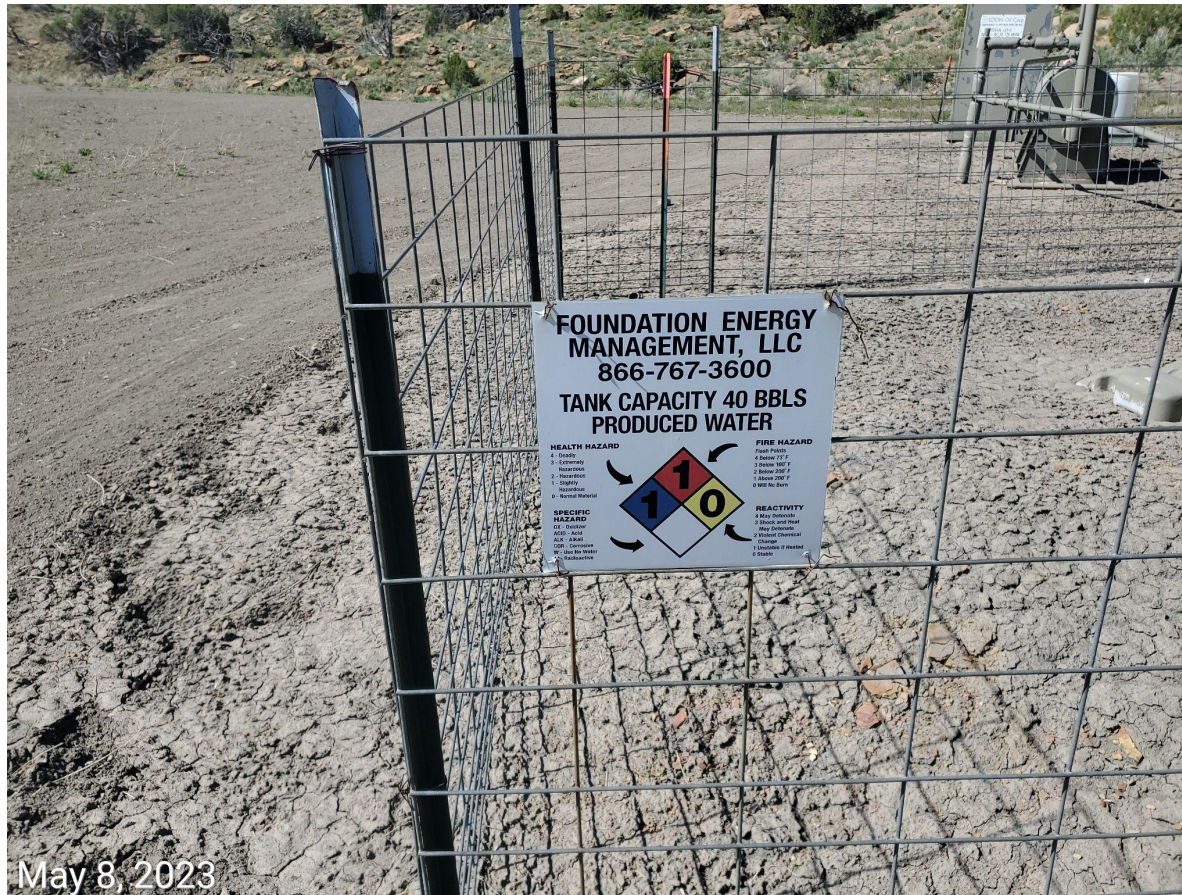
Photo 3: Signage at battery facility/tank remains inaccurate. Labels not observed on partially buried tank. Signage at battery does not comport with Rules 605.e and 605.h

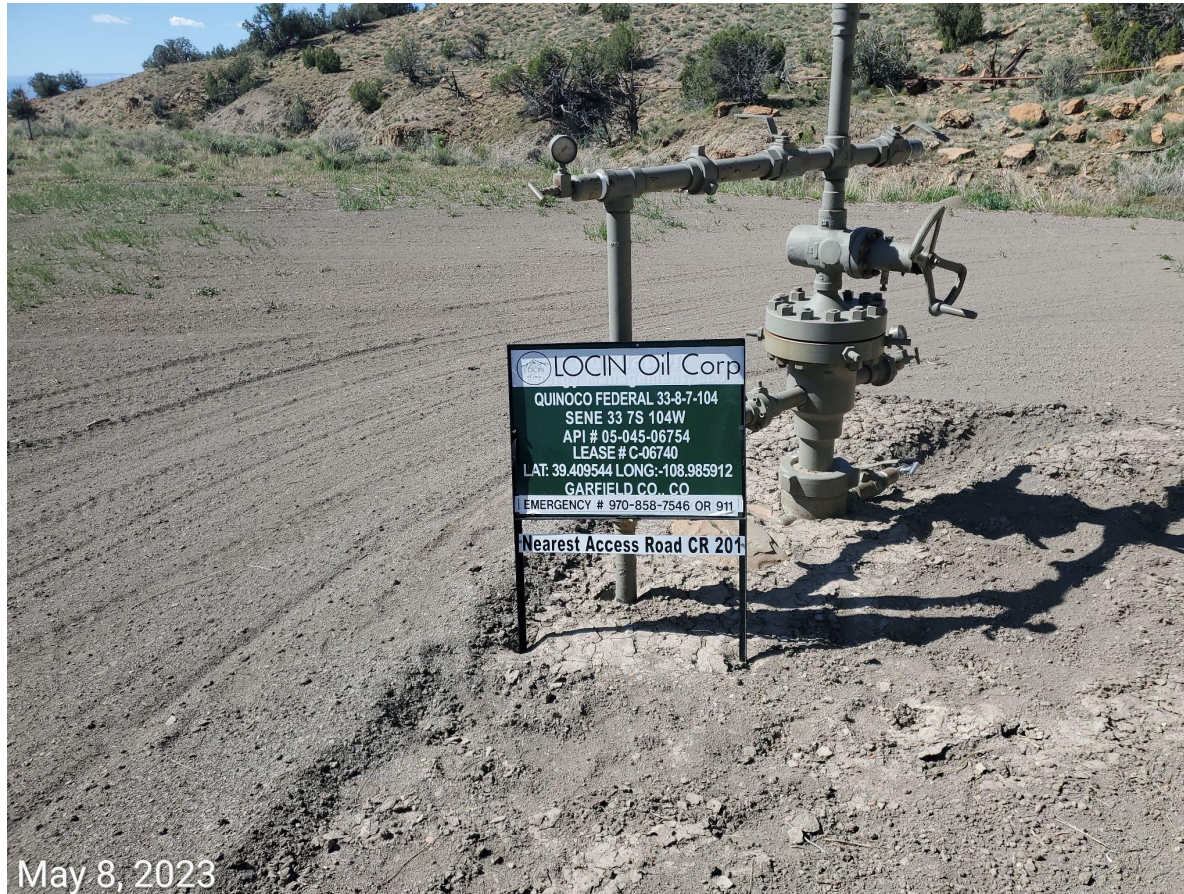
Photo 4: Wellhead.

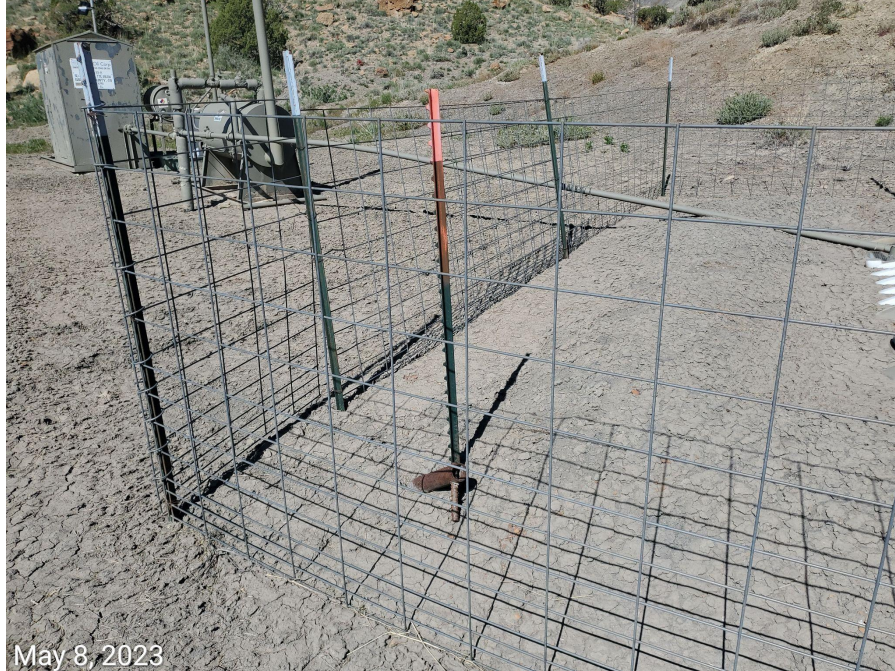
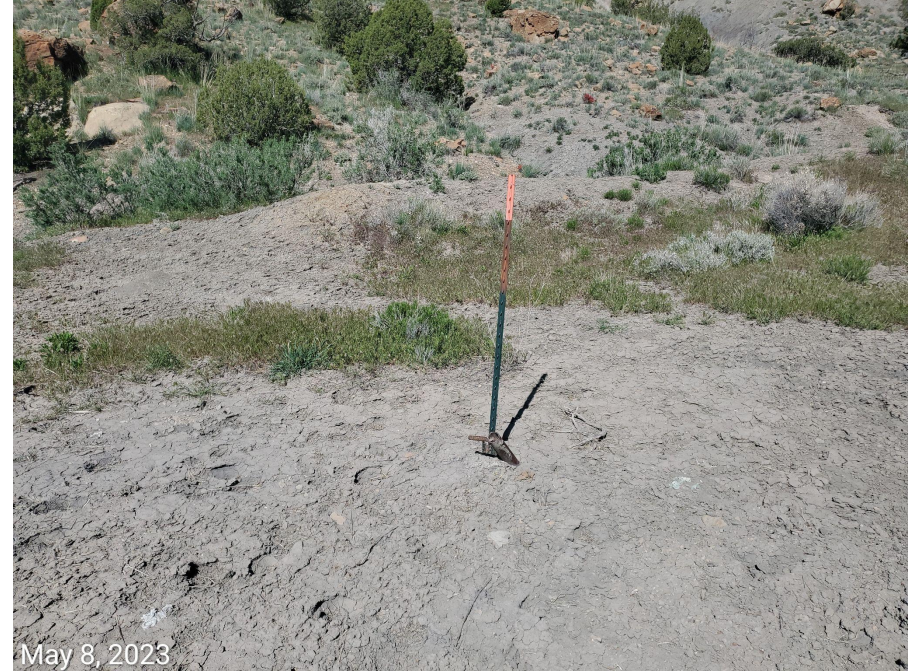
Photo 5: Photos 5-6 show anchors on the Location have been identified by a marker of bright color not less than four (4) feet in height.

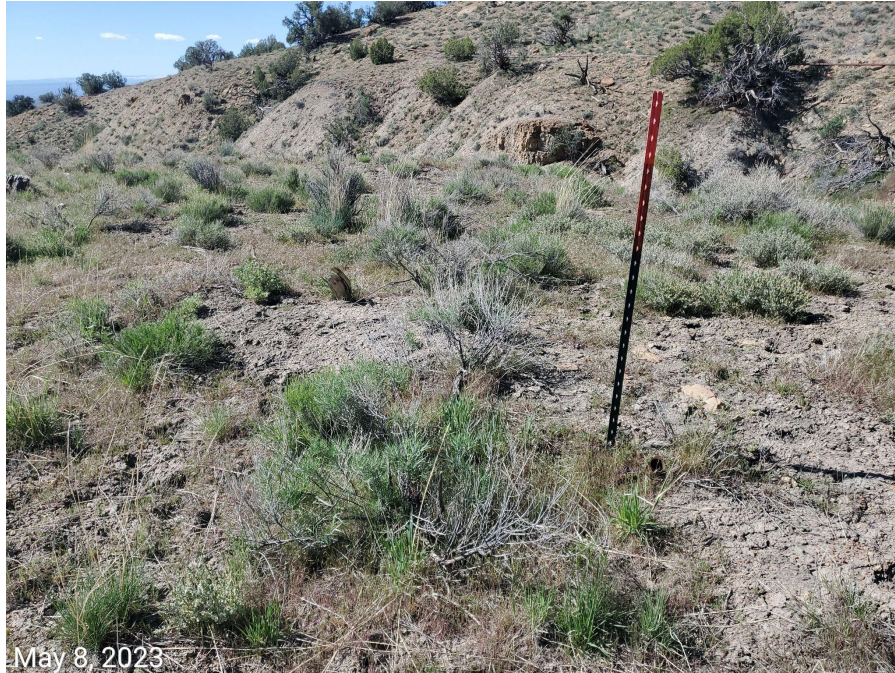
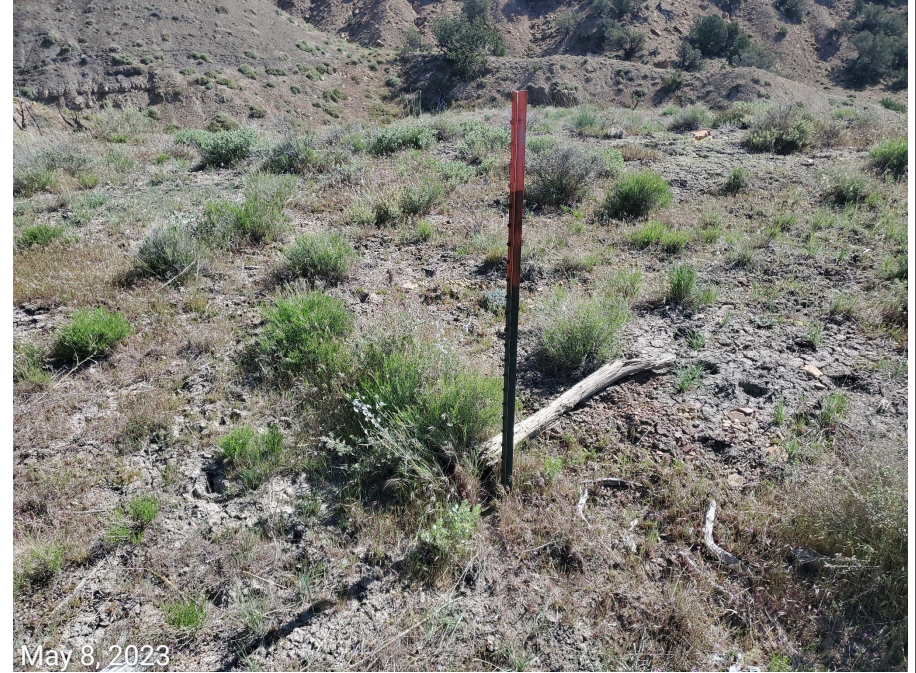
Photo 6: See comments under photo 5.
